## 13 St Johns St, Manchester

### Gazetteer

### **GAZETTEER**

This gazetteer was compiled in 2019 by The Bernard Taylor Partnership Ltd.

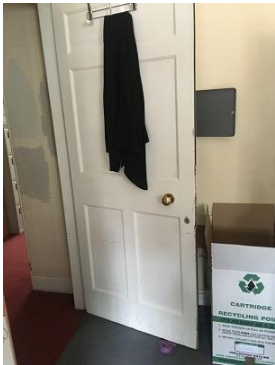
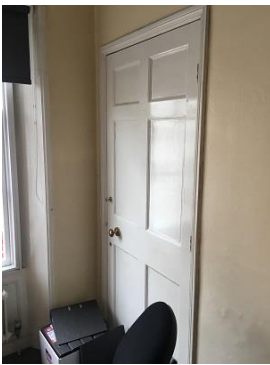
| <b>Entrance door</b><br> | <b>Internal door</b><br> | <b>Windows</b><br> |

| <b>Issues:</b><br>Suspect high portion has been re-plastered. Window fenestration does not match neighbouring properties. Modern radiators and surface mounted trunking. | <b>Policies/recommendations:</b><br>Additional bathroom introduction to allow for adaptive reuse for residential, conservation roof light to rear annex. Removal of radiators and trunking, installation of new radiators. Retention of original doors. |

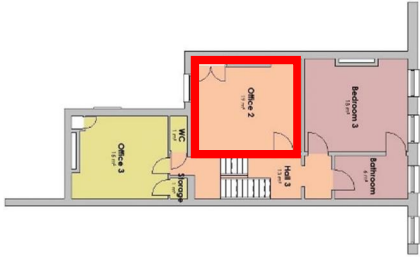
| <p>13 ST JOHNS ST<br/>2<sup>nd</sup> Floor, Rear Office</p> | <p>Gazetteer item No: 4</p> <p>Designation:<br/>Grade 2</p> |

| <p><b>Brief description:</b><br/>More modest features than ground and first, simply decorated, plastered, no cornice. Chimney breast in place, 20th Century, Chimney cupboard added, artex ceiling, new window panel</p> | <p><b>Summary history:</b><br/>Mid room possibly used for bedrooms/servants, current use is office</p> |

| <p><b>Issues:</b><br/>Suspect high portion has been re-plastered. Surface mounted trunking, damage to architraves.</p> | <p><b>Policies/recommendations:</b><br/>Additional bathroom introduction to allow for adaptive reuse for residential. Removal of radiators and trunking, installation of new radiators. Retention of original doors. Removal of unnecessarily closers</p> |

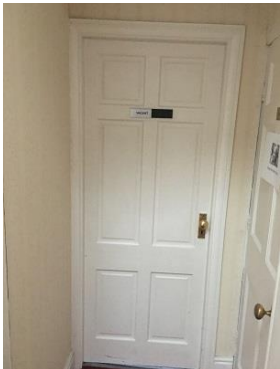
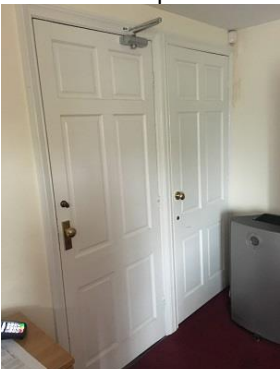
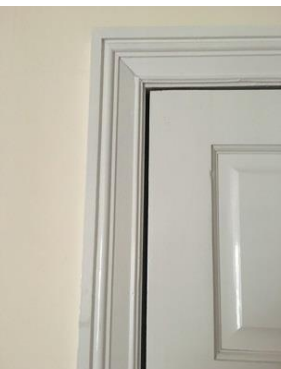
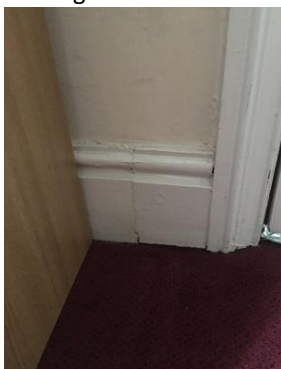
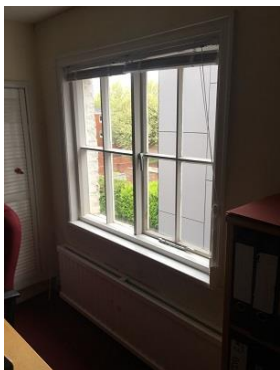
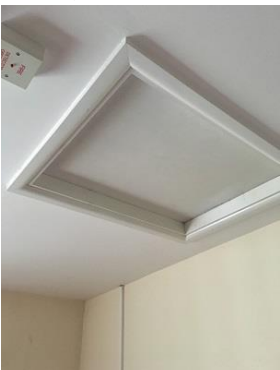
| <p>Entrance door</p> | <p>Entrance &amp; cupboard doors</p> | <p>Architrave</p> | <p>Skirting</p> |

| <p>Issues:<br/>Suspect high proportion has been re-plastered. Space has been subdivided, 20<sup>th</sup> Century doors and windows. Chimney breast boxed in</p> | <p>Policies/recommendations:<br/>Replacement of doors and windows with high quality facsimiles. Refine chimney breast. Conservation roof light addition. Removal of radiators and trunking, installation of new radiators/ sockets.</p> |

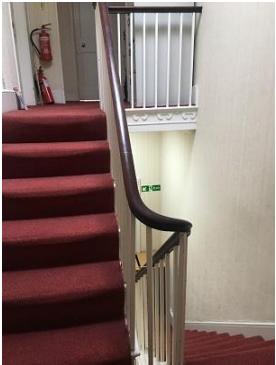
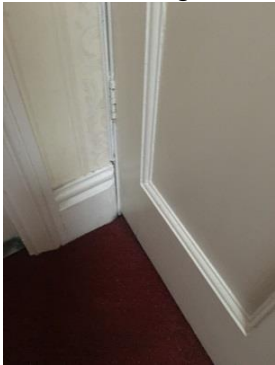
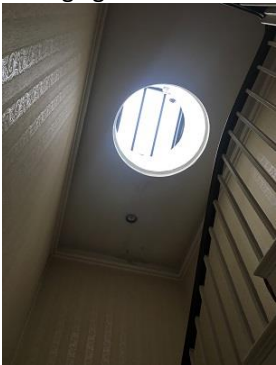
| <p><b>Handrail</b></p> | | <p><b>Skirting</b></p> | |

| <p><b>Brief description:</b><br/> Timber handrail swept over slender square balustrades, original doors to front part of the floor. New plaster evident on landing wall. Leaks evident form roof.</p> | <p><b>Summary history:</b><br/> Original staircase and balustrade, original plaster features and light well, with 20<sup>th</sup> Century roof finish.</p> |

| <p><b>Issues:</b><br/> Roof needs repairing/reroofing subject to survey, overhaul of finishes and plaster repairs and paint removal.</p> | <p><b>Policies/recommendations:</b><br/> Closer inspection of roof and timbers for rot, repairs, restore plasterwork and replace all new doors with high quality facsimile. Retain staircase and renew light well cover with appropriate facsimile.</p> |

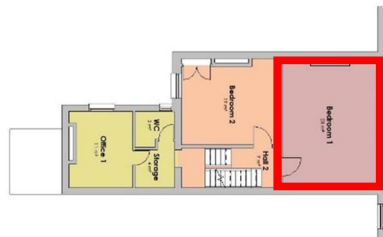
| Brief description:<br>Front room. Original ornate plaster details intact, picture rail, cornice. Deep skirting and window panelling intact. Suspect re-plastering and windows overhauled. | | | Summary history:<br>Original ornate cornice could indicate it was the parlour room, a ladies room. Current use office |
| Issues:<br>Fireplace has been removed, windows function. | | Policies/recommendations:<br>Additional dressing room partitions to allow for adaptive reuse for residential. Removal of radiators and trunking, installation of new radiators. Retention of original doors. Removal of unnecessarily closers. Removal of down lighters in ceiling. | |

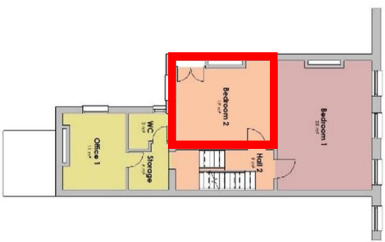
| <p>13 ST JOHNS ST<br/>1<sup>st</sup> Floor, Rear Office</p> | <p>Gazetteer item No: 9</p> <p>Designation:<br/>Grade 2</p> |

| <p><b>Brief description:</b><br/>Rear room. Original ornate plaster details intact, no picture rail, less ornate cornice. Deep skirting and window panelling intact. Suspect re-plastering and windows overhauled/replaced</p> | <p><b>Summary history:</b><br/>Original plaster details. Current use office</p> |

| <p><b>Issues:</b><br/>Built in cupboard chimney breast. Fireplace has been removed, windows function</p> | <p><b>Policies/recommendations:</b><br/>Additional dressing room partitions to allow for adaptive reuse for residential. Removal of radiators and trunking, installation of new radiators. Retention of original doors. Removal of unnecessarily closers. Removal of down lighters in ceiling. Installation of bathroom fittings, new opening below picture rail in front room.</p> |

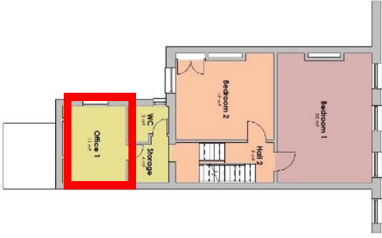
| <p>13 ST JOHNS ST<br/>1<sup>st</sup> Floor, Office Outrigger</p> | <p>Gazetteer item No: 10</p> <p>Designation:<br/>Grade 2</p> |

| <p>Brief description:<br/>20<sup>th</sup> Century doors, architraves and skirting, new plaster throughout, small amount of original architrave and skirting remains, subdivisions and bathroom addition</p> | <p>Summary history:<br/>20<sup>th</sup> Century door, window and plaster. Current use office</p> |

| <p>Issues:<br/>Fireplace has been removed, original features removed, down lighters, ceiling has cracking/deflection</p> | <p>Policies/recommendations:<br/>Reinstate door with facsimile, remove grills to window externally, renew ceiling remove downlighters</p> |

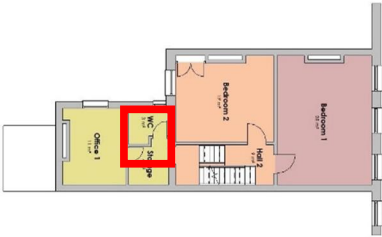
| 13 ST JOHNS ST<br>1 <sup>st</sup> Floor, WC | Gazetteer item No: 11 |

| Brief description:<br>20 <sup>th</sup> Century doors, architraves and skirting, new plaster throughout, partitions and fittings | Summary history:<br>20 <sup>th</sup> Century door, window and plaster to form WC. |

| Issues:<br>Original features removed, 20 <sup>th</sup> Century fittings, re-glazed window | Policies/recommendations:<br>Reinstate door with facsimile, remove grills to window externally, renew ceiling remove downlighters |

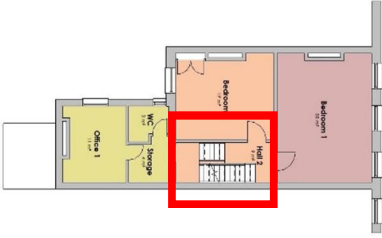
| 13 ST JOHNS ST<br>1 <sup>st</sup> Floor, Landing & Stairs | Gazetteer item No: 12 |

| <p><b>Brief description:</b><br/> Timber handrail swept over slender square balustrades, original doors to front part of the floor. New plaster evident on landing wall.</p> | <p><b>Summary history:</b><br/> Original staircase and balustrade,</p> |

| <p><b>Issues:</b><br/> Overhaul of finishes and plaster repairs and paint removal.</p> | <p><b>Policies/recommendations:</b><br/> Protection to handrail and balustrades whilst works are carried out</p> |

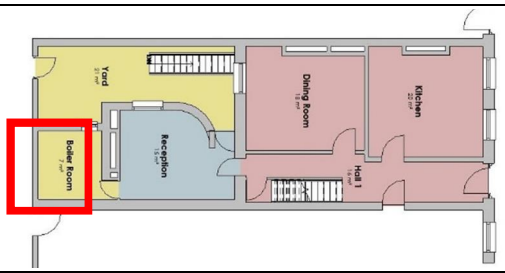
| 13 ST JOHNS ST<br>Ground Floor,<br>Boiler Room | | Gazetteer item No: 16<br><br>Designation:<br>Grade 2 |

| Brief description:<br>Single storey outrigger, re plastered, housing boilers, no historic features remain, simple interior | Summary history:<br>Use as possible Larder, current use |

| Issues:<br>Structural Condition, false ceiling, interior in poor condition | Policies/recommendations:<br>Renew window, remove external bars, existing opening allow for adaptive reuse as porch for residential conversion |

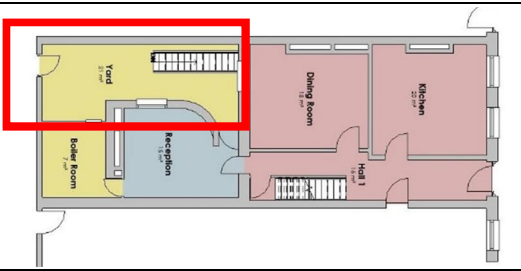
| 13 ST JOHNS ST<br>Ground Floor,<br>Yard | | Gazetteer item No: 17 |

| Brief description:<br>Original stone flags and rear boundary wall, 20 <sup>th</sup> century timber gate, basement steps, balustrades and exit door, flags over lay vault openings in basement. Brickwork painted white at ground floor level. | Summary history:<br>Original footprint, poor 20 <sup>th</sup> century alterations |

| Issues:<br>Extension colour of number 25, overbearing, negative impact on space, condition of drainage, gullies, need further inspection, structural assessment of boundary wall required. | Policies/recommendations:<br>General repairs to brickwork and repointing open joints, re-bedding copings to parapet wall and rebuilding if required, Lift and record rely flags at correct level, (built up) Open up basement window covered and allow alterations for adaptive reuse to residential, using existing voids present. |

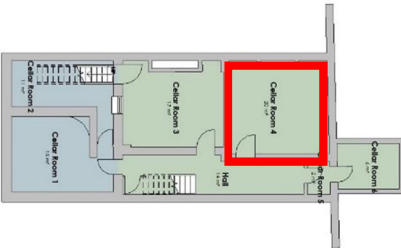
| <p>13 ST JOHNS ST<br/>Cellar Room 4</p> | <p>Gazetteer item No: 19</p> <p>Designation:<br/>Grade 2</p> |

| <p>Brief description:<br/>No original features are evident, 20<sup>th</sup> Century doors, dry lining</p> | <p>Summary history:<br/>Original use of cellars was storage for coal, pantries and staff, 20<sup>th</sup> Century alterations for use as offices</p> |

| <p>Issues:<br/>Structural integrity and damp</p> | <p>Policies/recommendations:<br/>Strip out 20<sup>th</sup> Century dry lining and inspect. New tanking and rebuilding as required</p> |

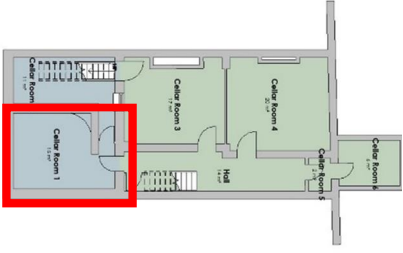
| <p>13 ST JOHNS ST<br/>Cellar Room 1</p> | <p>Gazetteer item No: 21</p> <p>Designation:<br/>Grade 2</p> |

| <p>Brief description:<br/>No original features are evident, 20<sup>th</sup> Century doors, dry lining</p> | <p>Summary history:<br/>Original use of cellars was storage for coal, pantries and staff, 20<sup>th</sup> Century alterations for use as offices</p> |

| <p>Issues:<br/>Structural integrity and damp</p> | <p>Policies/recommendations:<br/>Strip out 20<sup>th</sup> Century dry lining and inspect. New tanking and rebuilding as required</p> |

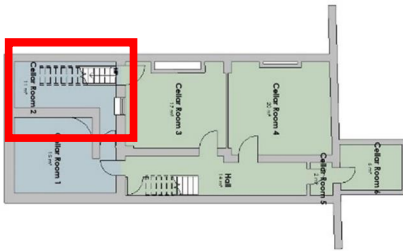
| 13 ST JOHNS ST<br>Cellar Room 2 | | Gazetteer item No: 22<br><br>Designation:<br>Grade 2 |

| Brief description:<br>Brick Vault with 20 <sup>th</sup> Century dividing wall and staircase, with light well and chute from rear yard | Summary history:<br>Original use of cellars was storage for coal, pantries and staff, 20 <sup>th</sup> Century alterations for use as offices |

| Issues:<br>Structural integrity and damp | Policies/recommendations:<br>Strip out 20 <sup>th</sup> Century dry lining and inspect. New tanking and rebuilding as required |

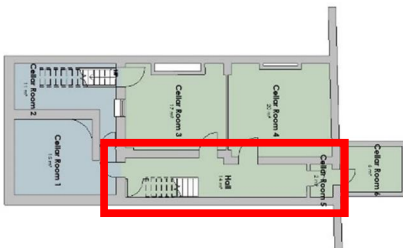
| <p>13 ST JOHNS ST<br/>Cellar Hall</p> | <p>Gazetteer item No: 24</p> <p>Designation:<br/>Grade 2</p> |

| <p>Issues:<br/>Structural integrity and damp</p> | <p>Policies/recommendations:<br/>Strip out 20<sup>th</sup> Century dry lining and inspect. New tanking and rebuilding as required</p> |
