Invek Surveys Ltd

Green End Development

03 December 2019

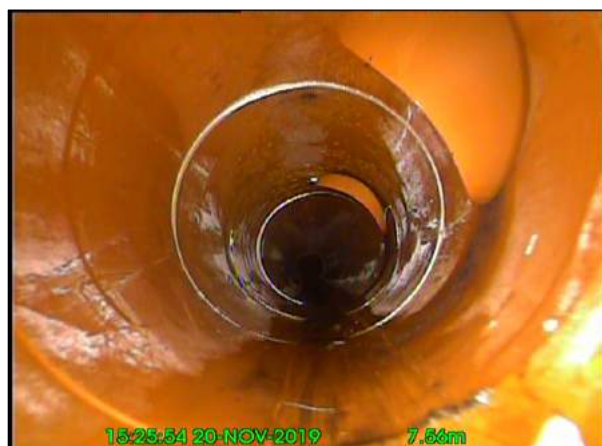
Photo: 4\_3A  
 7.8m, Connection other than junction, at 2 o'clock, diameter 100mm

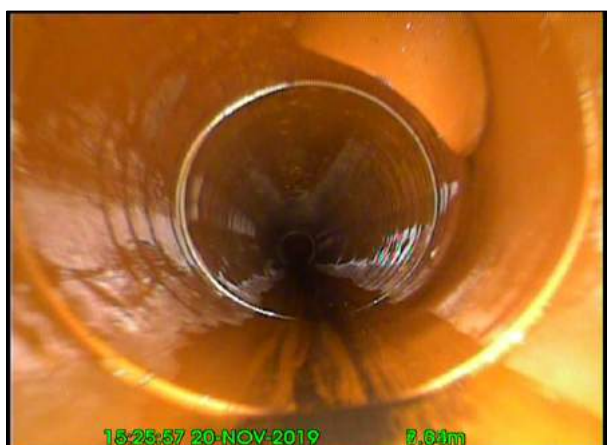
Photo: 4\_4A  
 8.1m, Connection other than junction, at 1 o'clock, diameter 100mm

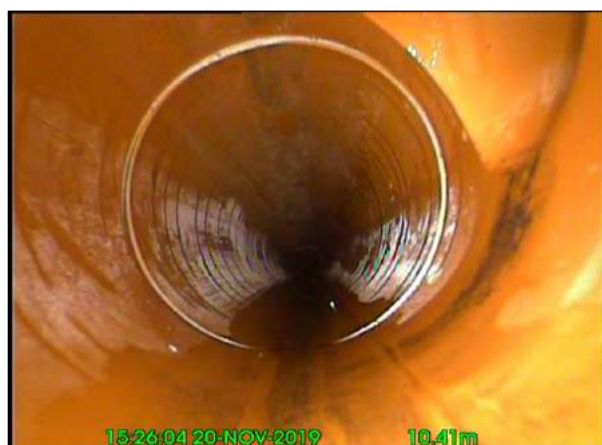
Photo: 4\_5A  
 10.6m, Connection other than junction, at 2 o'clock, diameter 100mm

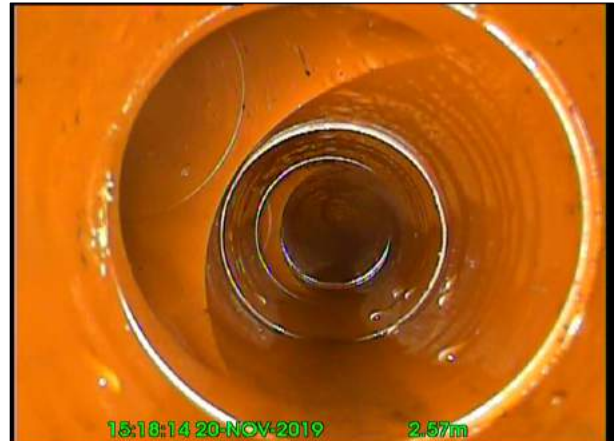
Photo: 5\_3A  
 2.9m, Connection other than junction, at 10 o'clock, diameter 150mm

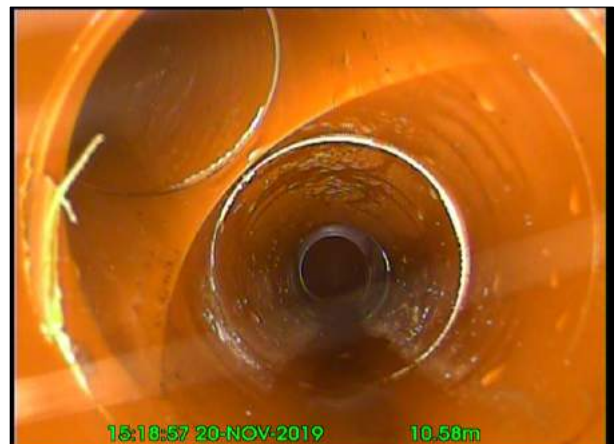
Photo: 5\_5A  
 10.7m, Connection other than junction, at 10 o'clock, diameter 150mm

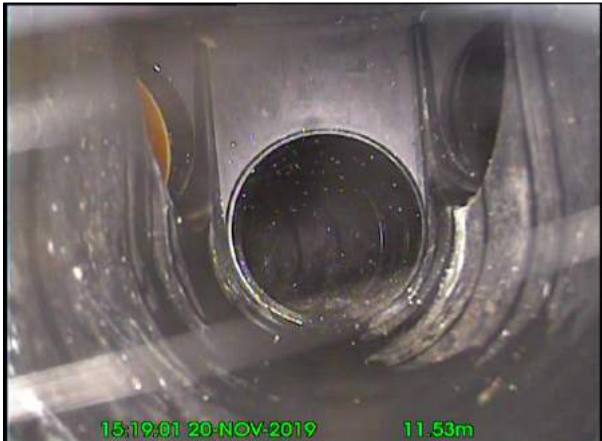
Photo: 5\_6A  
11.4m, Finish node type, manhole reference number: S15

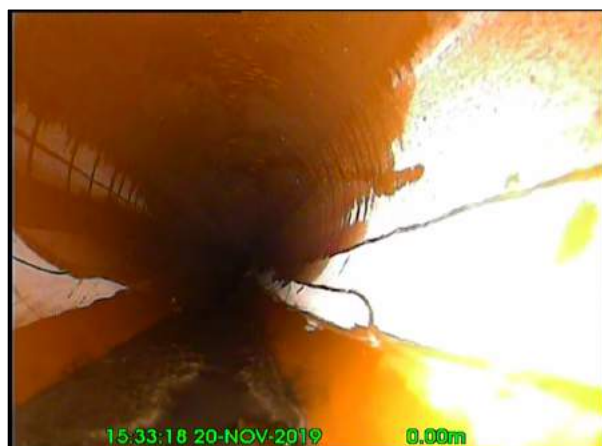
Photo: 6\_3A  
 0m, Settled deposits, fine, 15% cross-sectional area loss, Start

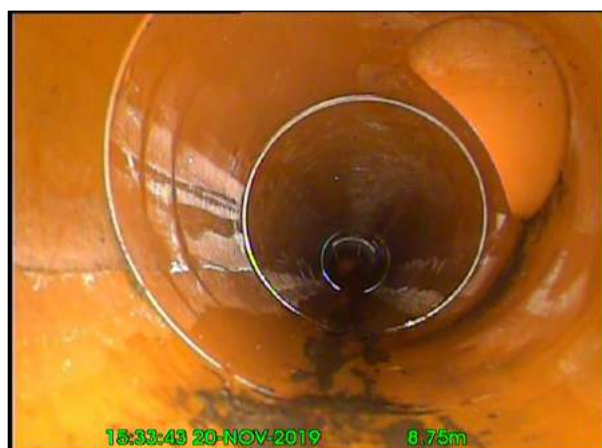
Photo: 6\_6A  
 9m, Connection other than junction, at 2 o'clock, diameter 100mm

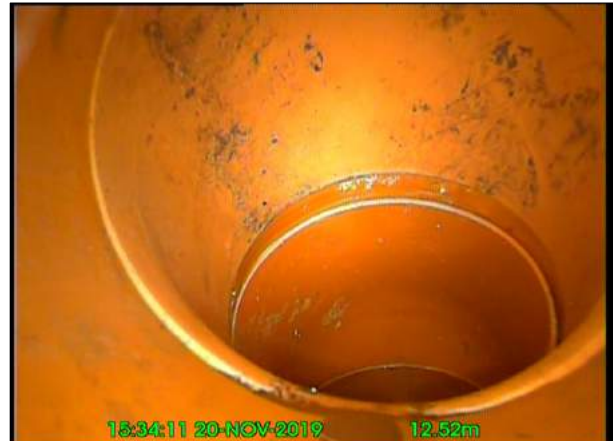
Photo: 6\_9A  
 12.7m, Line deviates down

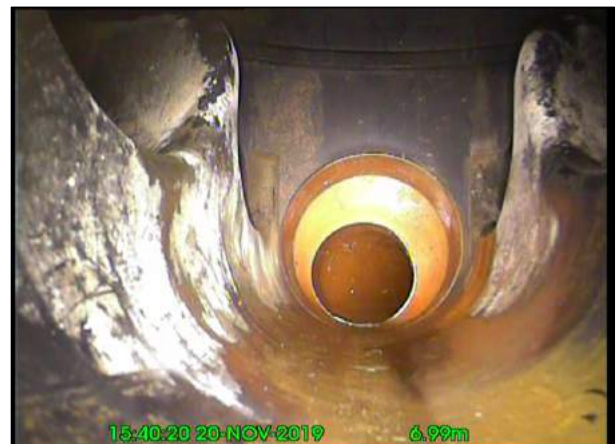
Photo: 7\_6A  
 6.99m, Finish node type, manhole reference number: S11

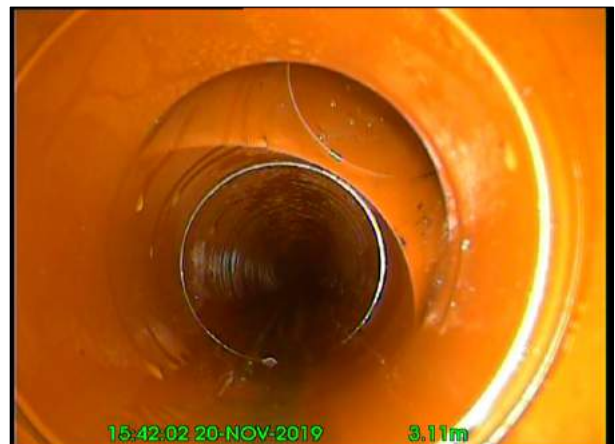
Photo: 8\_5A  
3.3m, Connection other than junction, at 1 o'clock, diameter 100mm

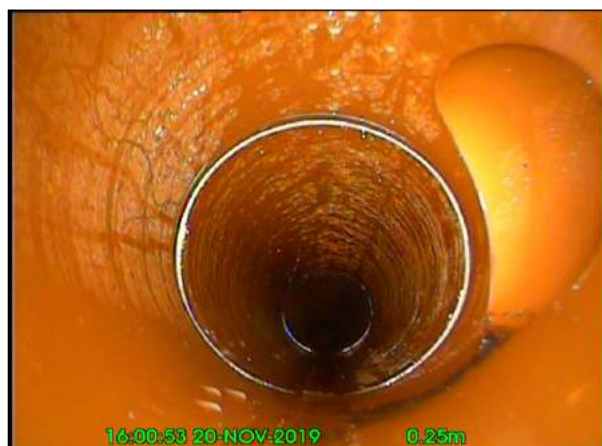
Photo: 9\_3A  
 0.5m, Connection other than junction, at 3 o'clock, diameter 100mm

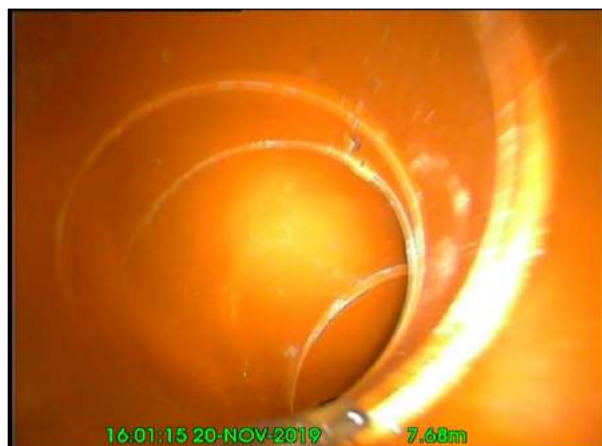
Photo: 9\_5A  
 7.8m, Joint displaced, medium

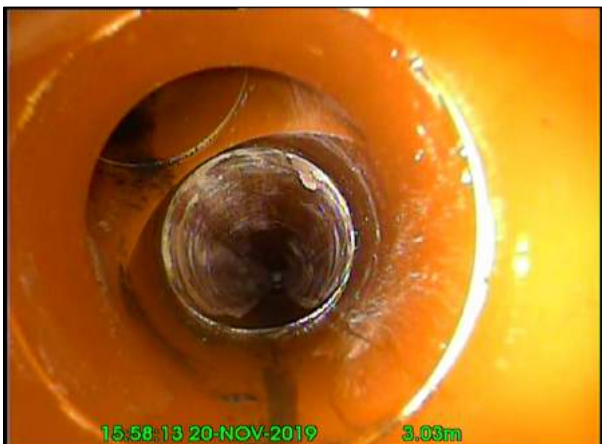
Photo: 10\_4A  
 3.3m, Connection other than junction, at 11 o'clock, diameter 100mm

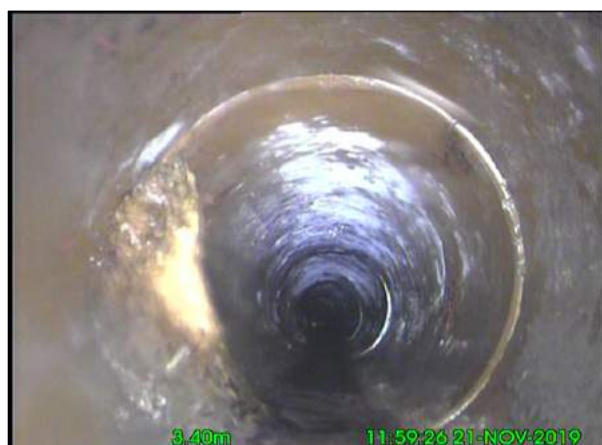
Photo: 11\_5A  
 3.7m, Attached deposits, encrustation at joint, from 6 to 10 o'clock, 15% cross-sectional area loss

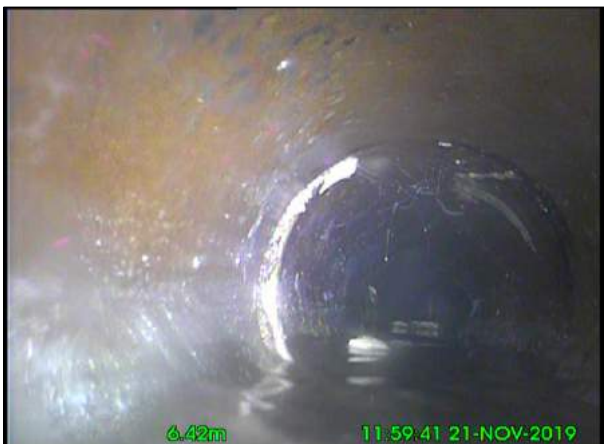
Photo: 11\_8A  
 6.6m, Joint displaced, medium

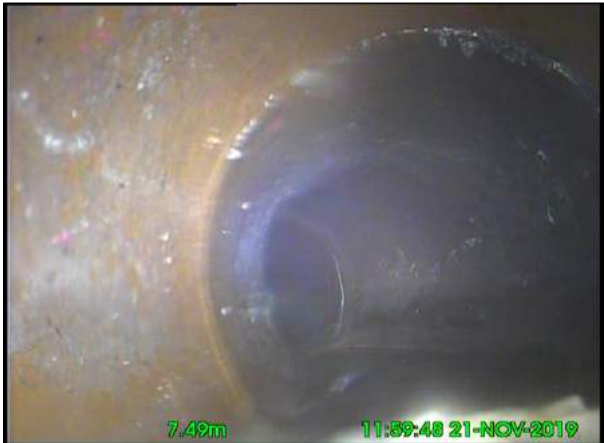
Photo: 11\_9A  
 7.8m, Line deviates left

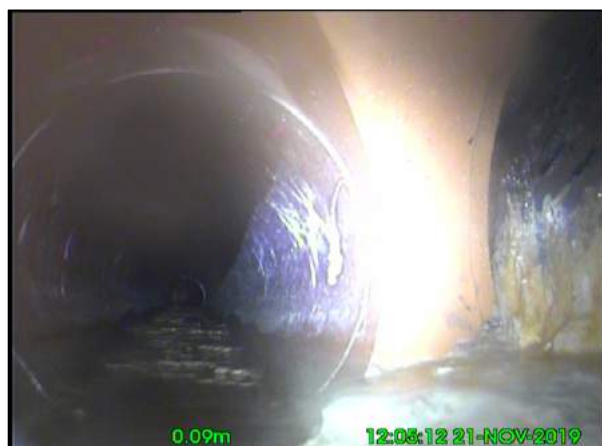
Photo: 12\_3A  
 0.1m, Connection other than junction, at 3 o'clock, diameter 150mm

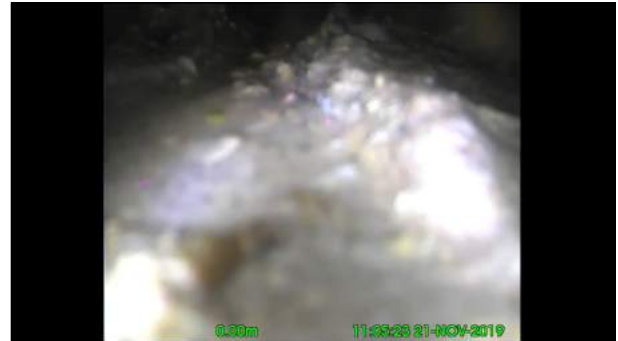
| 1:120 | Position | Code | Observation | MPEG | Photo | Grade | | | |
|---|---|---|---|---|---|---|---|---|---|
| | 0.00 | S01 DES | Settled deposits, fine, 15% cross-sectional area loss, Start | 00:00:03 | 13_3A | 3 | | | |

Photo: 13\_3A  
 0m, Settled deposits, fine, 15% cross-sectional area loss, Start

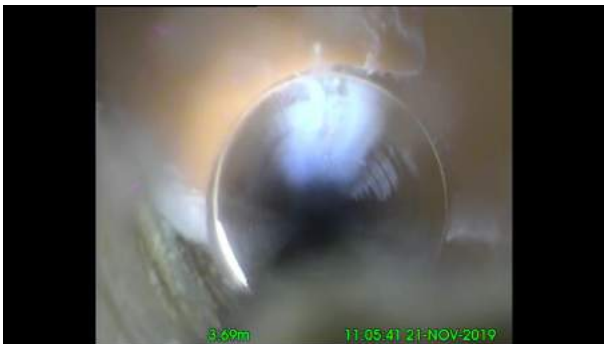
Photo: 13\_4A  
 3.8m, Connection other than junction, at 11 o'clock, diameter 100mm

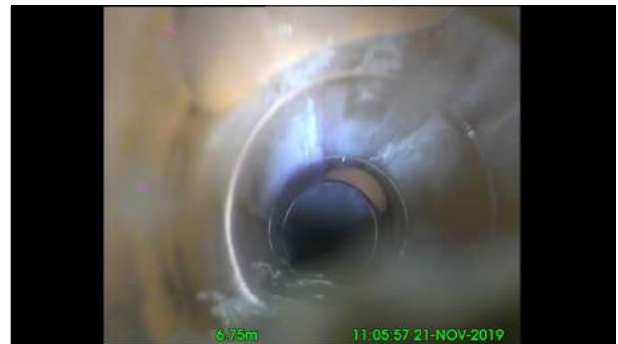
Photo: 13\_5A  
 6.9m, Connection other than junction, at 11 o'clock, diameter 100mm

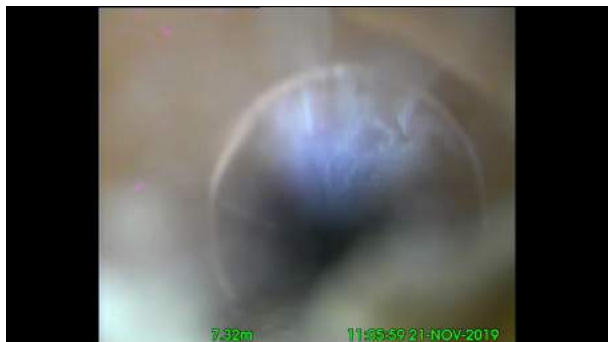
Photo: 13\_6A  
 7.4m, Connection other than junction, at 1 o'clock, diameter 100mm

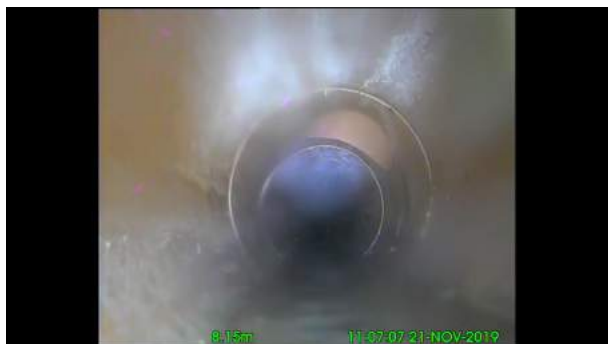
Photo: 13\_8A  
 8.5m, Connection other than junction, at 1 o'clock, diameter 100mm

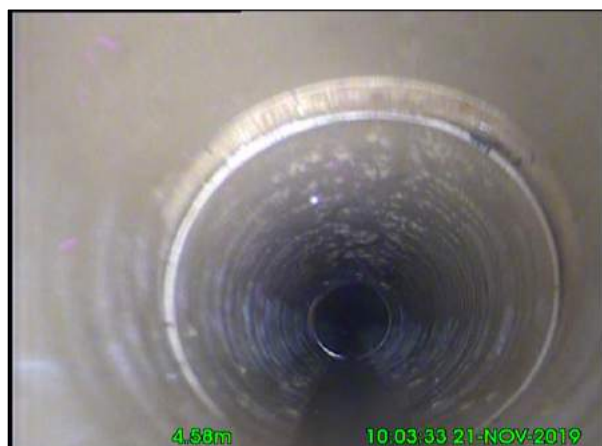
Photo: 15\_4A  
 4.8m, Joint displaced, medium

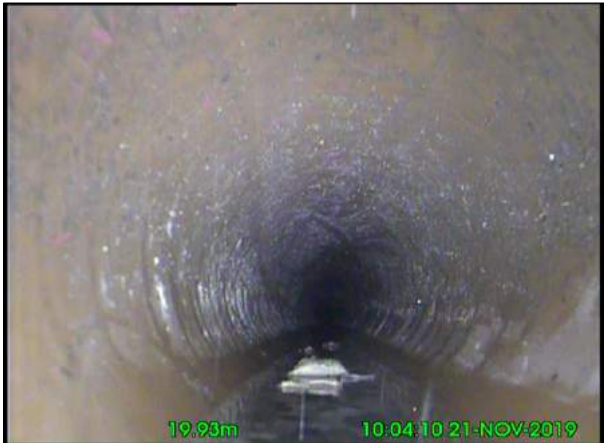
Photo: 15\_11A  
 19.95m, Settled deposits, fine, 10% cross-sectional area loss, Start

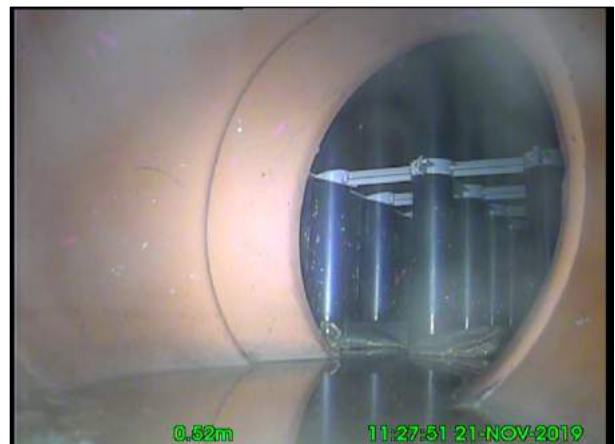
Photo: 18\_6A  
1.9m, Finish node type, other special chamber reference number: Tank Remarks: Tank

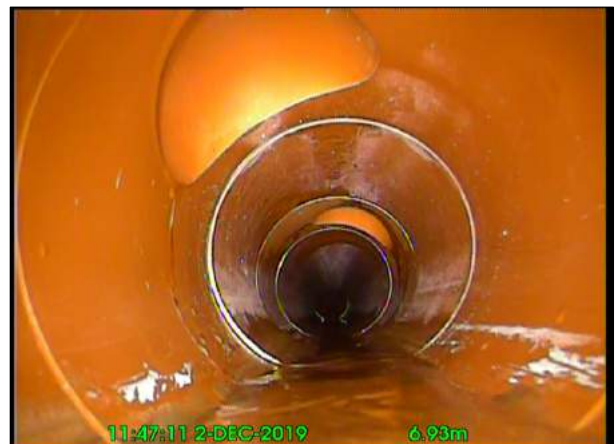
Photo: 19\_5A  
 7.1m, Connection other than junction, at 11 o'clock, diameter 100mm

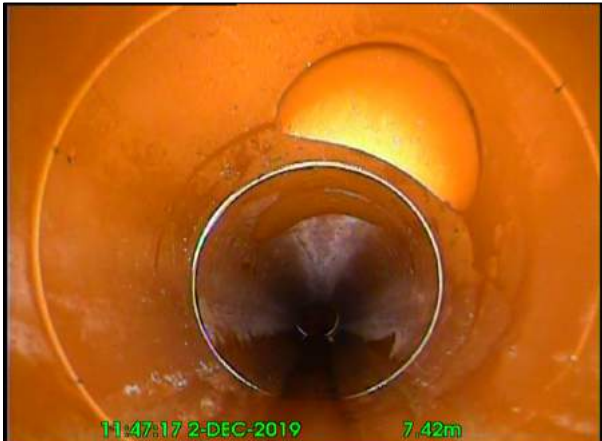
Photo: 19\_6A  
 7.6m, Connection other than junction, at 1 o'clock, diameter 100mm

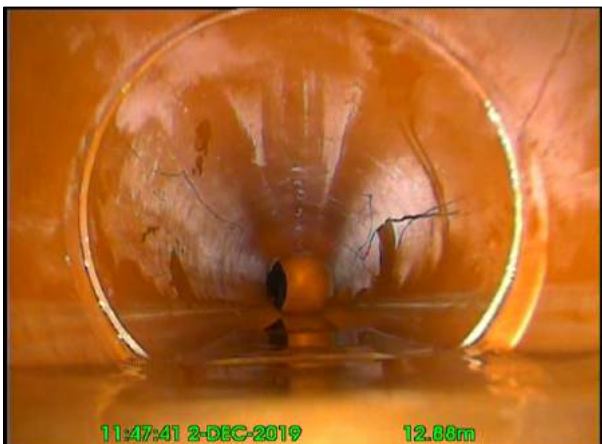
Photo: 19\_8A  
 13.1m, Joint displaced, medium

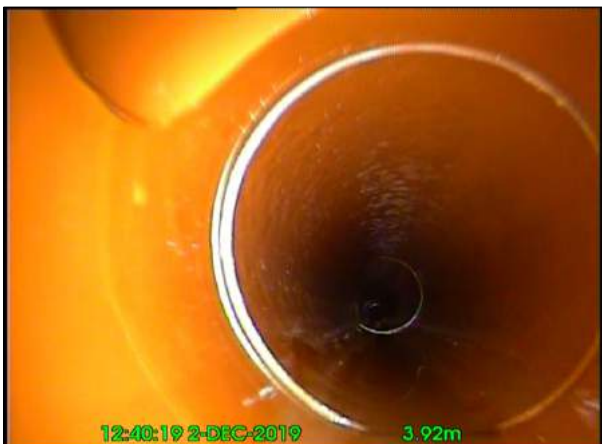
Photo: 20\_4A  
 4m, Connection other than junction, at 11 o'clock, diameter 100mm

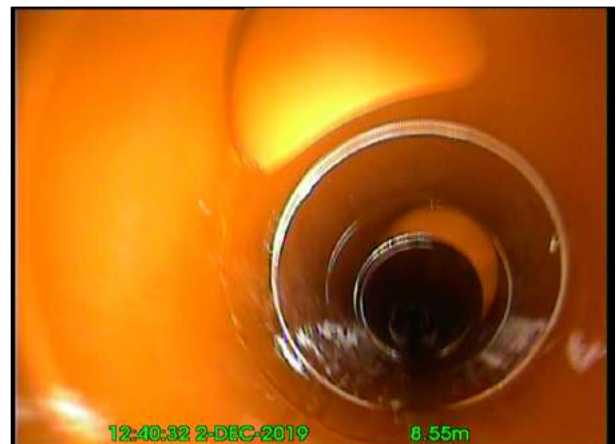
Photo: 20\_5A  
 8.8m, Connection other than junction, at 11 o'clock, diameter 100mm

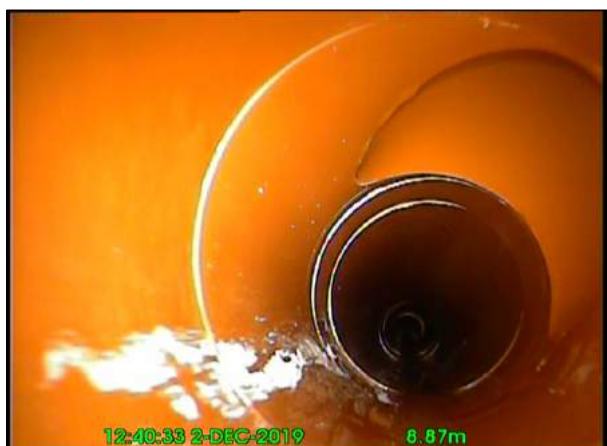
Photo: 20\_6A  
 9.2m, Connection other than junction, at 1 o'clock, diameter 150mm

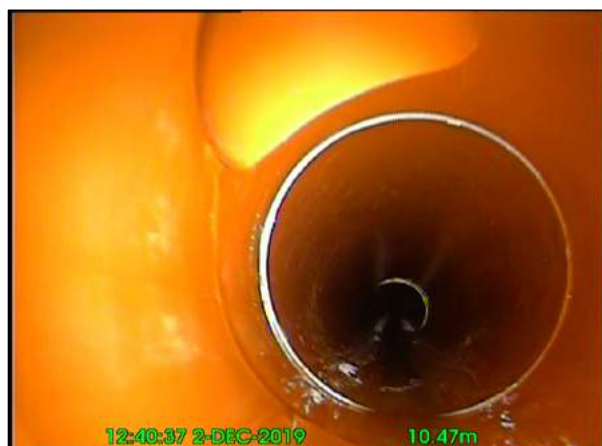
Photo: 20\_7A  
 10.6m, Connection other than junction, at 11 o'clock, diameter 100mm

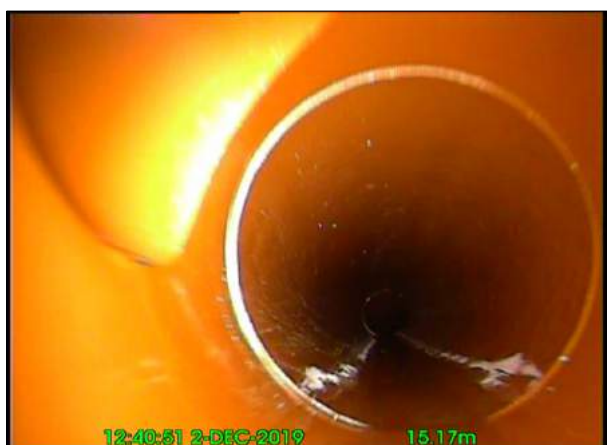
Photo: 20\_8A  
 15.4m, Connection other than junction, at 10 o'clock, diameter 100mm

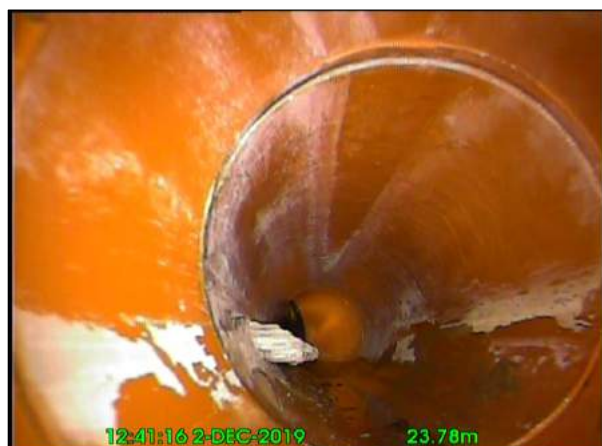
Photo: 20\_11A  
 23.8m, Line deviates left

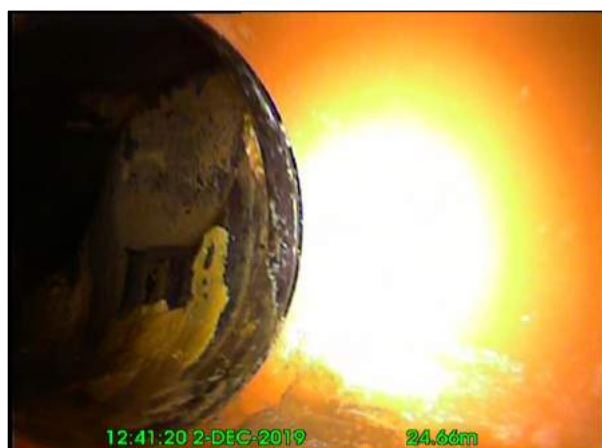
Photo: 20\_13A  
 24.9m, Line deviates left

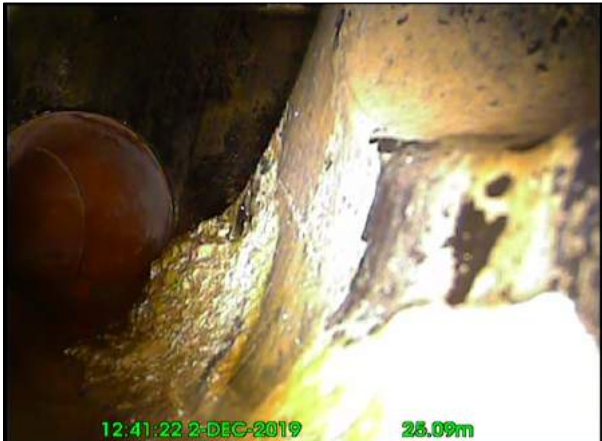
Photo: 20\_14A  
25.1m, Finish node type, manhole reference number: S05

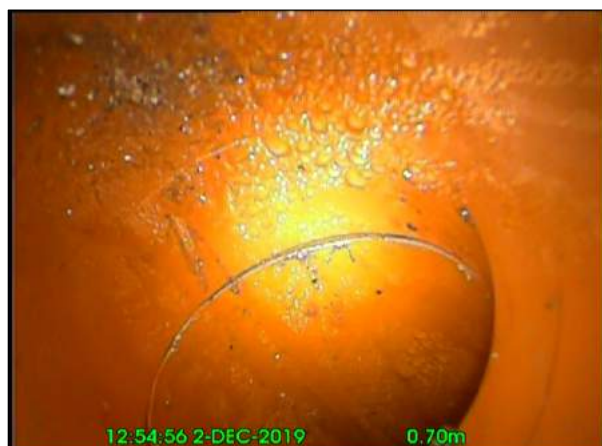
Photo: 21\_3A  
 0.9m, Line deviates down

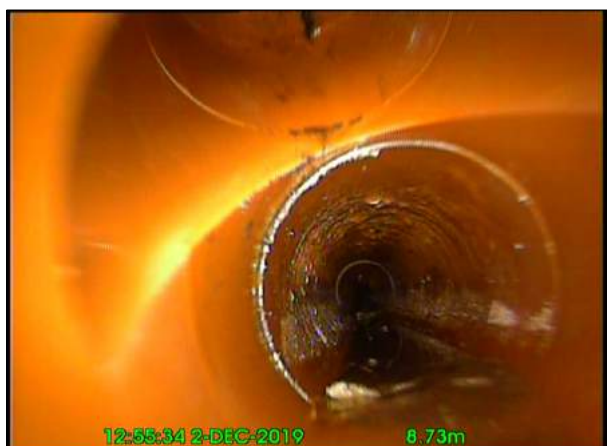
Photo: 21\_6A  
 8.9m, Connection other than junction, at 11 o'clock, diameter 100mm

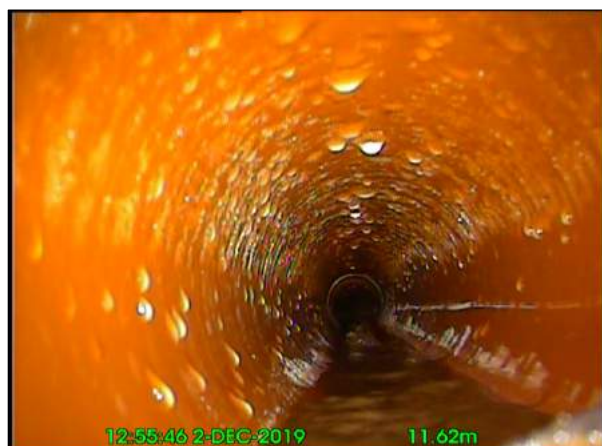
Photo: 21\_7A  
 11.62m, Turbid water level, 10% of the vertical dimension

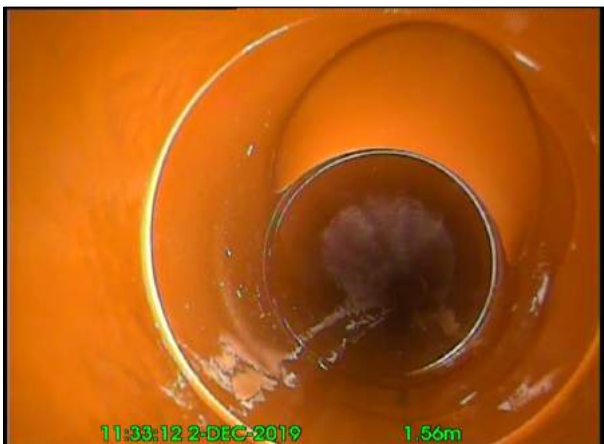
Photo: 22\_4A  
 1.8m, Connection other than junction, at 12 o'clock, diameter 100mm

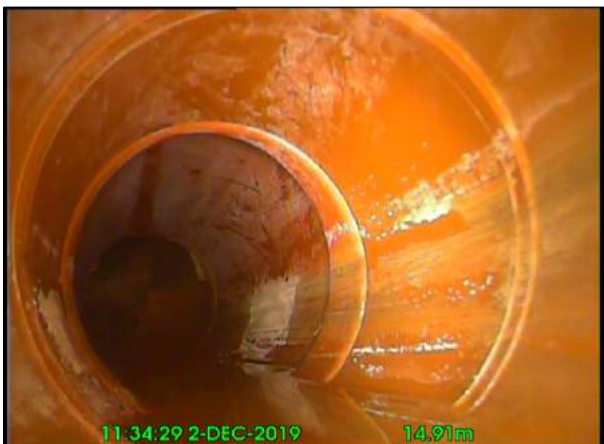
Photo: 22\_8A  
 15.1m, Line deviates left

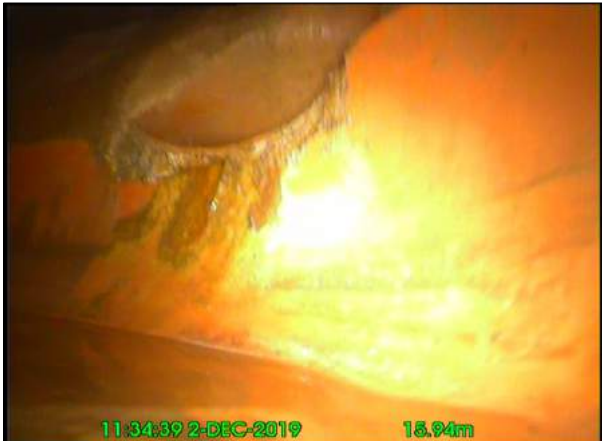
Photo: 22\_10A  
16m, Finish node type, manhole reference number: S07

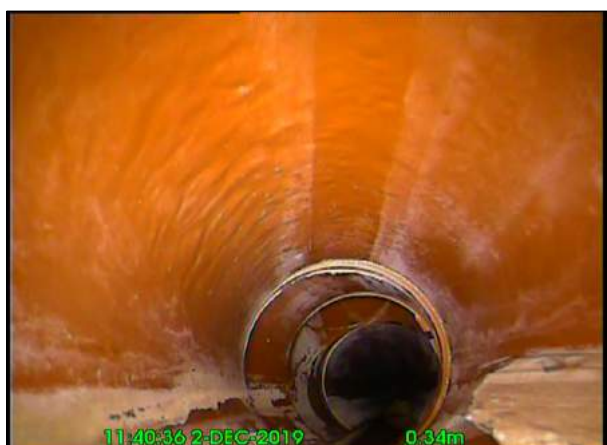
| 1:50 | Position | Code | Observation | MPEG | Photo | Grade |
|---|---|---|---|---|---|---|
| | 0.30 | DEE | Attached deposits, encrustation, from 3 to 4 o'clock, 10% cross-sectional area loss | 00:00:16 | 23_4A | 3 |

Photo: 23\_4A  
 0.3m, Attached deposits, encrustation, from 3 to 4 o'clock, 10% cross-sectional area loss

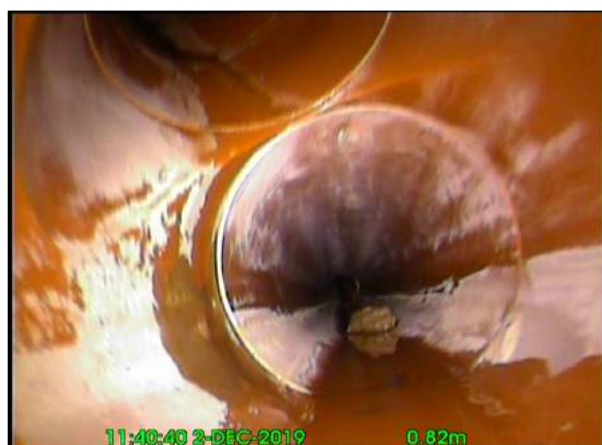
Photo: 23\_5A  
 1m, Connection other than junction, at 11 o'clock, diameter 150mm

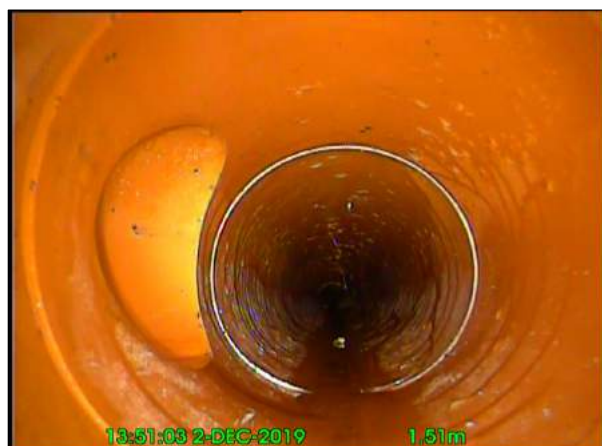
Photo: 24\_3A  
 1.8m, Connection other than junction, at 9 o'clock, diameter 100mm

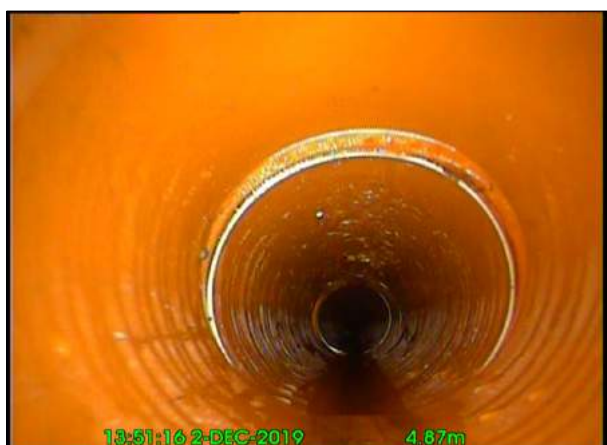
Photo: 24\_4A  
 5.1m, Joint displaced, large

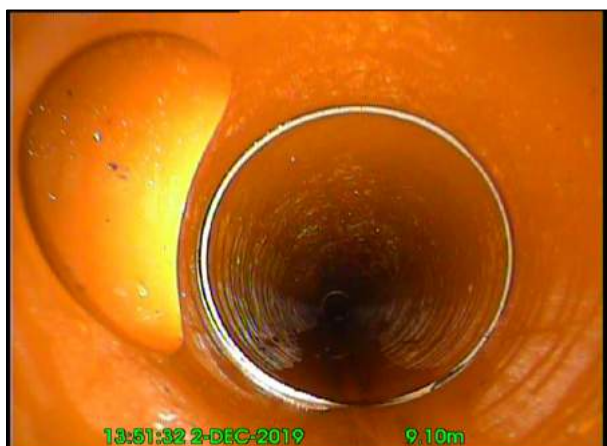
Photo: 24\_6A  
 9.3m, Connection other than junction, at 9 o'clock, diameter 100mm

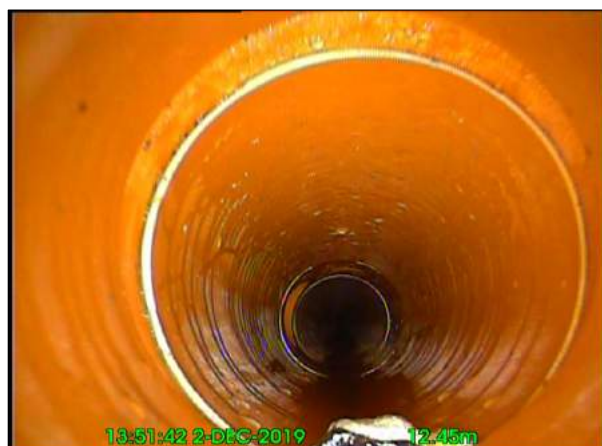
Photo: 24\_7A  
 12.7m, Joint displaced, large

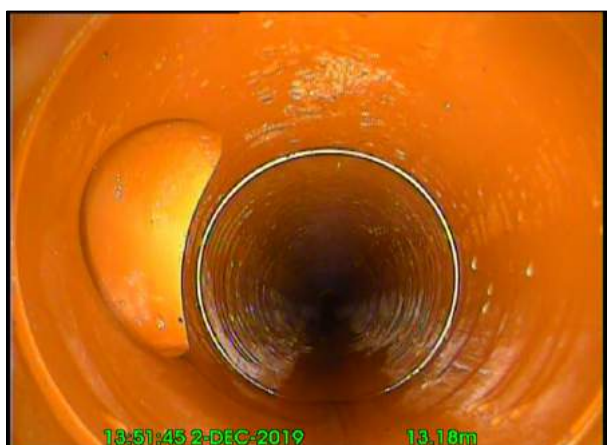
Photo: 24\_8A  
 13.4m, Connection other than junction, at 9 o'clock, diameter 100mm

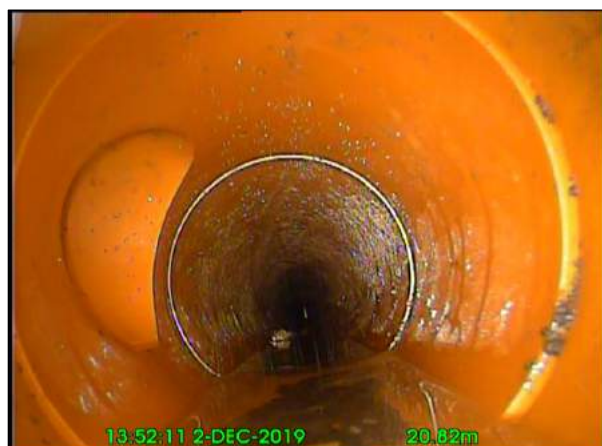
Photo: 24\_11A  
 21.1m, Connection other than junction, at 9 o'clock, diameter 100mm

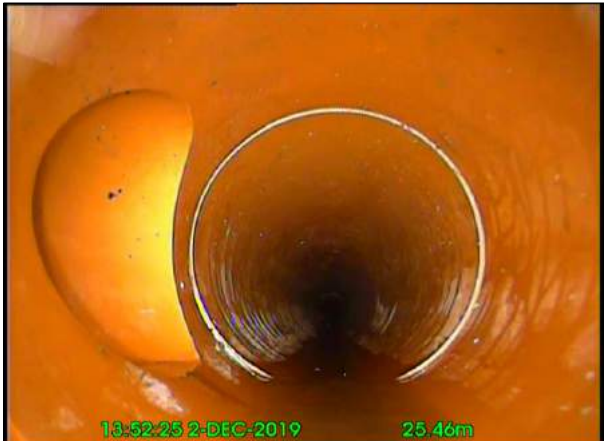
Photo: 24\_14A  
 25.7m, Connection other than junction, at 9 o'clock, diameter 100mm

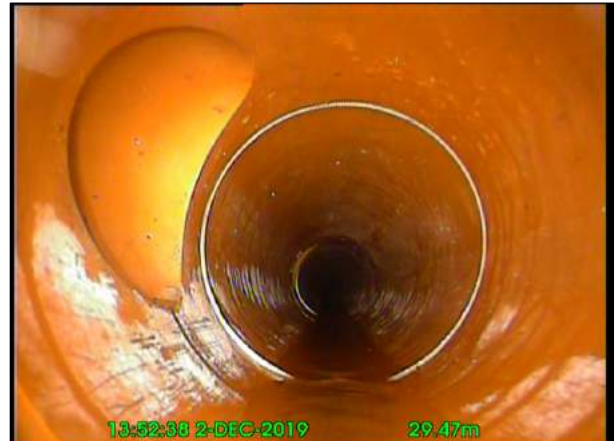
Photo: 24\_15A  
 29.8m, Connection other than junction, at 10 o'clock, diameter 100mm

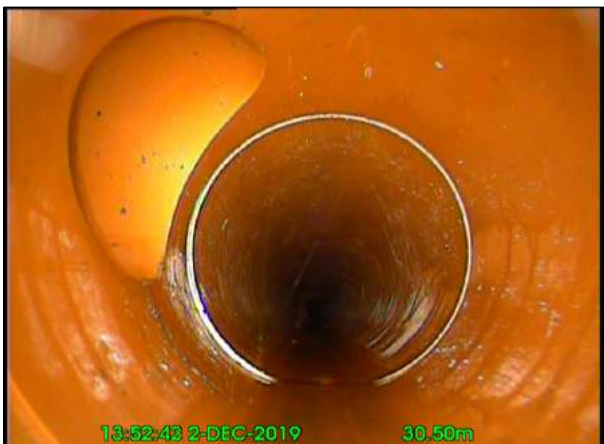
Photo: 24\_16A  
 30.7m, Connection other than junction, at 10 o'clock, diameter 100mm

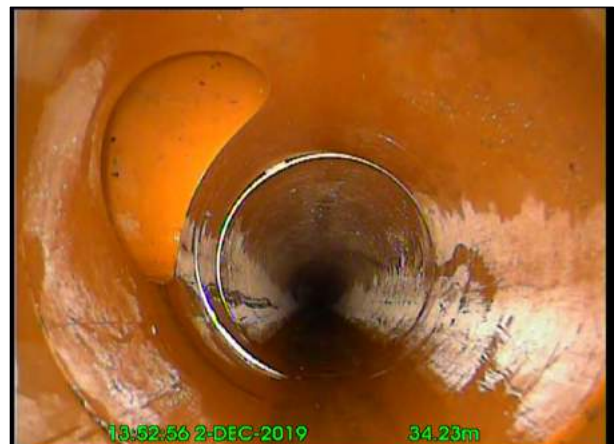
Photo: 24\_17A  
 34.5m, Connection other than junction, at 10 o'clock, diameter 100mm

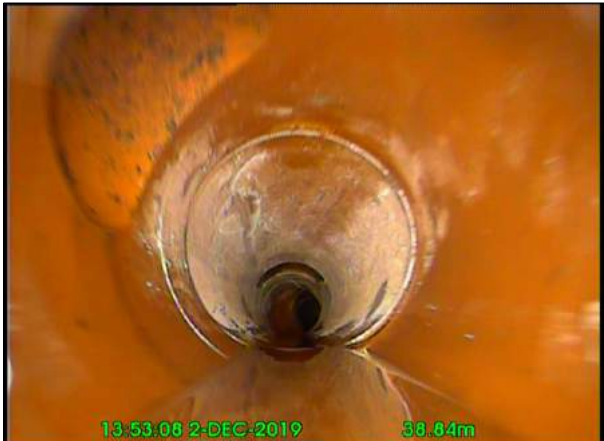
Photo: 24\_18A  
 39.1m, Connection other than junction, at 10 o'clock, diameter 100mm

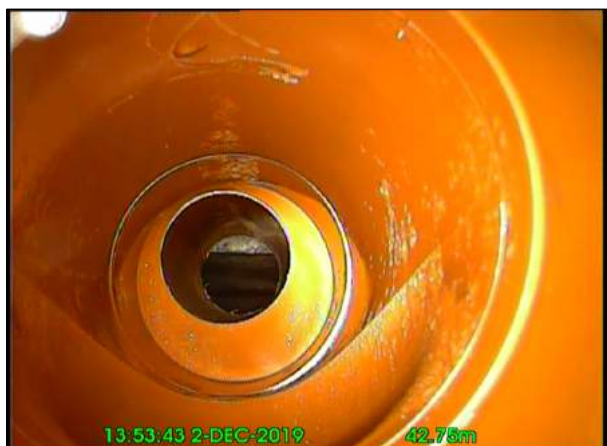
Photo: 24\_24A  
42.8m, Connection other than junction, at 6 o'clock, diameter 100mm

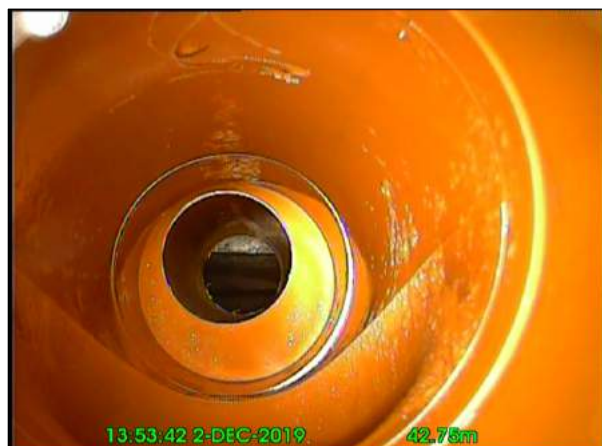
Photo: 24\_25A  
42.8m, Survey abandoned Remarks: Unable to pass drop shaft

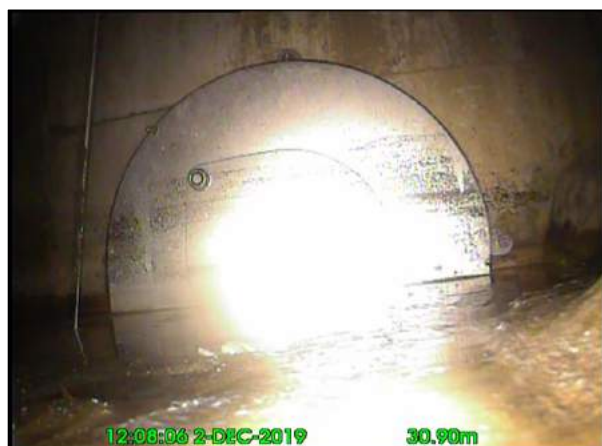
Photo: 25\_3A  
30.9m, Finish node type, manhole reference number: S08
