**18/18a KINGSLEY ROAD,  
WYTHENSHAW, MANCHESTER**

**PRELIMINARY BAT ROOST  
ASSESSMENT**

Report No: RT-MME-128973

Date: November 2018

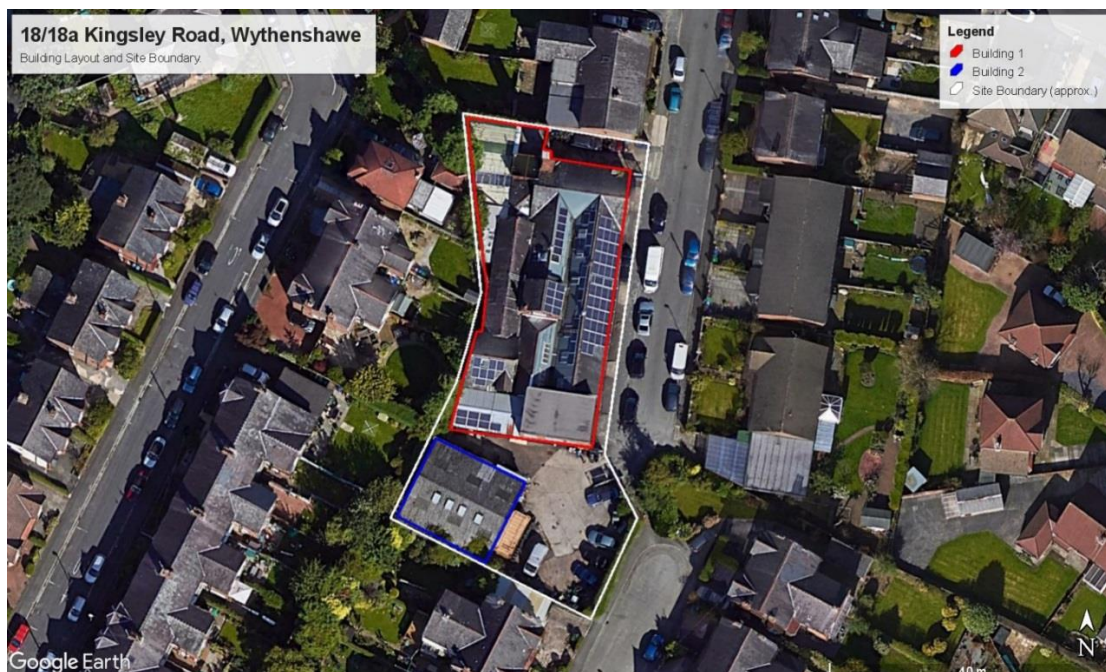
**Figure 4.1: Building Layout and Approximate Site Boundary.**

Two buildings were present on site which were No. 18 (Building 1) and 18a Kingsley Road (Building 2). Building 1 had been partitioned into many smaller units, and various extensions had been added over a number of years. Figure 4.1 shows the approximate boundaries of the buildings surveyed in relation to the site boundary.

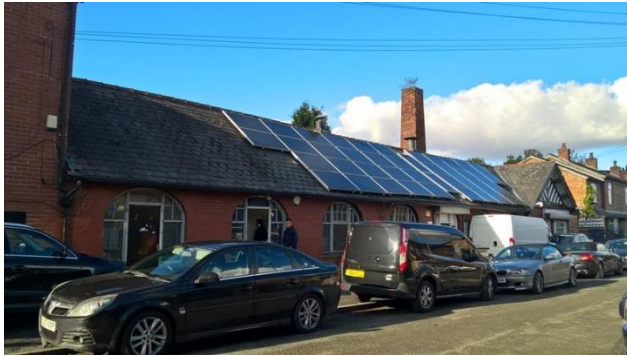
**Plate 6: Eastern Elevation of Building with Solar Panels.**

The eastern elevation of the building comprised a pitched roof structure with flat slate roof tiles and solar panels along approximately half of its length (Plate 6). It had brick walls and well-sealed, arched windows and doors. The north-eastern corner gable end extended from the northern section of the building. This had a mock-tudor section below the gable, and uPVC cladding, windows and doors on the ground floor (Plate 7). Some of the barge boarding was degraded at the gable end, but the soffit areas and supporting beams were in good condition. Some raised brickwork was noted above a metal shutter box over the door (Plate 8) and this appeared to extend some way, providing a suitable roosting crevice for bats. A number of small gaps were also noted in the wall brickwork towards the north-eastern end and centre of this elevation. These were clear of debris and also appeared to extend into the walls.

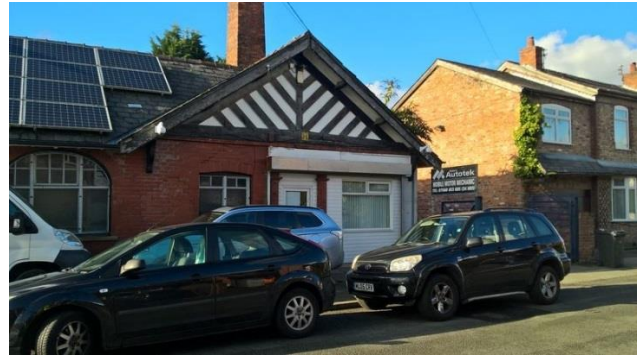
**Plate 7: North-eastern Section of Building with Mock-Tudor Gable and uPVC Cladding.**

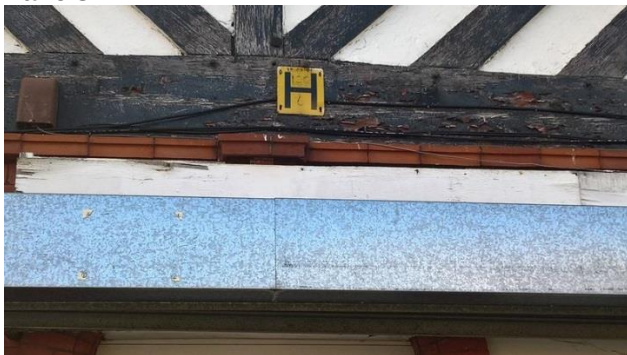
**Plate 8: Raised Brickwork Above Shutter Box.**

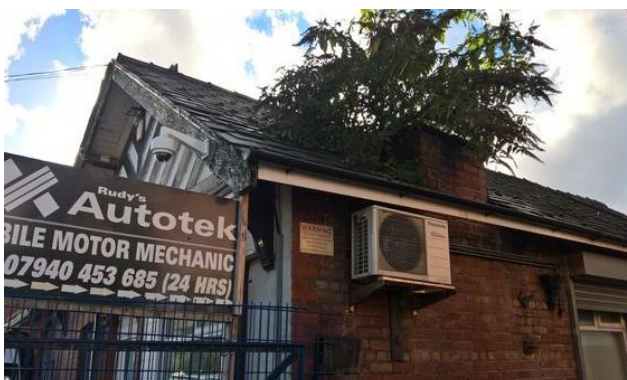
**Plate 9: The Northern Pitched Roof Section.**

The northern side of the building comprised a pitched roof section running across the site from west to east (with the eastern gable extending slightly beyond the eastern building elevation – Plate 9), and Rudy's Autotek workshop to the north-west which had a flat-roof and parapet (Plate 10). A tall chimney feature was present in this area and this had crumbling brickwork which was considered to provide potential roosting opportunities for bats (Plate 11). The roof of the pitched section was slate tiled with clay interlocking ridge tiles. A number of the slates had lifted on the northern elevation, and gaps were also noted beneath ridge tiles at the eastern gable end of this section. All of these features were considered to provide suitable roosting crevices for bats. The parapet wall along the eastern elevation of Rudy's Autotek restricted visibility to the roof from the building exterior, but the construction of the roof was able to be determined during the internal inspection.

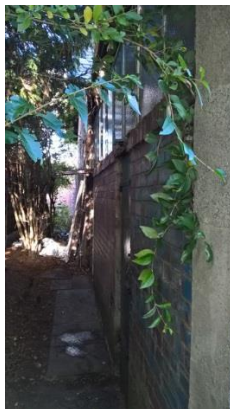
The western side of Building 1 ran very close to the fences of the adjacent residential gardens and some scrub vegetation was present (Plate 4), meaning that a visual assessment of the roof on this side could not be undertaken. Missing fascia/soffit boards were noted close to the southern end. A brick wall ran along the northern end of the western boundary and crumbling brickwork was noted within the wall approximately half way along its length (Plate 5), some of which was cobwebbed. Where the brickwork was crumbling, gaps were also noted underneath the coping stones along the wall top, which provided a potential roosting feature for bats.

**Plate 4: Scrub Vegetation on Western Side of the Building.**

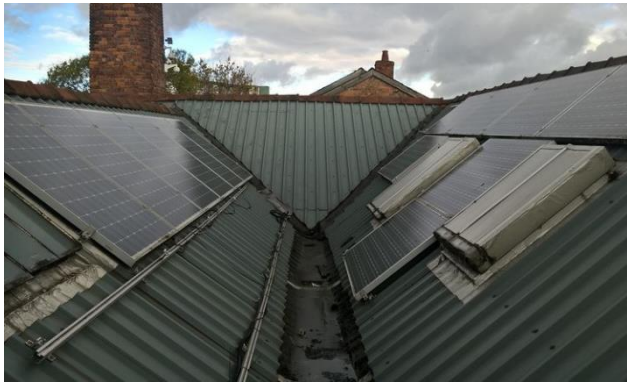
Access to the central portion of the roof was available from an office window on the first floor towards the centre of the building, and the presence of a single walkway which spanned the length of the building facilitated access to some areas (Plate 12). From here the parts of the roof that could be accessed were thoroughly inspected. The roof pitches comprised a mix of flat slate and metal corrugated sheeting with clay ridge tiles. Solar panels and some skylights were fitted to several of the roof pitches (Plate 12).

**Plate 12: The Roof Walkway with Corrugated Metal Sheeting, Skylights and Solar Panels Present.**

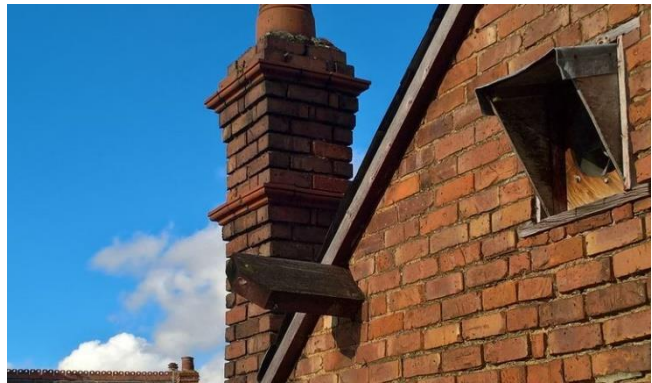
**Plate 15: Chimney which Extended from the South-western Corner.**

The central office building (which facilitated access to the roof) extended beyond the height of the surrounding roofs and was of brick construction. It had a pitched slate tiled roof with solar panels on the eastern elevation. The roof was supported by beams, in a poor condition, which extended beyond the eastern and southern eaves, and many gaps were identified between the roof tiles on the northern and southern gable eaves (Plate 13), around the southern office window (Plate 14) and within the brickwork of the building and the chimney which extended from the south-western corner (Plate 15).

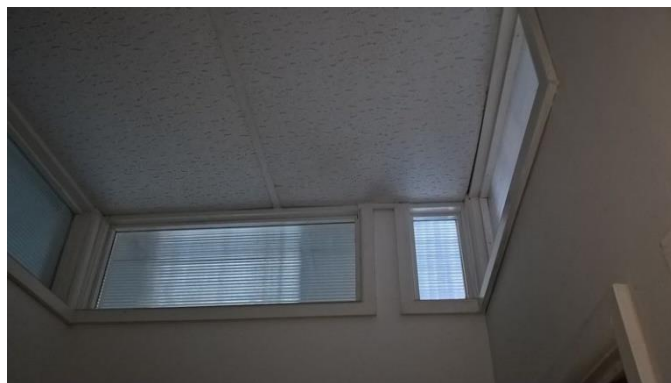
**Plate 19: The Roof in the Hallway Outside the South-eastern Offices.**

The offices on the first floor, above the gym to the south-east of the building, had a suspended ceiling and a flat roof. It was not possible to enter these offices as they were locked but an assessment was made of the stairway/ hallway which lead to them (Plate 19). This area had been recently re-decorated and no suitable gaps for roosting bats were identified.

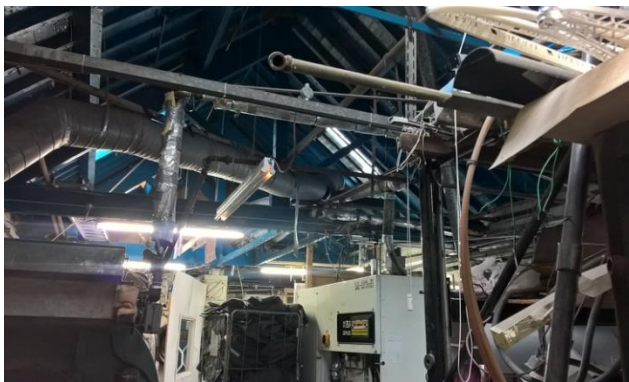
**Plate 20: The Interior of the Laundrette/Workshop**

The laundrette/workshop on the ground floor along the eastern extent of the building was largely open to the roof (Plate 20), with the exception of a small area to the south where a mezzanine was present (Plate 21). Windows were present along the eastern elevation of the building, and a mix of painted wooden boards with metal support beams and plasterboard lined the roof. Some of the plasterboard was lifting and clear sheeting skylights were also present on the western roof elevation (Plate 22). A small gap was recorded close to the ridge beam, but this was very cobwebbed and did not appear to extend. Another room extended from the western elevation of the main laundrette area, and this was two-storey with an office on the first floor (which facilitated access to the roof). On the ground floor, gaps were identified within the brickwork on the west side and these appeared to extend into the wall cavity (Plate 23). The first-floor office room was open to the loft and the ceiling was lined with plasterboard with suspended lights attached (Plate 24). There was an old fan unit to the south of the room, but this had been blocked and did not provide an access point for bats (Plate 25).

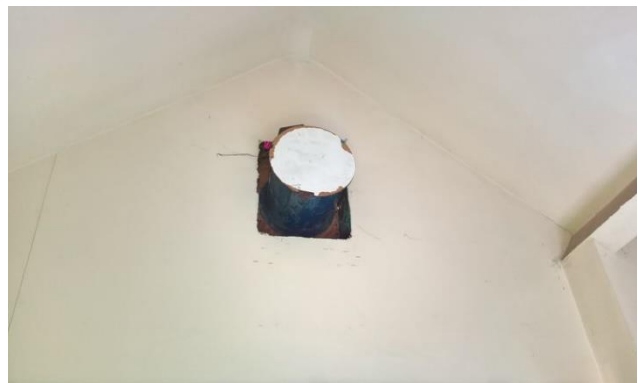
**Plate 25: Old Blocked-off Fan Unit in the Southern Elevation of the Laundrette Office.**

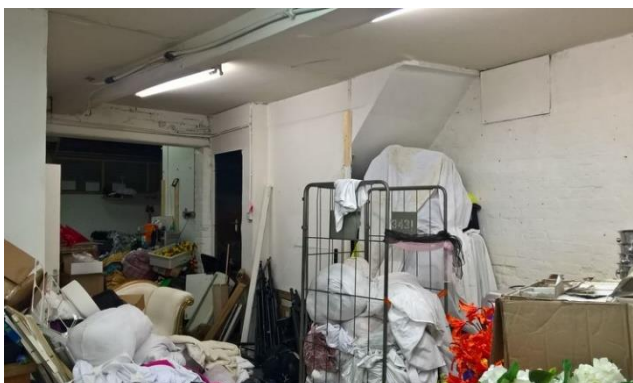
**Plate 26: Storage Area to the West of the Building.**

Three adjoining rooms were used for storage along the western side of Building 1 (Plate 26). At the southern end, two of the rooms were open plan internally and they had a suspended ceiling which was in good condition with a loft hatch to the south-east (Plate 27). Although the loft hatch was too high to access during the survey, an assessment by torchlight indicated that the roof in this area comprised metal corrugated sheeting which was supported by wooden beams.

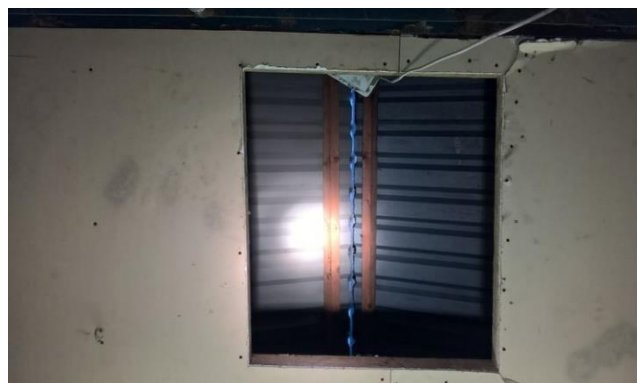
**Plate 27: Metal Corrugated Roof Seen Through the Loft Hatch.**

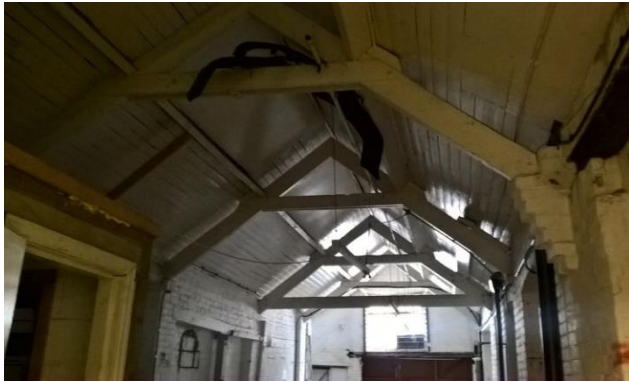
**Plate 28: Wooden Boarded Ceiling.**

The third storage room on the western side was open to the roof and was supported by wooden beams and lined with wooden boarding/panelling (Plate 28). Some gaps were identified at the roof apex where the boards met (Plate 29), but these appeared largely cobwebbed suggesting that they had not been accessed by bats. There was an old fan unit present towards the southern apex of this building section, which could potentially allow bat access to the building interior (Plate 30). A small breezeblock structure was also recorded in the south-western corner of this room, but this was considered to be of negligible value to roosting bats.

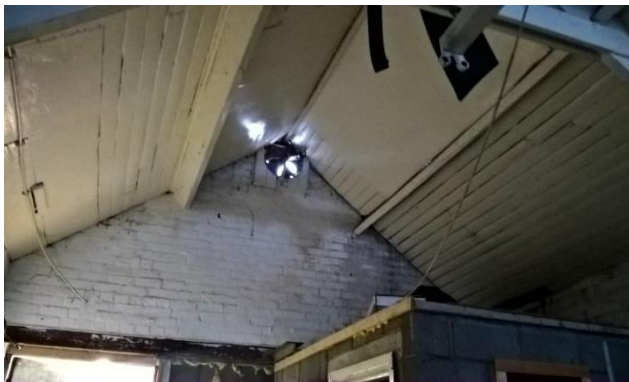
**Plate 30: Old Fan Unit to the South with Breezeblock Structure below.**

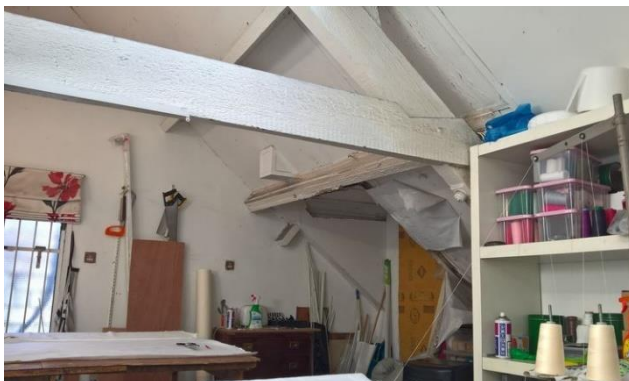
**Plate 31: The First-floor Sewing Room.**

A sewing room was present on the first-floor above the storage area to the south-west of the building. This was open to the loft space and the ceiling was lined with wooden boarding (Plate 31), with skylights installed to the south of the room. The walls and wooden boarding was generally in good condition but there was some exposed insulation to the south (Plate 32).

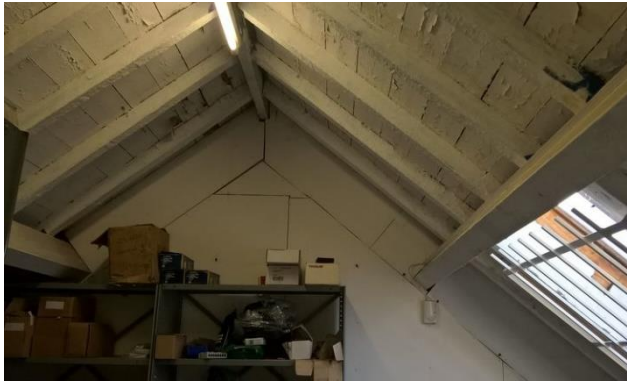
**Plate 33: The Wooden Boarded Ceiling of the First Floor.**

A workshop was present towards the centre and north of the building, and this had two-storeys. On the ground floor the rooms were in use as workshops, offices and a kitchen, all of which were well-sealed. The whole first floor area above the workshop was used as storage space with wooden boards and beams lining the roof (Plate 33). The wooden boards were generally intact, but some were lifting (Plate 34). The ridge and brickwork were largely cobwebbed but light could be seen through the ridge gaps suggesting potential access points were present. A mezzanine was present at the northern end of this storage area which had a large gap leading down to the ground floor/adjacent yard, used as a loading bay (Plate 35).

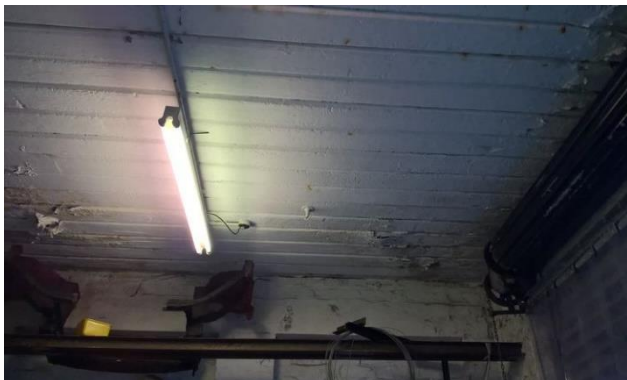
**Plate 36: The Wooden Panelling Ceiling**

A car workshop was present to the north-west next to the yard. This was a single storey area with ceilings comprising of a mix of metal/plastic corrugated sheeting and wooden boarding (Plates 36 and 37). Some gaps were recorded to the west of this section where brickwork was missing.

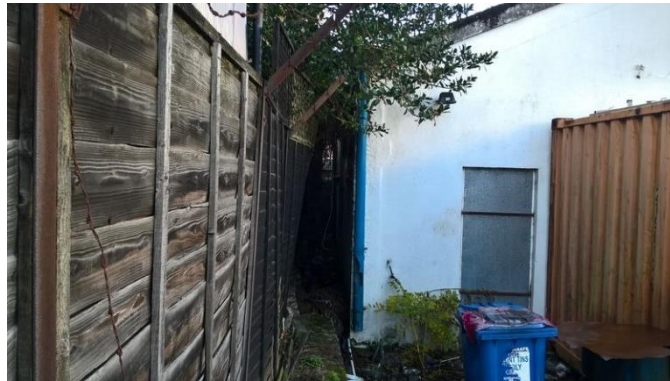
**Plate 38: Southern Side of Building 2.**

This building was a tall single storey structure which was in use as a car workshop at the time of survey. There was limited visual access to the western and southern sides of the building, and the roof could not be inspected on the south side due to the close proximity of the immediately adjacent garden fences (Plate 38).

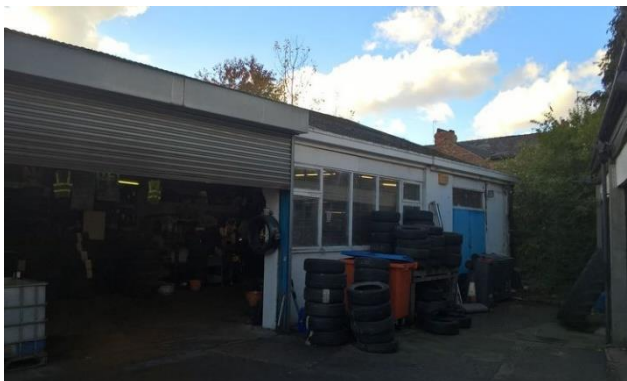
A large metal shutter door was present to the north-east and windows were present on the northern (Plate 39) and southern aspects of the building. On the eastern gable end, a bargeboard was present which had some lifting at the north-eastern end (Plates 40 and 41). Although some areas were partially cobwebbed, others appeared clear of debris. It was not possible to inspect these gaps due to the height at which they were located and as such it was not possible to establish if bats had used these features to enter a roost location.

**Plate 39: Northern Aspect of the Workshop with the Metal Shutter Door and Intact Windows.**

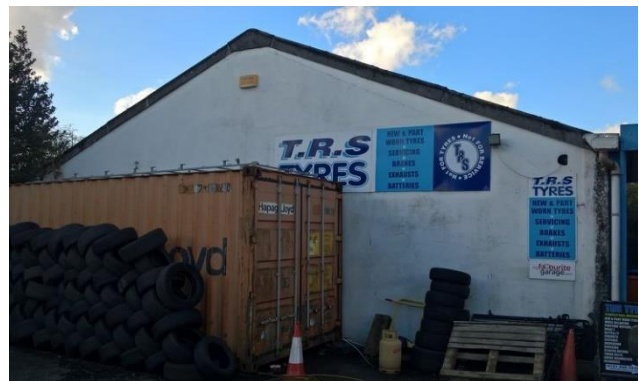
**Plate 40: Eastern Aspect of the Workshop.**

During the field survey, a small gap was noted around the barge board on the eastern elevation of the building, which could not be fully inspected, but appeared clear of debris. As the remainder of the building was considered largely unsuitable for bats, the building was determined to have low bat roost potential.

No. 18a Kingsley Road has been identified as having low potential to support roosting bats. Bat Surveys: Good Practice Guidelines, published by the Bat Conservation Trust (Collins, 2016), recommends for structures with low bat roosting potential that at least one survey (consisting of either a dusk emergence survey or a dawn re-entry survey) be undertaken during the peak season for emergence/re-entry surveys (May to August) to determine the presence/absence of roosting bats within the structure. Should this survey confirm the presence of roosting bats, it will be necessary to undertake additional surveys in order to inform a Natural England licence application. In addition, should the survey identify the presence of significant levels of bat activity at the site, it may be necessary to undertake further survey visits to comprehensively assess the value of the site to bats.

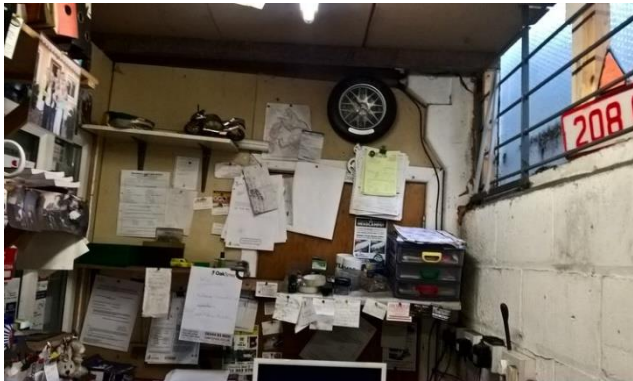
**Plate 41: Kitchen Area to the South-west.**

The building was in use as a car workshop with tyre storage and an office/small kitchen to the south-west (Plate 42). The building was open to the roof so there was no internal loft space (Plate 43). The walls were made of brick and the ceiling comprised corrugated metal with occasional plastic sheets serving as skylights. Composite concrete lined the corrugated metal sheets, some of which had crumbled away on the northern side exposing the sheeting below (Plate 44). There were windows to the north and south of the building and a large open shutter door to the north-east. Holes were noted in the brickwork to the north-east and south-east where large bolt supports were present, and at the eaves on the west side where light could be seen (Plate 45). These gaps would potentially facilitate fauna access into the building, but no suitable bat roost features were recorded internally.
