# LAND AT WHITE MOSS ROAD, BLACKLEY

## Remediation & Enabling Works Strategy

| Report No | BEK-24070-1 (Rev D) |
| Date | June 2025 |

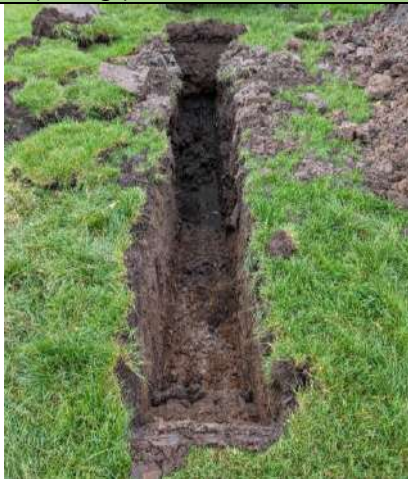
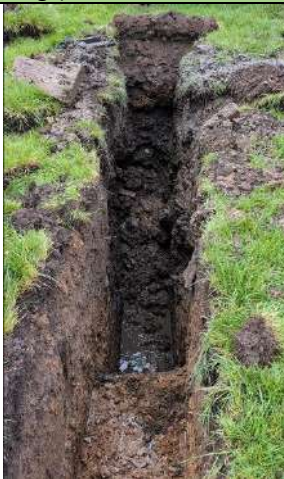
| <b>P15: Trial Pit TP6 (natural strata in east of pit, MG in west)</b> | <b>P16: Trial Pit TP6 (natural strata in east of pit, MG in west)</b> |

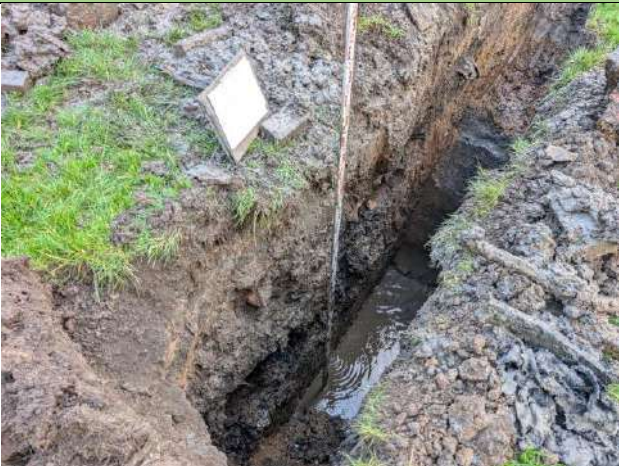
| <b>P17: Trial Pit TP6</b> | <b>P18: Trial Pit TP6 (arising)</b> |
