## Lock 87, Rochdale Canal Design & Access

# Lock 87, Rochdale Canal

## Design & Access

This statement has been prepared to support the application for listed building consent for works of maintenance at lock 87, a grade II listed building (list entry number: 1247580), on the Rochdale Canal in Manchester.

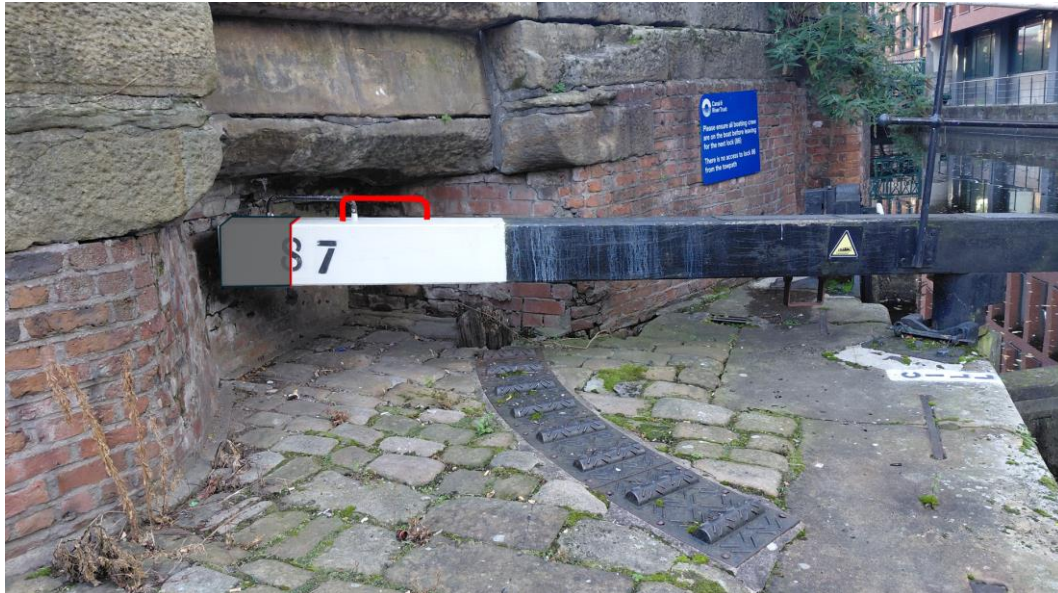
*Figure 9 Visualisation of appearance after shortening by 300 mm*

There is a trapping hazard between the lock gate balance beam and the adjacent retaining wall on the offside of the top lock gates (figure 8). There could be serious injury should an approaching boat strike a partially open gate whilst somebody stands between the partially open gate balance beam and the wall.

It is proposed to reduce the balance beam length by 300mm to provide additional space between the balance beam and the wall. The balance beam handle will be moved 300mm to allow the beam to be shortened. A visualisation shows how this will appear (figure 9).
