# Elizabeth Street, Cheetham Hill

## Phase 4 Validation Report

**Curtins Ref: 080139-CUR-XX-XX-T-GE-00006**

Site Address: Land off Elizabeth Street, Cheetham Hill, Manchester, M8 8BB

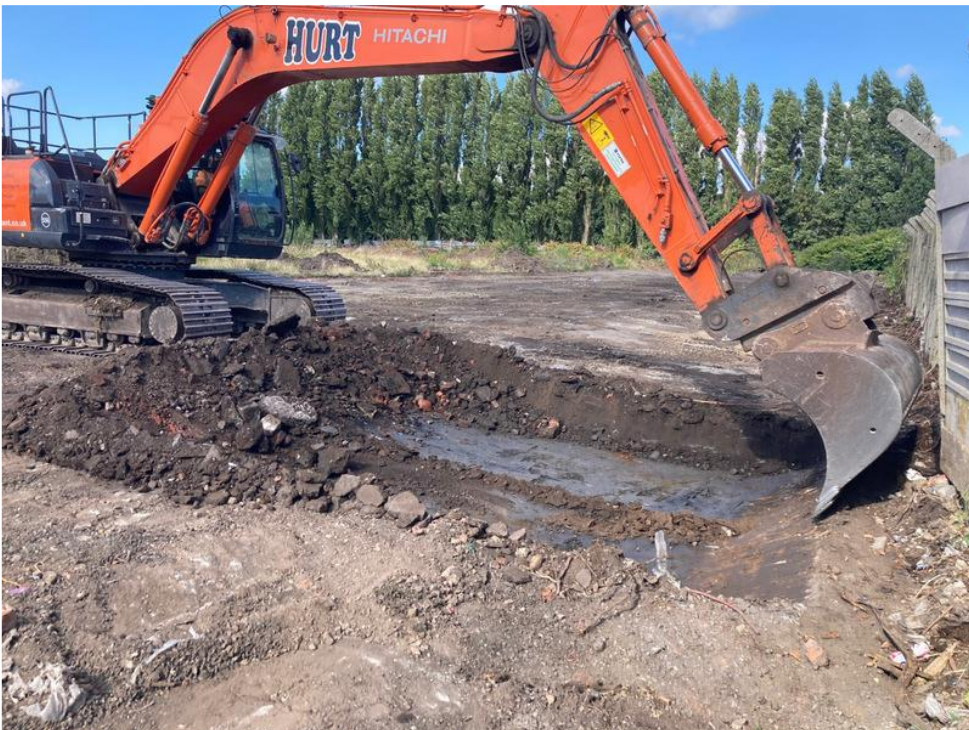
**Figure 0-2Excavtions began along the northern boundary**

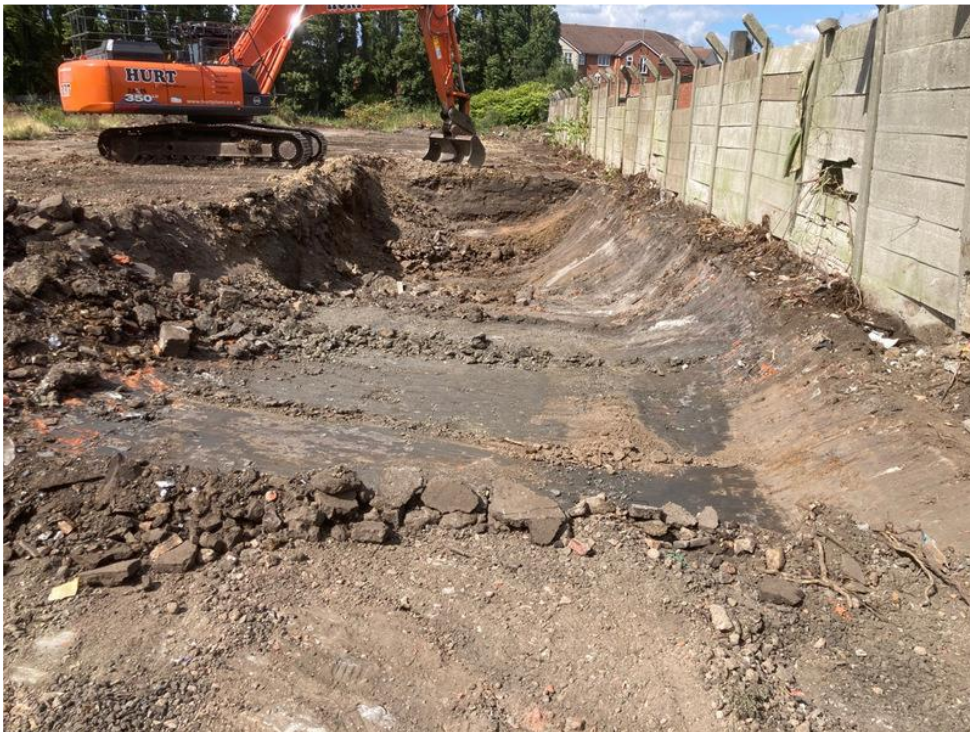
**Figure 0-1 Northern boundary excavations**

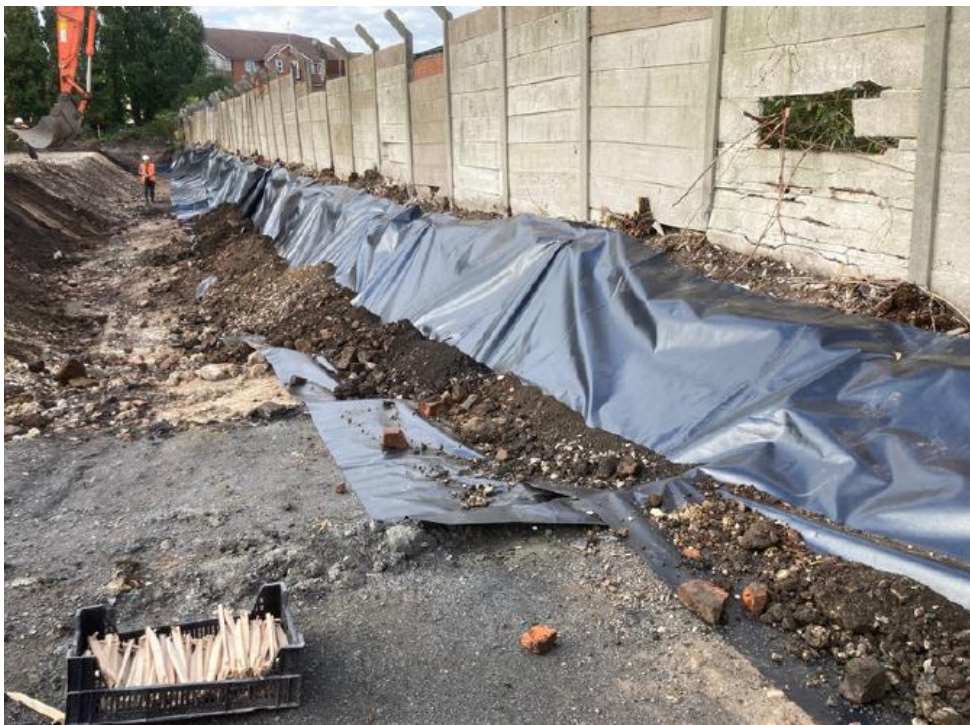
**Figure 0-1 root barrier membrane installed to the northern boundary**

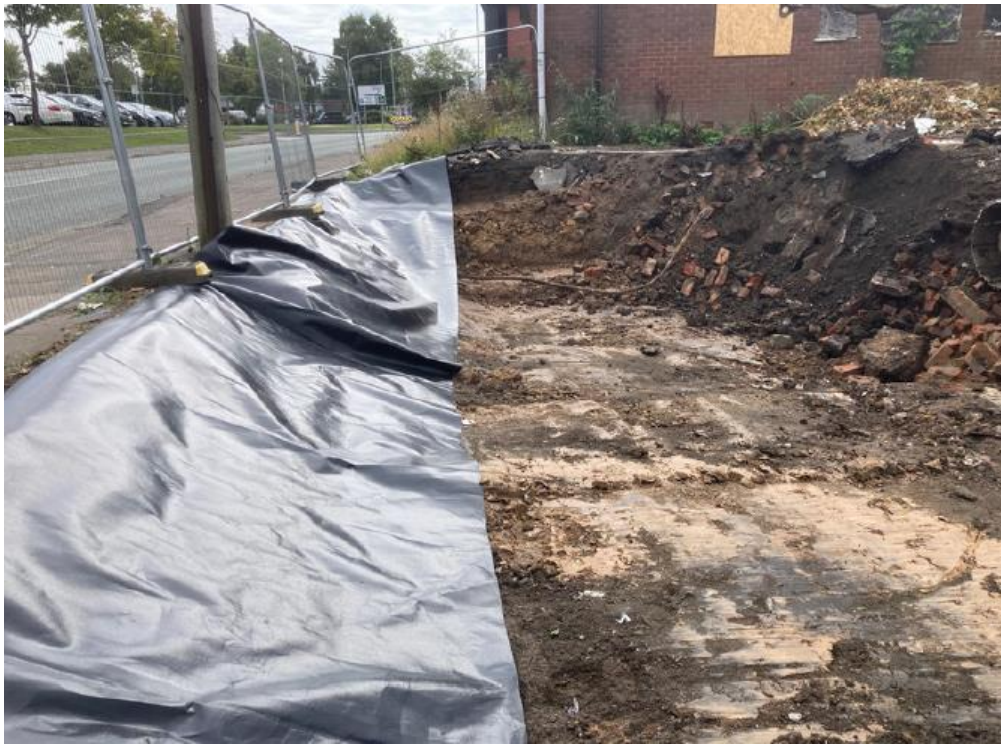
**Figure 0-2 JK area 4 Excavations and barrier install to public footpath**

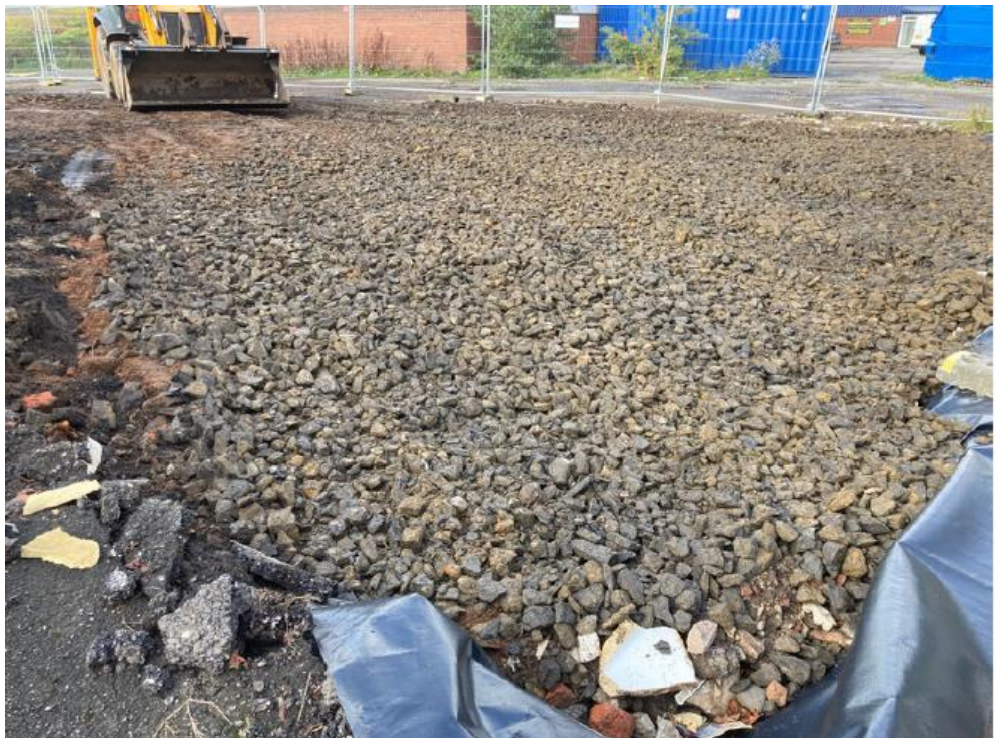
**Figure 0-1 JK area 4 now backfilled with clean imported stone**

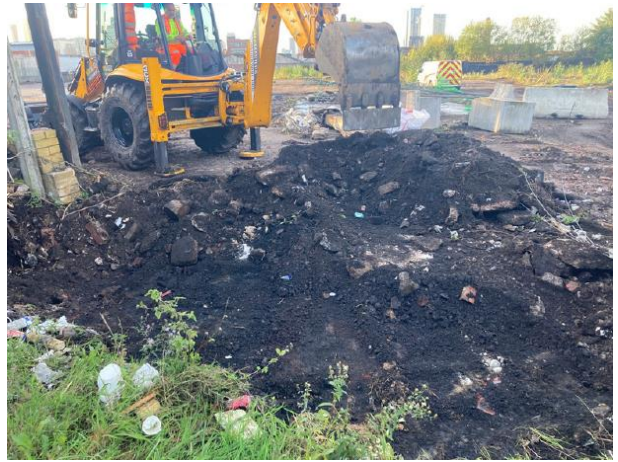
Figure 2: Excavation of regrowth (17/10/22)

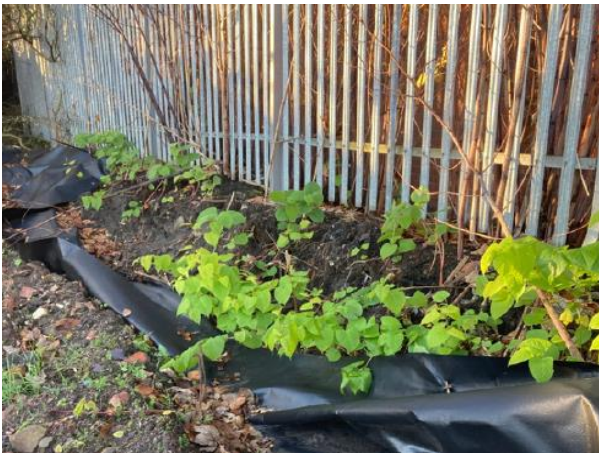
Figure 3: Japanese knotweed at root barrier (12/06/22)

Spot treatment of Japanese Knotweed behind the root barrier identified on the map above.

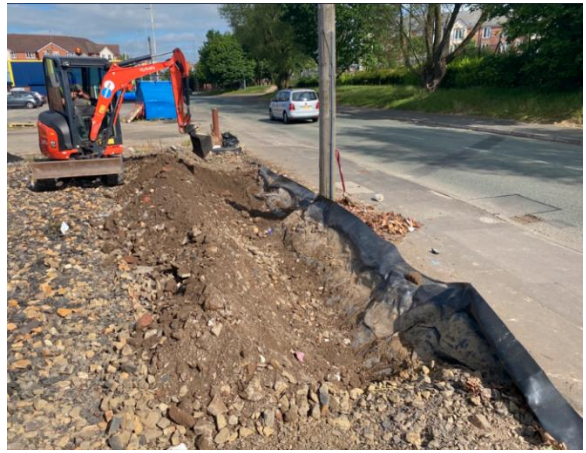
Figure 4: excavation of Japanese knotweed rhizome under root barrier (01/06/23)

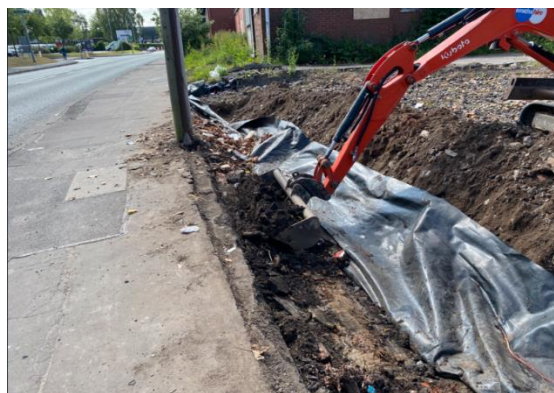
Figure 5: Removal of material from in front of the root barrier (01/06/23)

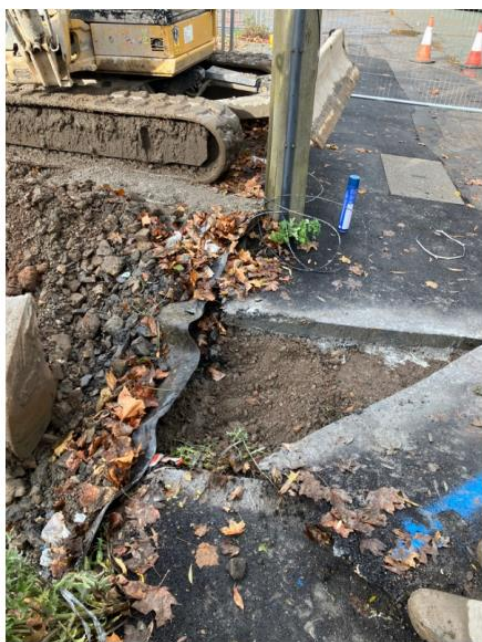
Figure 6: Uncovering the root barrier membrane (November 2023)

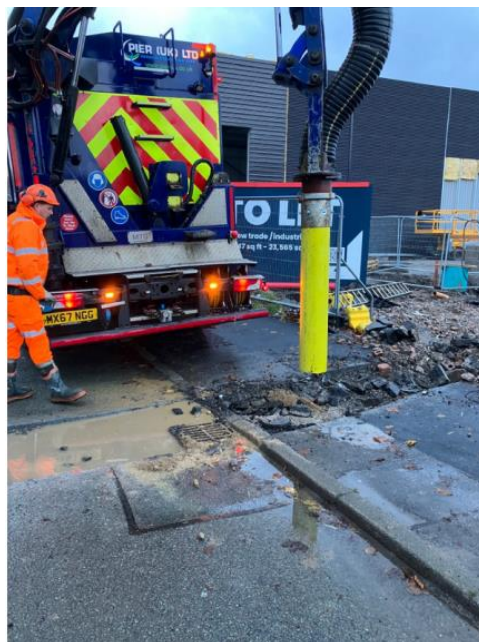
Figure 7: Vacuum excavator works (November 2023)

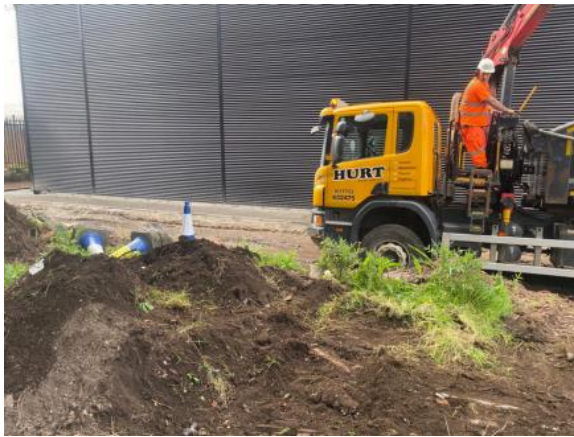
Figure 10: Excavation of Japanese knotweed (May 2024)

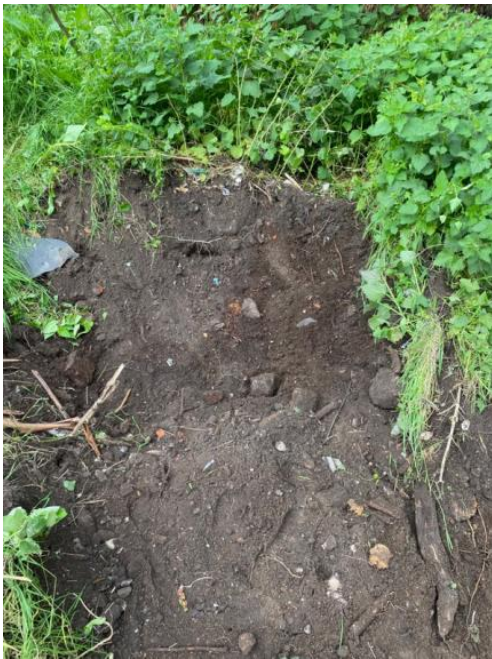
Figure 11: Excavation of Japanese knotweed (May 2024)

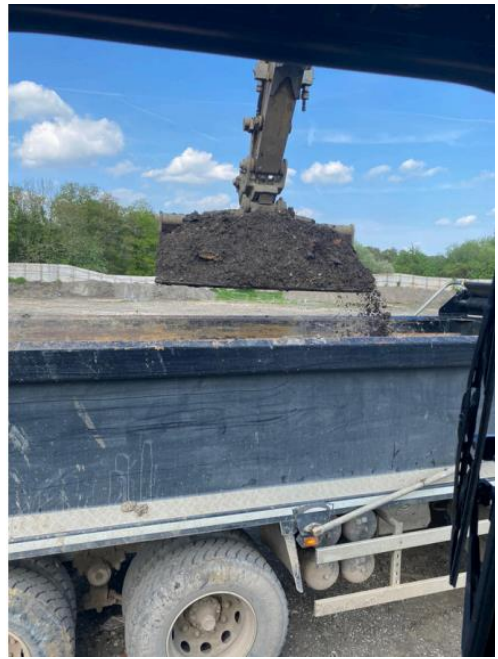
Figure 12: Loading wagons with contaminated material (May 2024)

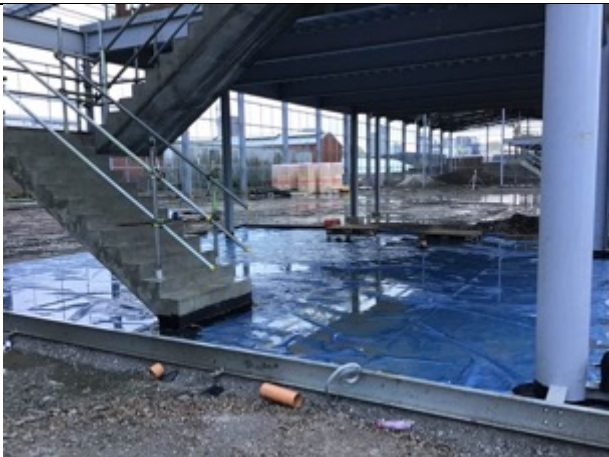
Unit 2 core area line out installation

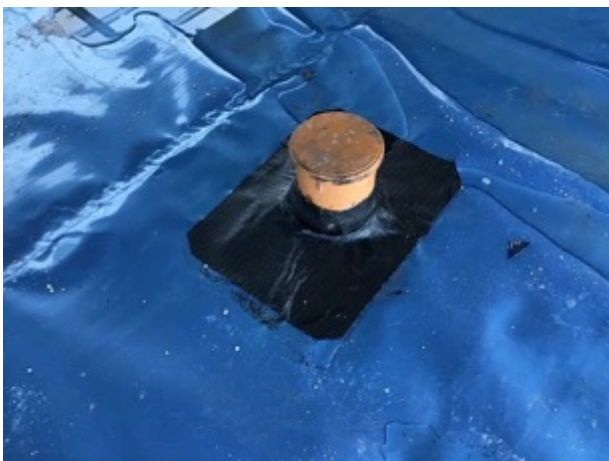
Unit 2 sealed pipe penetration

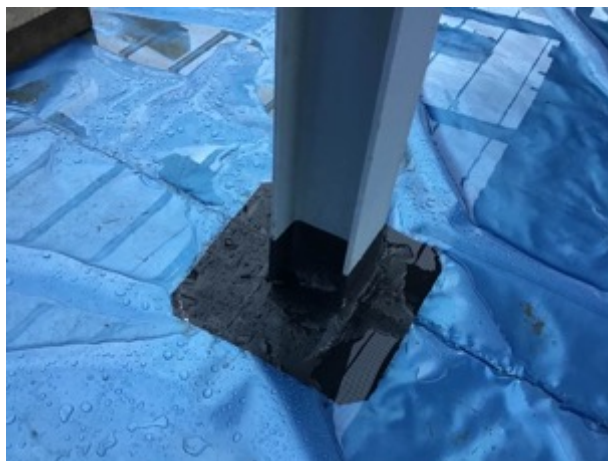
Unit 2 sealed stanchion detailing

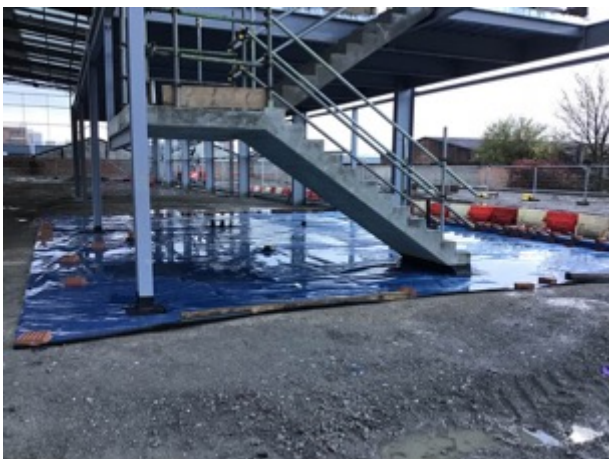
Unit 3 core area line out installation

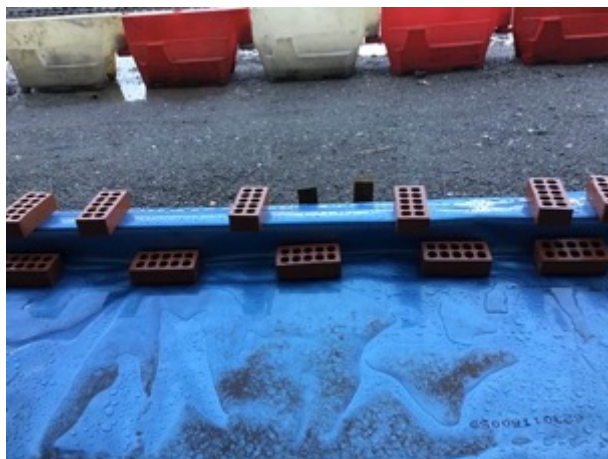
Unit 3 membrane extended over the perimeter edge

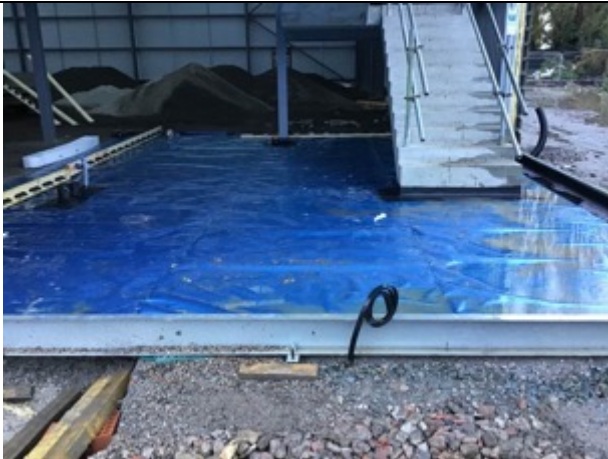
Unit 9 core area line out installation

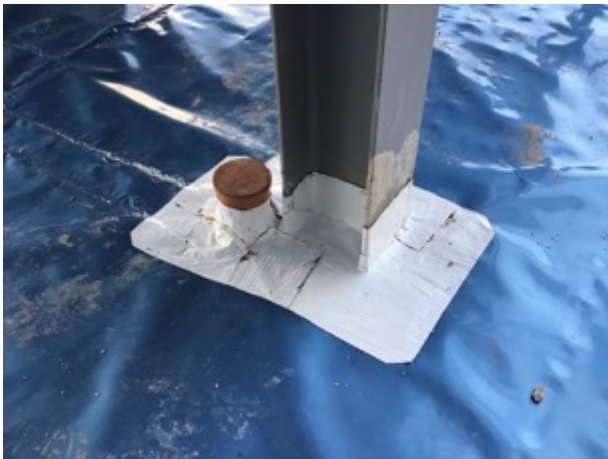
Core 4 sealed pipe penetration and stanchion detailing

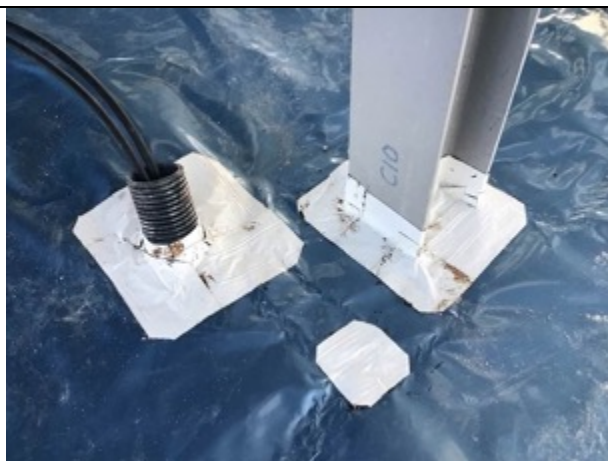
During our inspection the following defects and repairs were carried out: 4no patch repairs made by the installers in core area 8 using SAGM and heat applied.

Core 8 sealed stanchion detailing, pipe penetration and patch repair

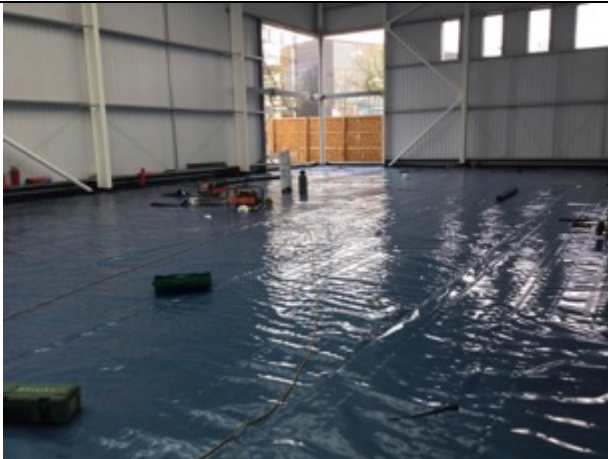
Overview to the membrane line out to unit 1.

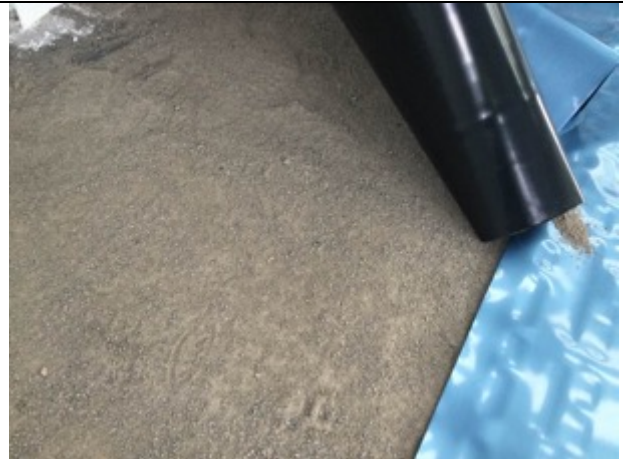
Sand blinding across the footprint within unit 1.

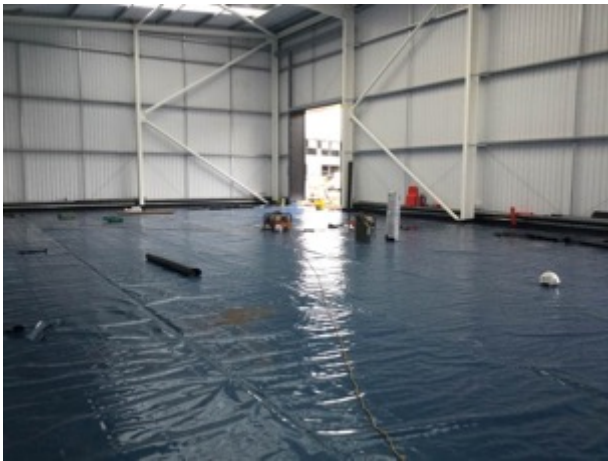
Membrane line out to unit 1

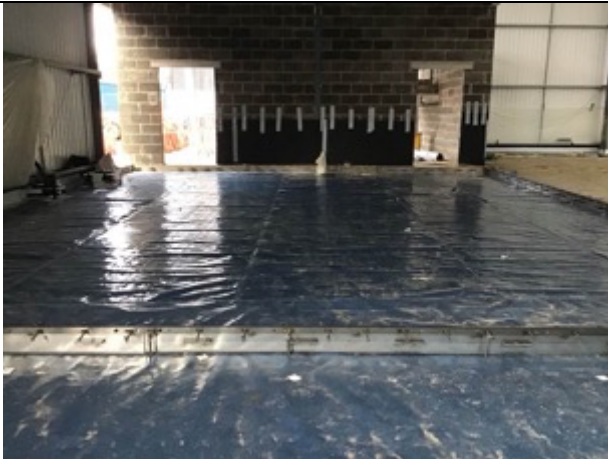
Unit 2 undercroft overview

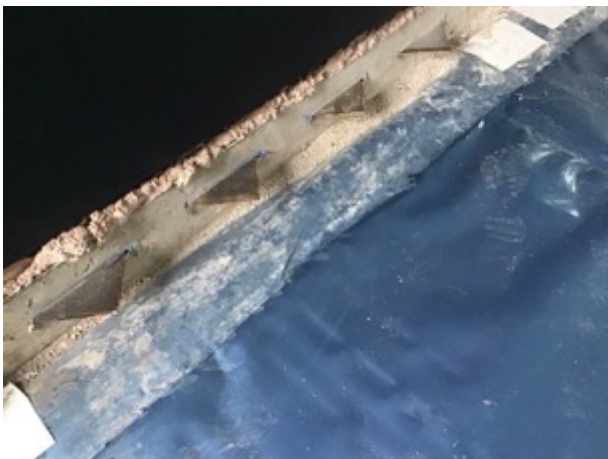
Unit 2 membrane sealed to core area existing membrane

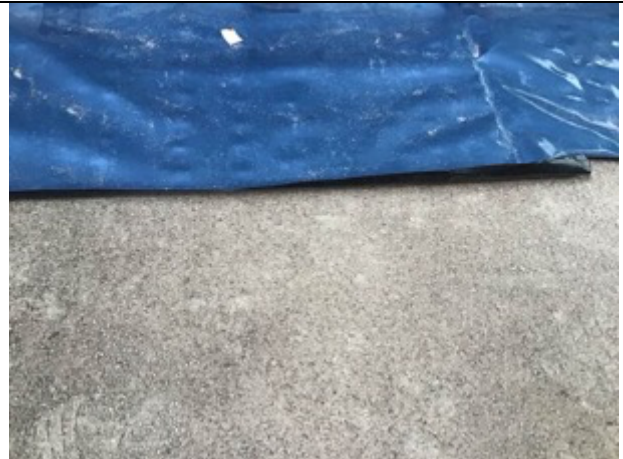
Rolled sub grade

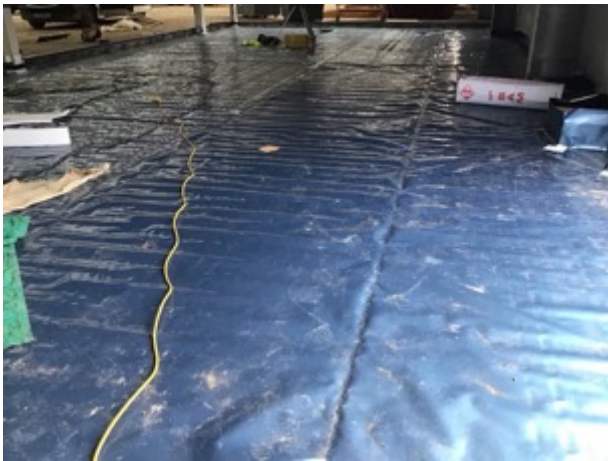
Unit 3 undercroft overview

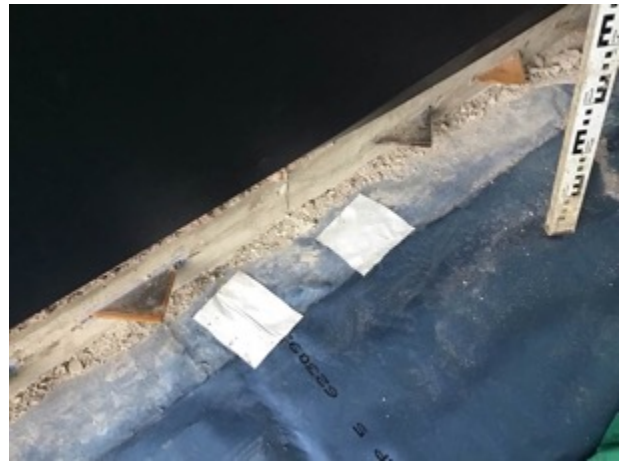
Unit 3 patch repairs

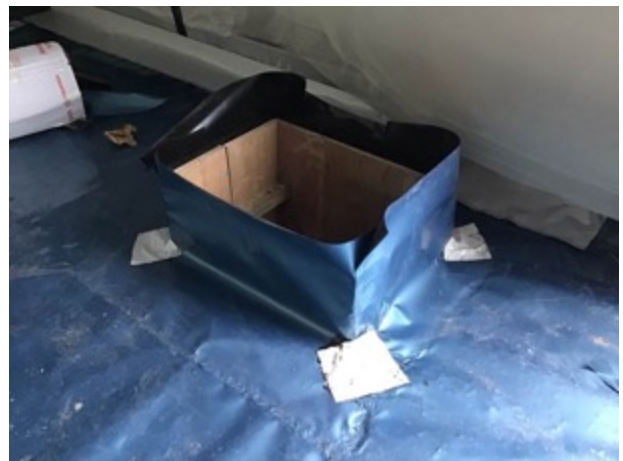
Unit 3 boxed out area

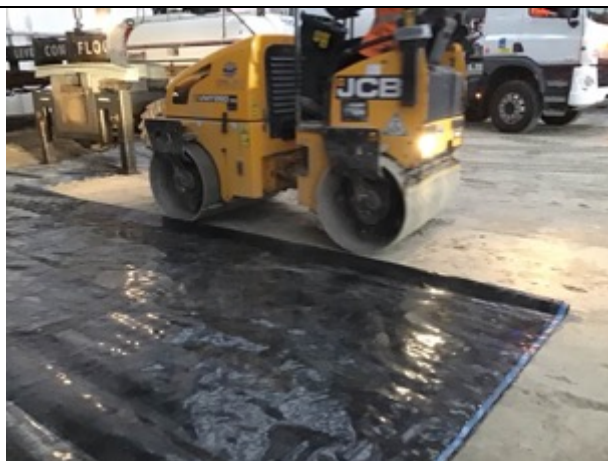
Sub grade prep ahead of the membrane installation

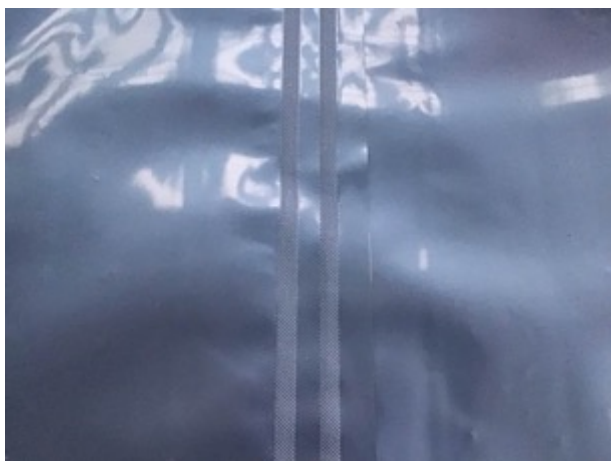
Sealed auto weld

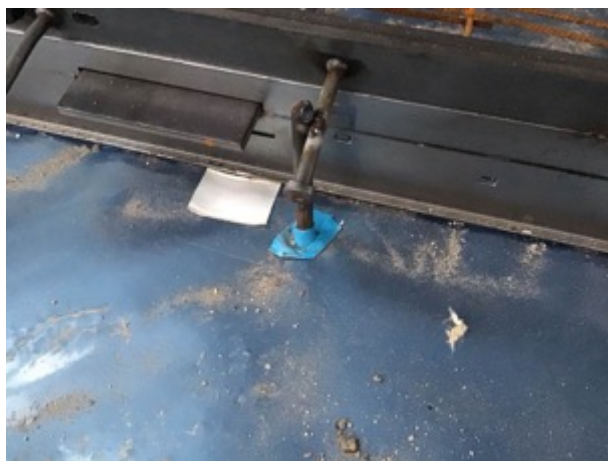
Butyl tape on armoured joint pin

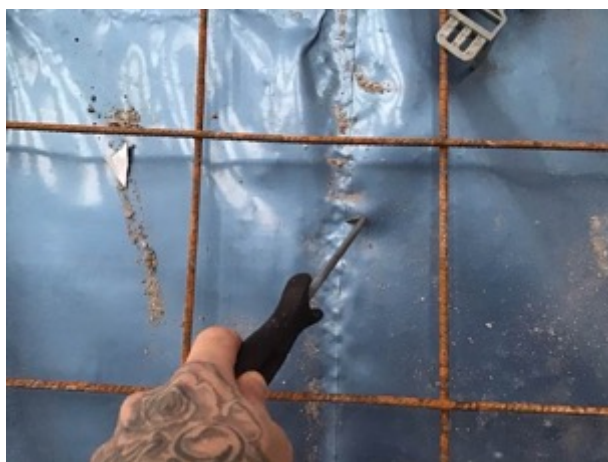
Probe test to hand weld

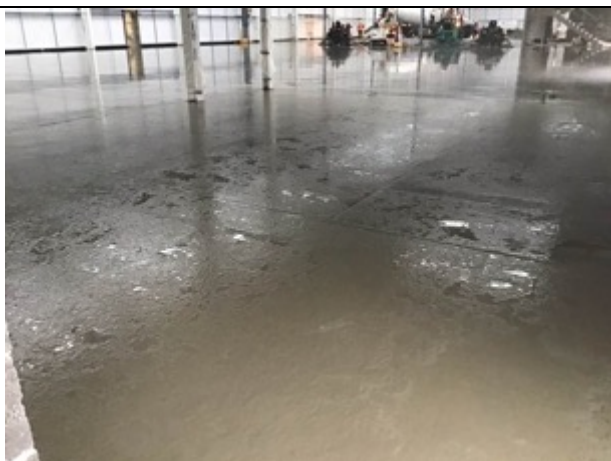
Poured under crotch area

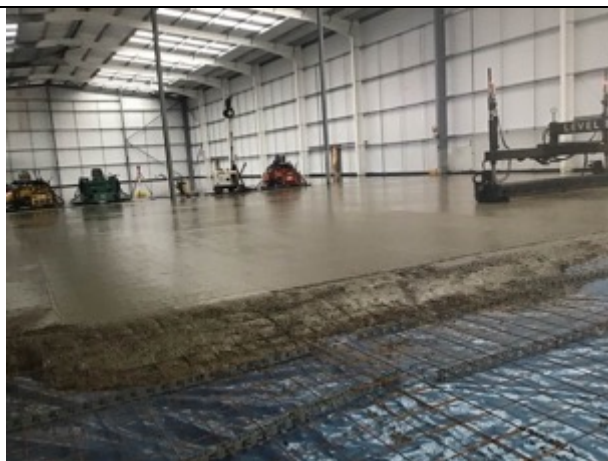
Laser screed pour

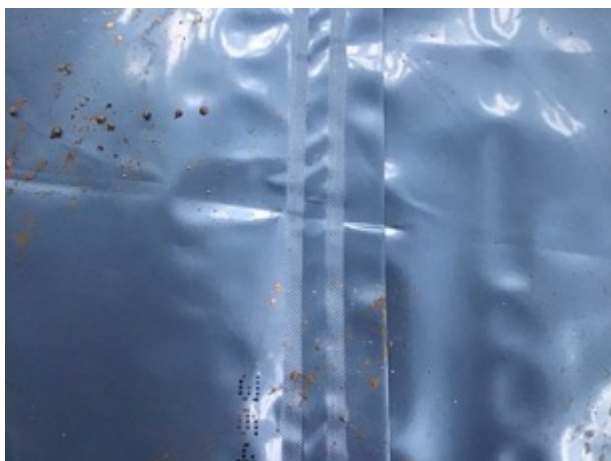
Sealed auto weld membrane joint

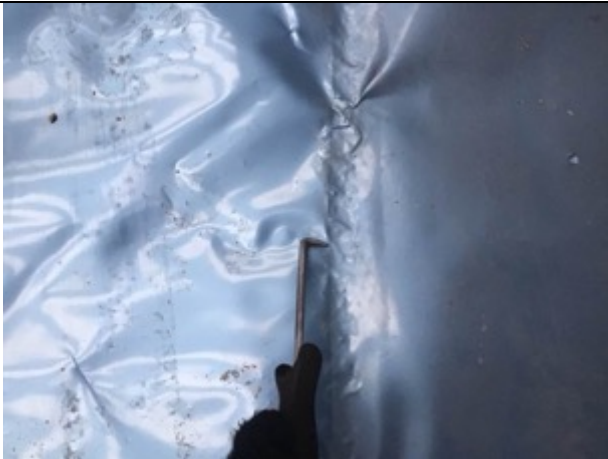
Pick test to hand weld

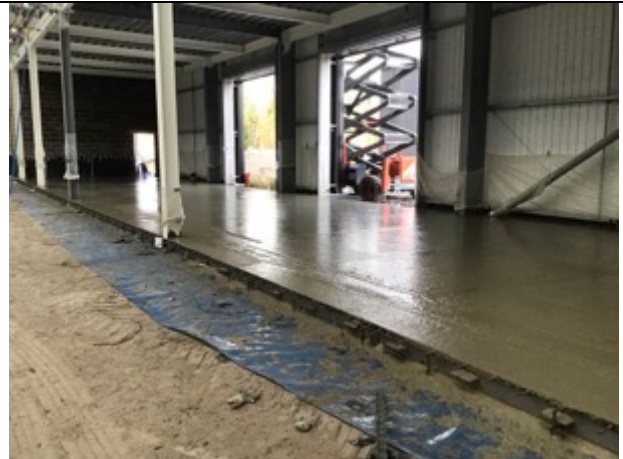
Laser screed pour

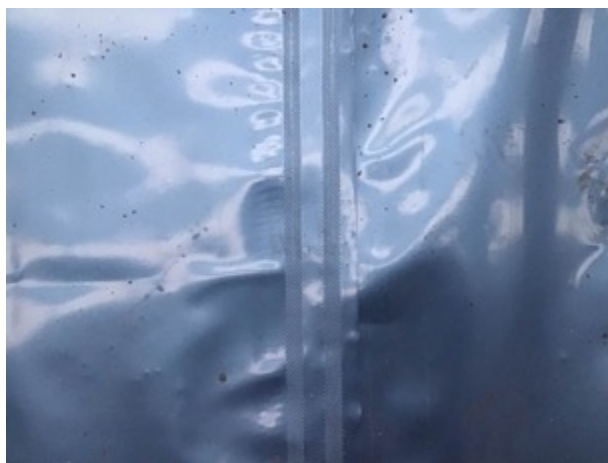
Sealed auto weld membrane joint

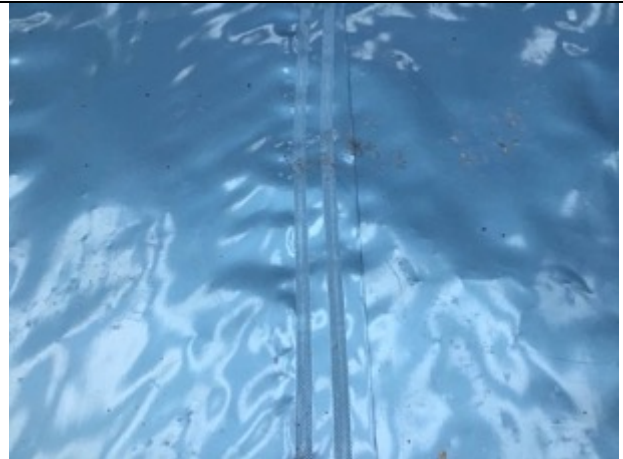
Auto weld membrane joint
