## GAS MEMBRANE VALIDATION – BENNETT STREET

| <b>Project Name:</b> | Bennett Street |
| <b>Project Number:</b> | 15-974 |
| <b>Plot:</b> | Apartment Block 2 |

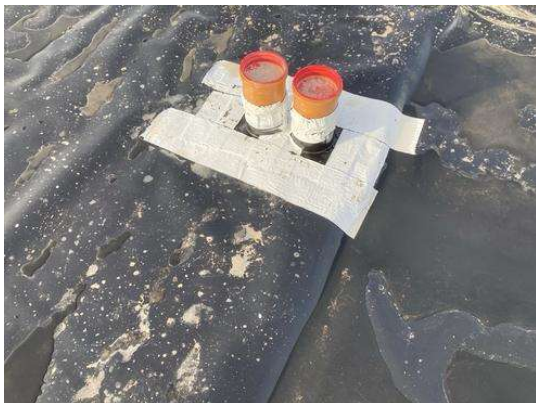
Photo 22

**Service entries seals: Top hats seal arrangements fixed around service entries? Use of Jubilee clips?**

Yes
