Bat Survey Report - 2025 Surveys

**Fallowfield Campus Redevelopment  
Project**

**John Graham Construction Ltd**

Report Reference: GRA001-013-004/001/002

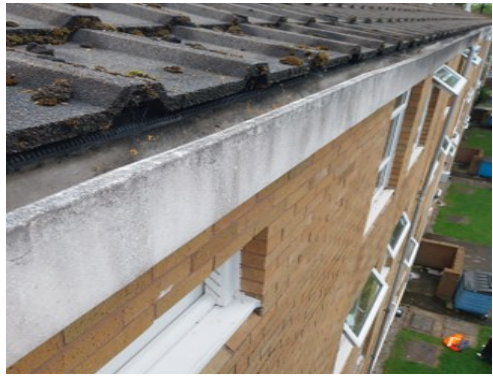
Photograph 2: Slate tile roofing present on all buildings surveyed.

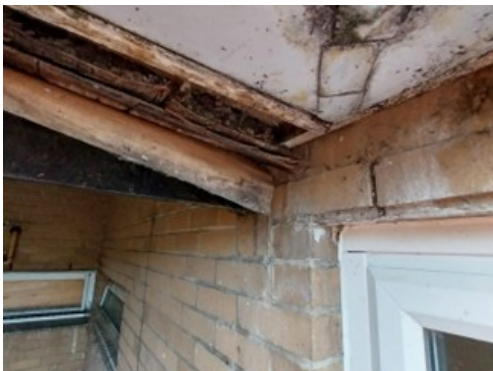
Photograph 7: Rooted wood creating gap in roof

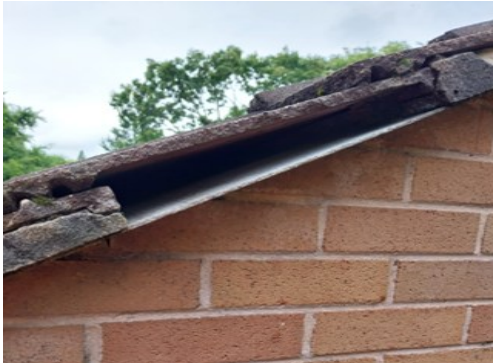
Photograph 11:  
Gap in slate tile roofing

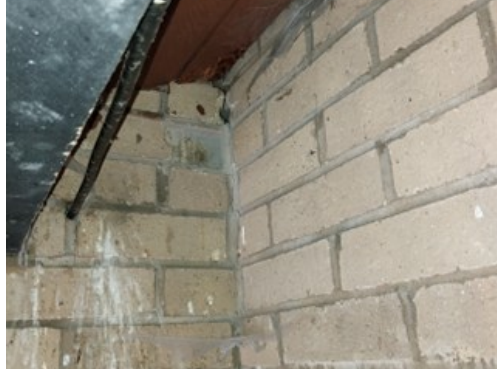
Photograph 12: : Gap in roof of B18 with bat droppings

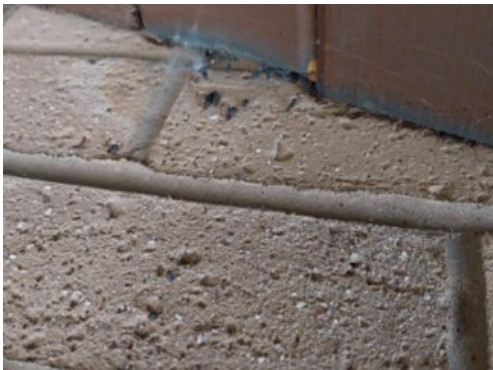
Photograph 13: Gap in roof of B18 with bat droppings

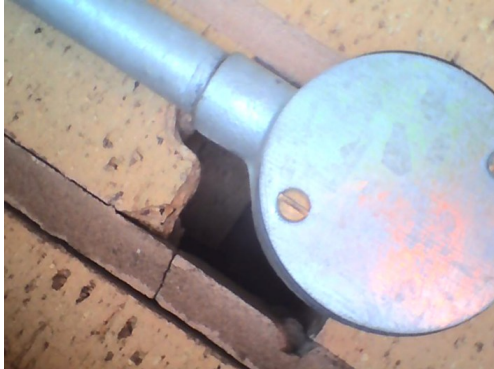
Photograph 19: Gap in wall leading into wall cavity

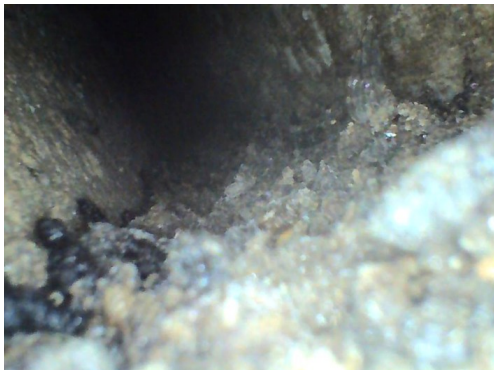
Photograph 21: Endoscope inspection of B18. Bat droppings present
