## Hammerstone Road Depot, Manchester

# Discharge of Planning Condition 11

**Curtins Ref: HRD-CUR-00-XX-T-RE-006**

Revision: P02

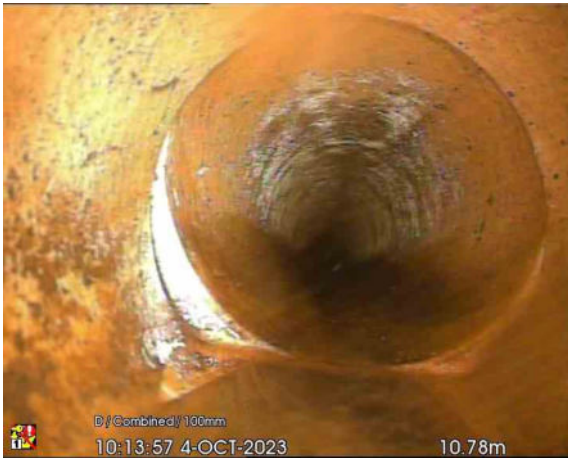
MH24 DS\_10-78m\_101357.jpg, 00:00:41, 10.78 m  
Joint displaced, medium

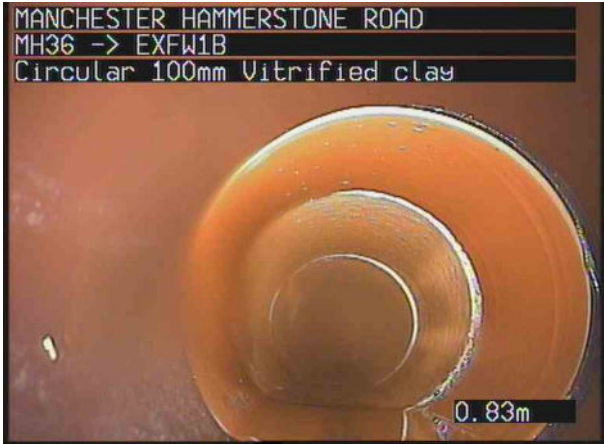
MH36X\_bd74fbc5-b345-47a2-8157-43e8e117741c\_20230822\_120336\_574.jpg, 00:00:43, 0.83 m  
Pipe material changes to polyvinyl chloride at this point

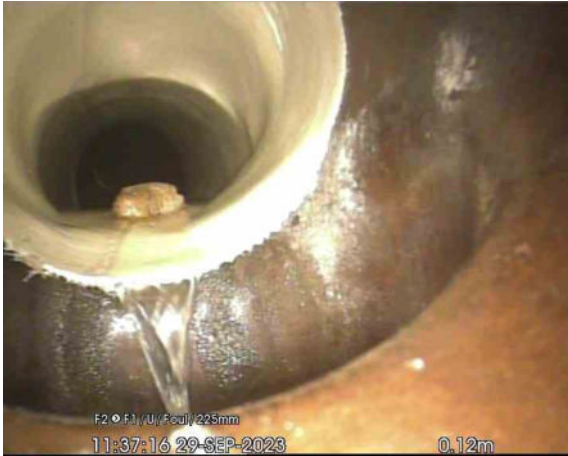
F1X\_71490003-b3f0-40ea-863b-8bdebed17308\_20231017\_1  
45304\_211.jpg, 00:00:45, 0.02 m  
Finish node, manhole, reference: F1, patch on view

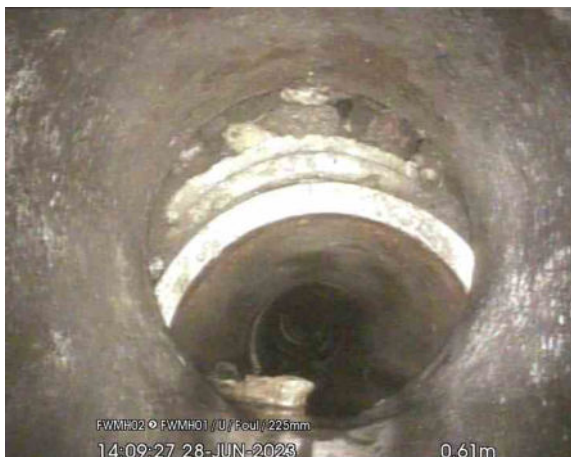
FWMH02 US FWMH01\_0-61m\_140927.jpg, 00:00:15, 0.61 m  
Joint displaced, large

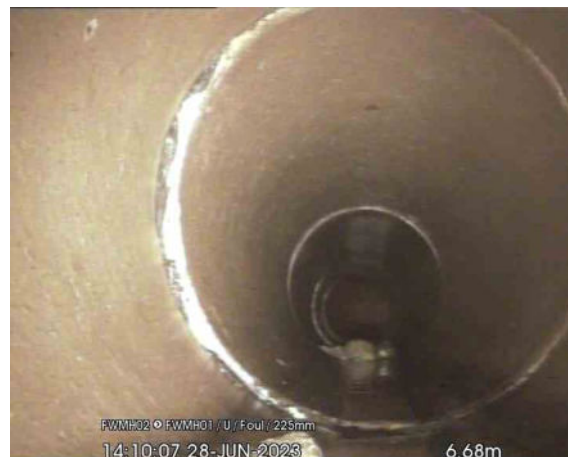
FWMH01X\_fca69c75-ec5f-4891-b983-80ffa3de1089\_20230704\_091625\_459.jpg, 00:00:43, 6.68 m  
Settled deposits, coarse, 5% cross-sectional area loss

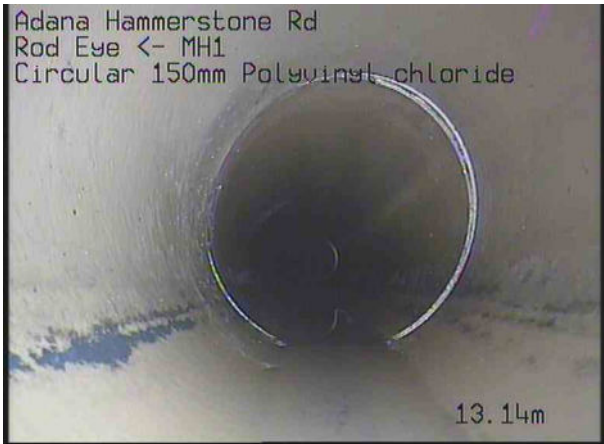
Rod  
EyeX\_89df72d6-3b80-41c3-8f57-19804605fbd5\_20231002\_1  
10348\_578.jpg, 00:01:22, 13.14 m  
Deformed sewer or drain, 30%

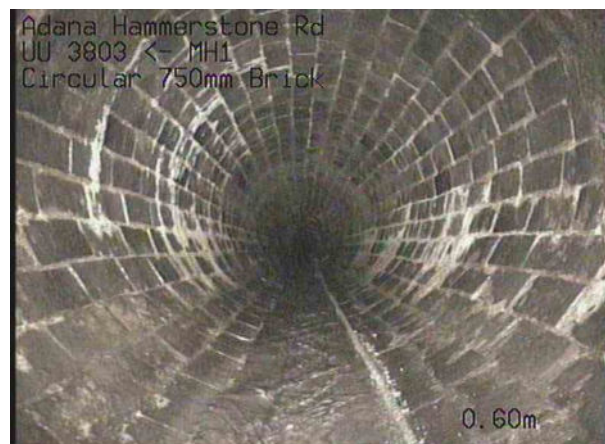
3803X\_eca04b50-e131-4dfe-8786-ba9a1bf9edd0\_20230929\_110618\_260.jpg, 00:00:38, 0.60 m  
Attached deposits, encrustation from 7 o'clock to 5 o'clock, 5% cross-sectional area loss, start, Patchy

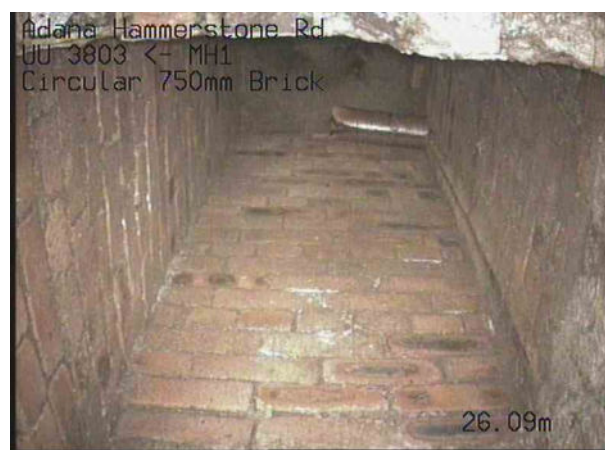
3803X\_7c8327ac-b3ef-4fae-86ac-5e048638f9f8\_20230929\_110857\_666.jpg, 00:03:18, 26.09 m  
Start node, manhole, reference: Node point, 150mm pipe incoming

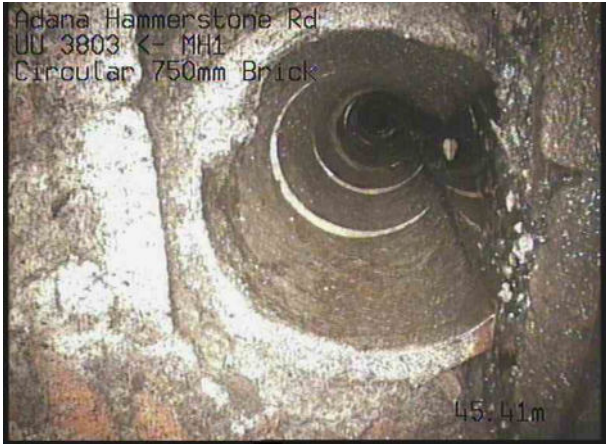
3803X\_3ca19a47-249f-40ed-abcb-2825530696c9\_20230929\_111346\_245.jpg, 00:08:06, 45.40 m  
Connection other than junction at 3 o'clock, 300mm dia

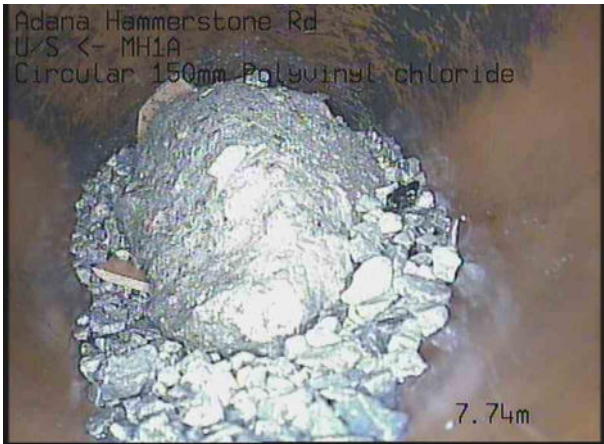
U\_SX\_551ced77-9085-490f-9a3d-03c1825fe094\_20231002\_1  
11536\_088.jpg, 00:01:23, 7.74 m  
Collapsed drain or sewer, 95% cross-sectional area loss

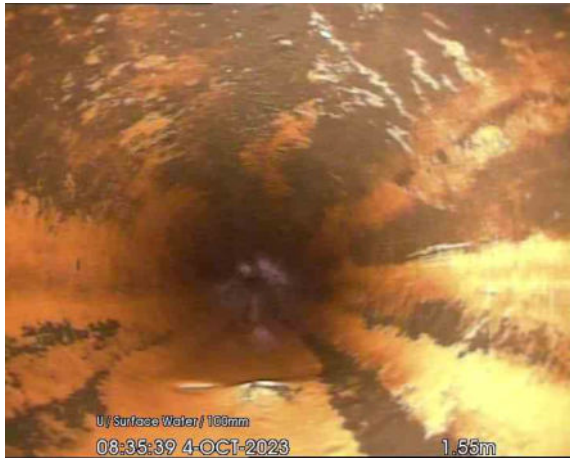
MH3 US RWP\_1-55m\_083539.jpg, 00:00:12, 1.55 m  
Deformed sewer or drain, 15%

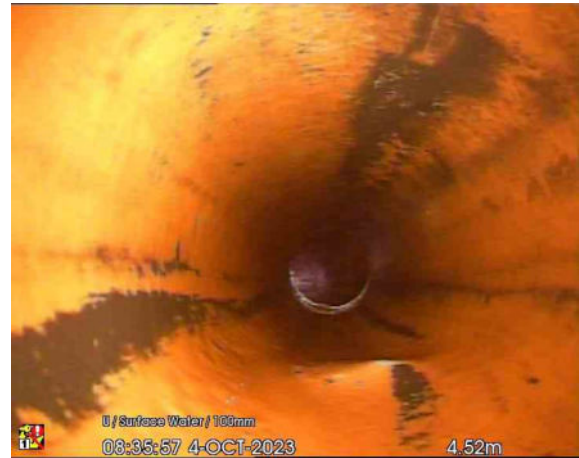
MH3 US RWP\_4-52m\_083557.jpg, 00:00:25, 4.52 m  
Deformed sewer or drain, 10%

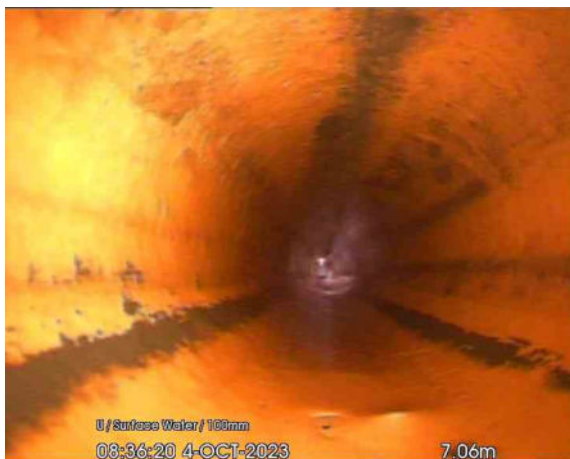
MH3 US RWP\_7-06m\_083620.jpg, 00:00:39, 7.06 m  
Deformed sewer or drain, 10%

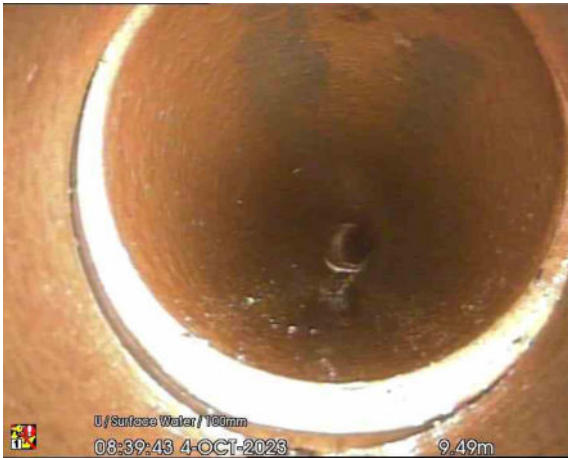
MH3 US ACO\_9-49m\_083943.jpg, 00:00:41, 9.49 m  
Joint displaced, medium

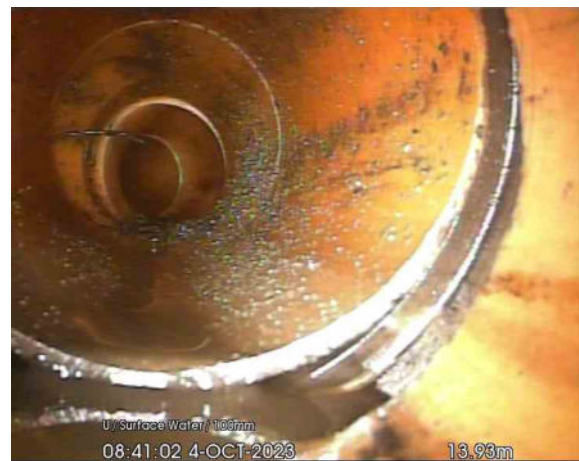
MH3 US ACO\_13-93m\_084102.jpg, 00:01:23, 13.93 m  
Joint displaced, large

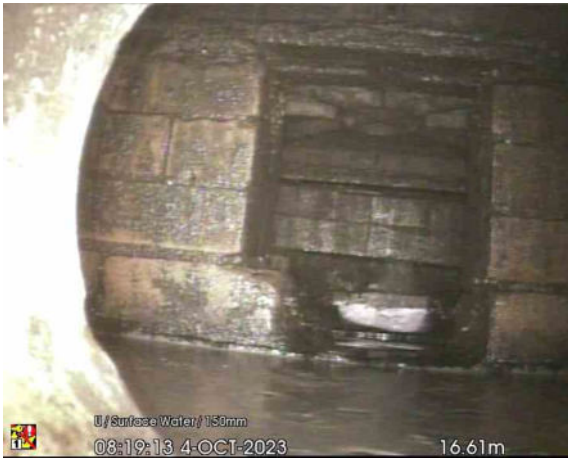
MH4A US INTERCEPTOR MH\_16-61m\_081913.jpg, 00:01:02,  
16.61 m

Finish node, other special chamber, reference:  
INTERCEPTOR MH, INT MH WASH DOWN AREA

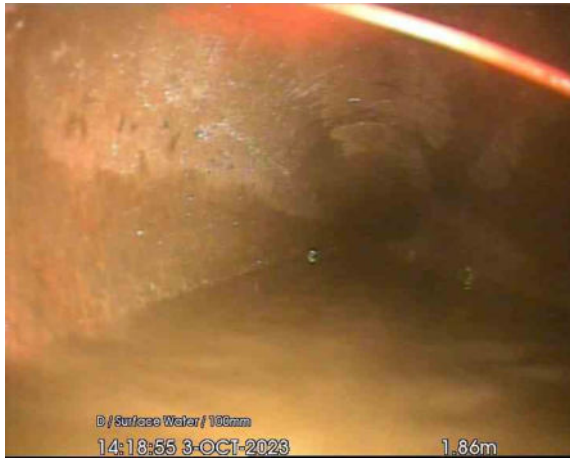
MH4A DS MH5\_1-88m\_141855.jpg, 00:00:11, 1.88 m  
Other obstacles at joint from 10 o'clock to 3 o'clock, 5% cross-sectional area loss, PLASTIC

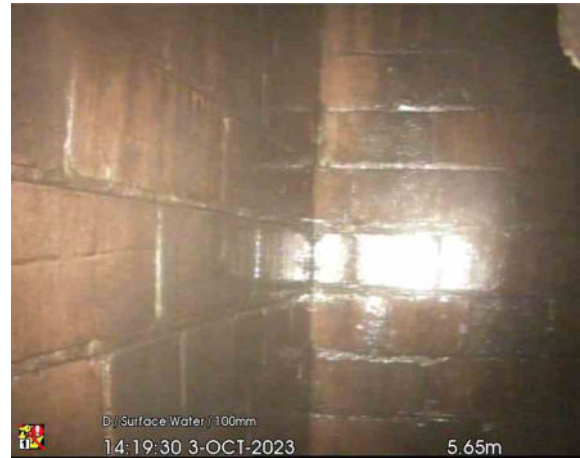
MH4A DS MH5\_5-65m\_141930.jpg, 00:00:33, 5.65 m  
Finish node, manhole, reference: MH5, CULVERT MH

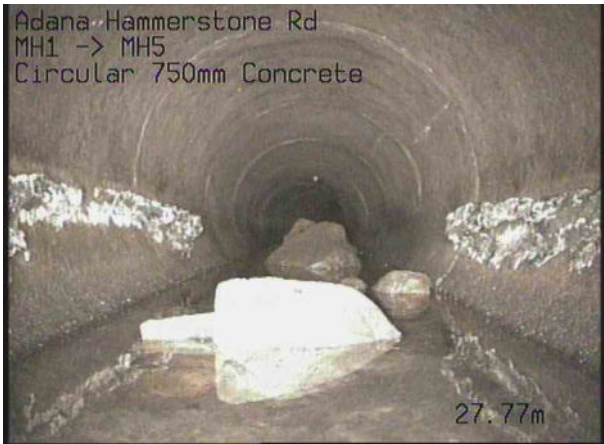
MH1X\_0bc624e5-c3b6-449d-b80d-909b61ccf2e0\_20230929\_083200\_349.jpg, 00:09:04, 27.77 m

Settled deposits, hard or compacted, 40% cross-sectional area loss, Bricks/rubble

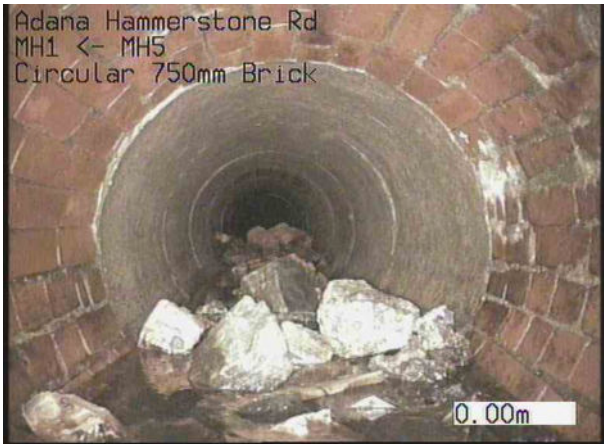
MH1X\_1e4fff8e-f462-4aec-b3d1-adf4e246590f\_20230928\_14  
4150\_540.jpg, 00:01:02, 0.00 m

Settled deposits, hard or compacted, 40% cross-sectional area  
loss, Rocks & Bricks ahead

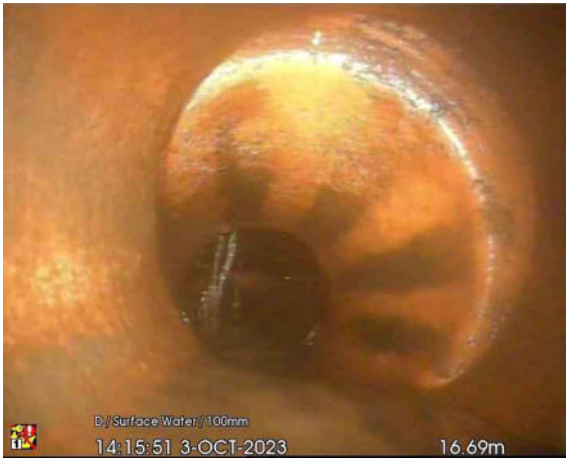
MH4 DS MH5\_16-69m\_141551.jpg, 00:01:10, 16.69 m  
Joint displaced, medium

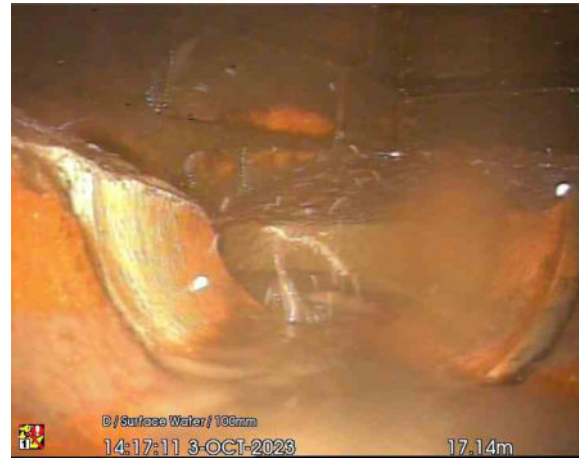
MH4 DS MH5\_17-14m\_141711.jpg, 00:02:08, 17.14 m  
Finish node, manhole, reference: MH4A, UNCHARTED MH

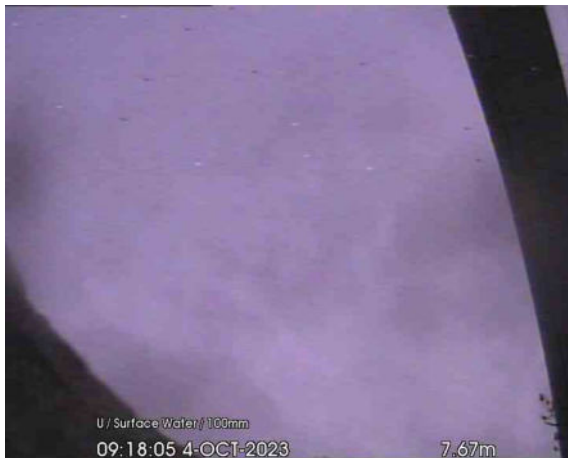
MH16 US ROD EYE\_7-67m\_091805.jpg, 00:00:34, 7.67 m  
Finish node, rodding eye, reference: ROD EYE, NO CAP ON  
RE

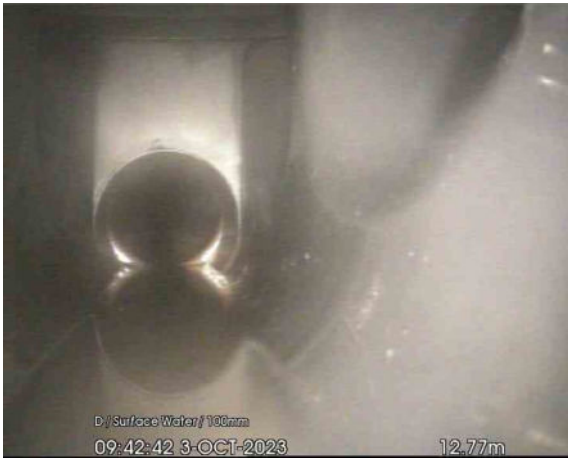
MH17 DS MH18\_12-77m\_094242.jpg, 00:00:47, 12.77 m  
Finish node, inspection chamber, reference: MH18, DIP IN  
CHAMBER

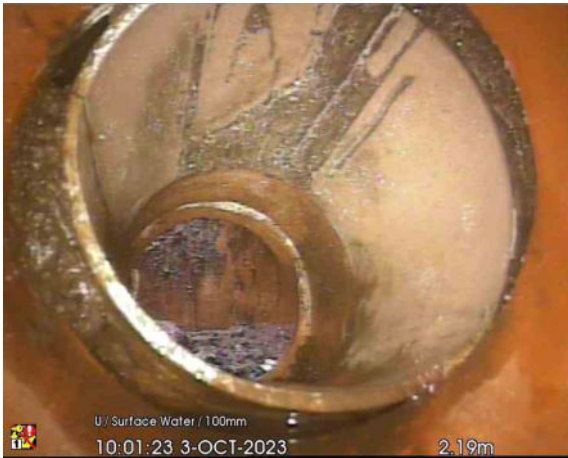
MH18 US GULLY\_2-19m\_100123.jpg, 00:00:14, 2.19 m  
Joint displaced, large

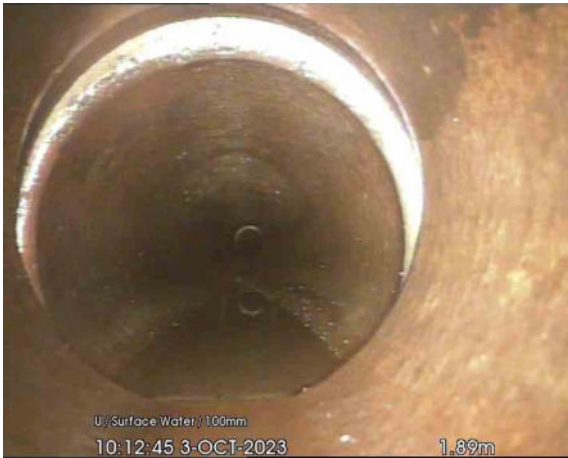
| Item No. | Inspection Direction | PLR | Client's Job Ref | Contractor's Job Ref |
|---|---|---|---|---|
| 31 | Upstream | GULLYX | DK0526 ADANA | NRC WWS LTD |

MH19 US GULLY\_1-89m\_101245.jpg, 00:00:16, 1.89 m  
Joint displaced, medium

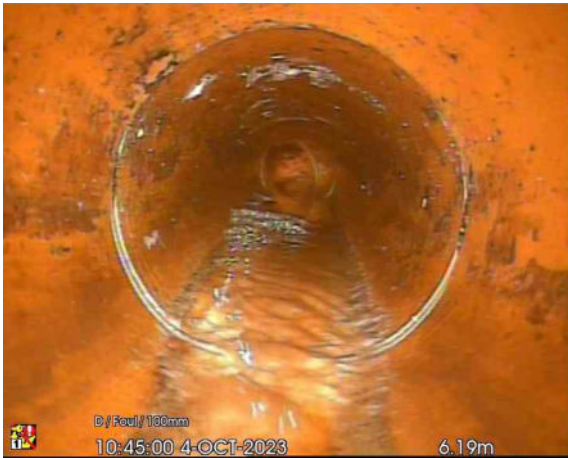
| Item No. | Inspection Direction | PLR | Client's Job Ref | Contractor's Job Ref |
|---|---|---|---|---|
| 36 | Downstream | FWIC1X | DK0526 ADANA | NRC WWS LTD |

FWIC1 DS MH25\_6-19m\_104500.jpg, 00:00:27, 6.19 m  
Water level, 20% of the vertical dimension, DIP

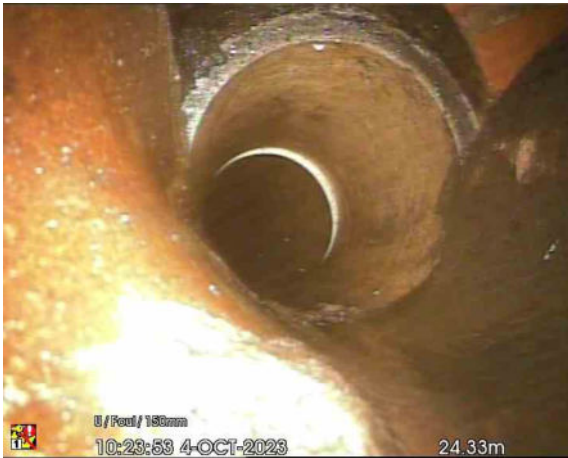
| Item No. | Inspection Direction | PLR | Client's Job Ref | Contractor's Job Ref |
|---|---|---|---|---|
| 37 | Upstream | USX | DK0526 ADANA | NRC WWS LTD |

MH25 US\_24-33m\_102353.jpg, 00:01:47, 24.33 m  
Finish node, manhole, reference: US UTL

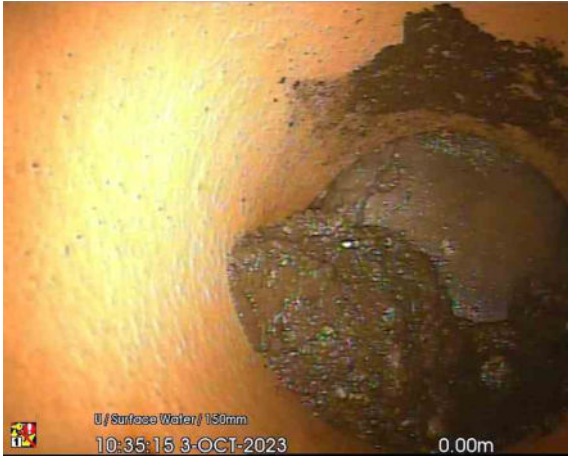
| Item No. | Inspection Direction | PLR | Client's Job Ref | Contractor's Job Ref |
|---|---|---|---|---|
| 38 | Upstream | USX | DK0526 ADANA | NRC WWS LTD |

MH26 US\_0-00m\_103515.jpg, 00:00:02, 0.00 m  
General remark, CAPPED

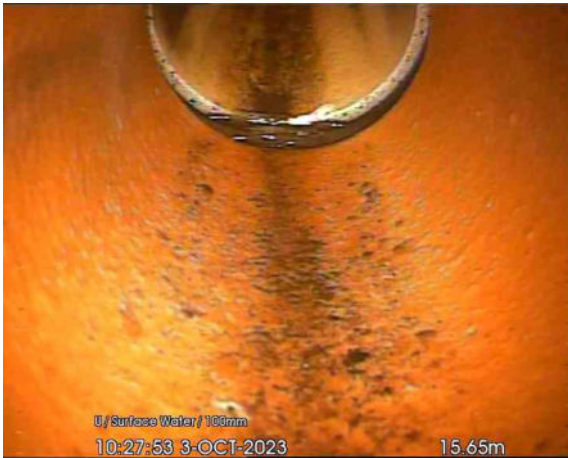
| Item No. | Inspection Direction | PLR | Client's Job Ref | Contractor's Job Ref |
|---|---|---|---|---|
| 41 | Upstream | RWP BX | DK0526 ADANA | NRC WWS LTD |

MH28 US RWP B\_15-65m\_102753.jpg, 00:01:41, 15.65 m  
Survey abandoned, RWP B

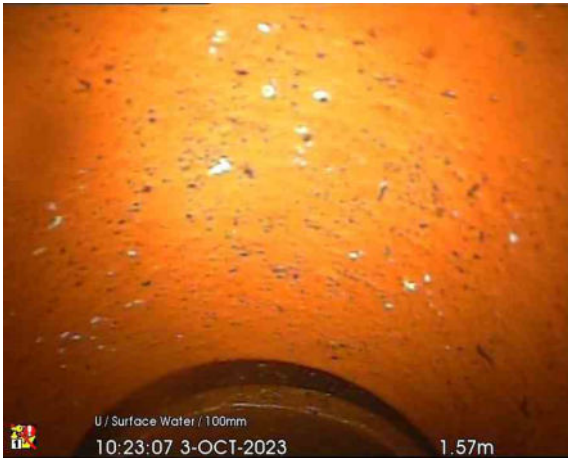
| Item No. | Inspection Direction | PLR | Client's Job Ref | Contractor's Job Ref |
|---|---|---|---|---|
| 42 | Upstream | RWP AX | DK0526 ADANA | NRC WWS LTD |

MH28 US RWP A\_1-57m\_102307.jpg, 00:00:32, 1.57 m  
Open joint, medium

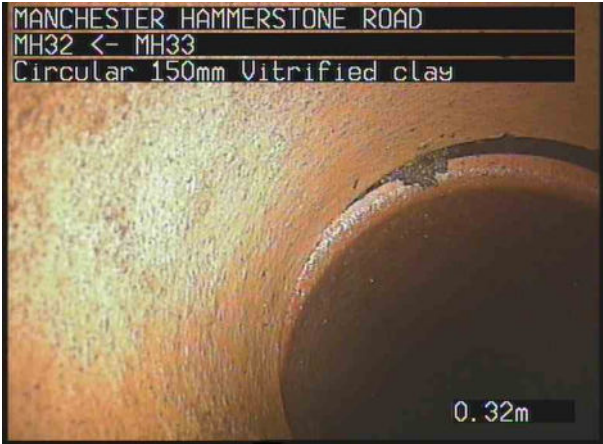
| Item No. | Inspection Direction | PLR | Client's Job Ref | Contractor's Job Ref |
|---|---|---|---|---|
| 46 | Upstream | MH32X | | DK0472 |

MH32X\_24bb07b8-93c2-4e3b-8492-e88e5f53e045\_20230822  
\_123855\_790.jpg, 00:00:15, 0.30 m  
Joint displaced, large

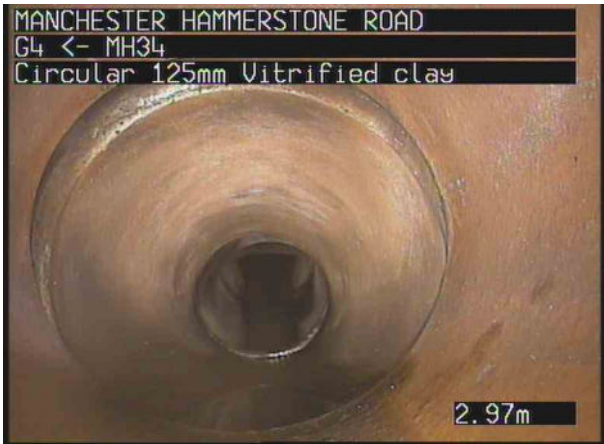
| Item No. | Inspection Direction | PLR | Client's Job Ref | Contractor's Job Ref |
|---|---|---|---|---|
| 50 | Upstream | G4X | | DK0472 |

G4X\_9f5969be-001d-4340-b98b-1ba644824653\_20230822\_1  
50615\_700.jpg, 00:00:49, 2.95 m  
Joint displaced, large

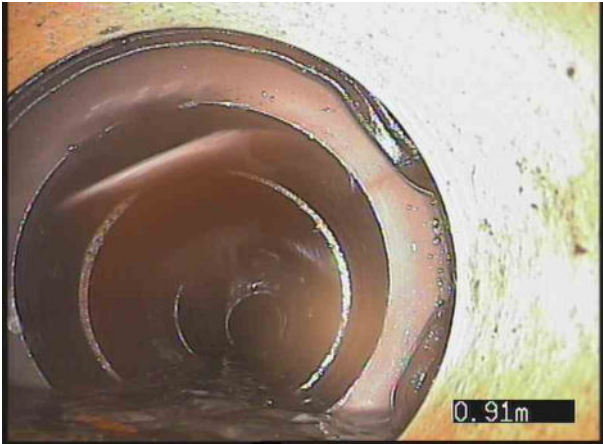
| Item No. | Inspection Direction | PLR | Client's Job Ref | Contractor's Job Ref |
|---|---|---|---|---|
| 51 | Downstream | MH37X | | DK0472 |

MH37X\_2a16aa07-31ea-4574-9c90-f29b9d278d83\_20230822\_115907\_537.jpg, 00:00:24, 0.91 m  
Joint displaced, large, SEALING RING VISIBLE

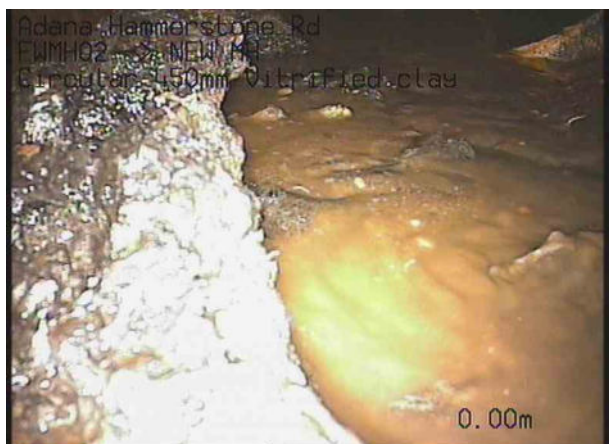
| Item No. | Inspection Direction | PLR | Client's Job Ref | Contractor's Job Ref |
|---|---|---|---|---|
| 54 | Downstream | FWMH02X | N Kirton | NRC WWS Ltd |

FWMH02X\_db9322b8-9ab3-4d4a-8258-9b1e2f5a8361\_20230929\_124453\_432.jpg, 00:00:00, 0.00 m  
Start node, manhole, reference: FWMH02, Hard standing in MH

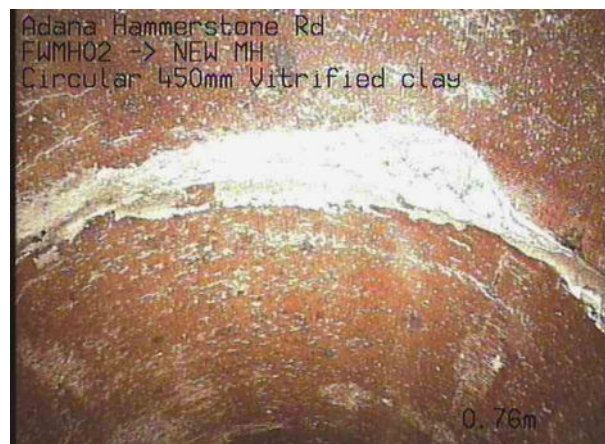
FWMH02X\_d2215c8f-f3bb-4127-9b8e-fde0659868d8\_20230929\_124600\_242.jpg, 00:01:26, 0.76 m  
Attached deposits, encrustation from 7 o'clock to 5 o'clock, 5% cross-sectional area loss, start

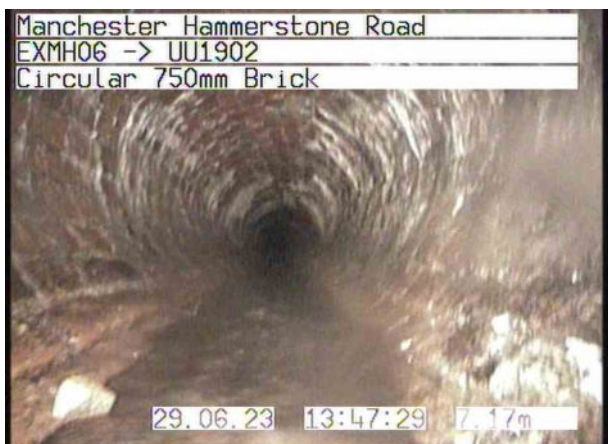
| Item No. | Inspection Direction | PLR | Client's Job Ref | Contractor's Job Ref |
|---|---|---|---|---|
| 56 | Downstream | EXMH06X | DK0363 | |

EXMH06X\_eed5b47b-ed46-48a0-857e-6e44c42f80e7\_20230704\_092341\_194.jpg, 00:00:36, 7.27 m  
Settled deposits, coarse, 5% cross-sectional area loss

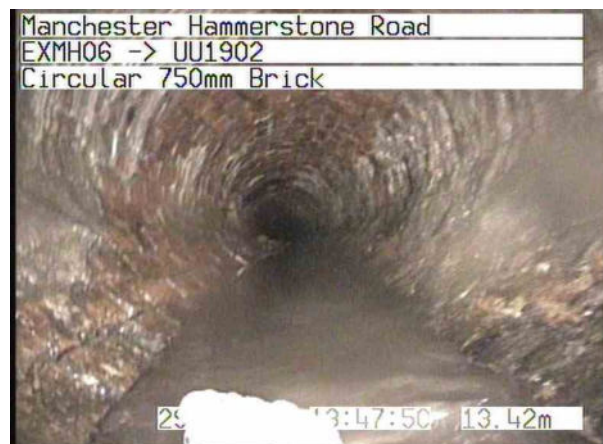
EXMH06X\_a55d7d83-2f42-41d3-88d7-abd184265b1f\_20230704\_092346\_033.jpg, 00:00:56, 13.44 m  
Settled deposits, coarse, 5% cross-sectional area loss

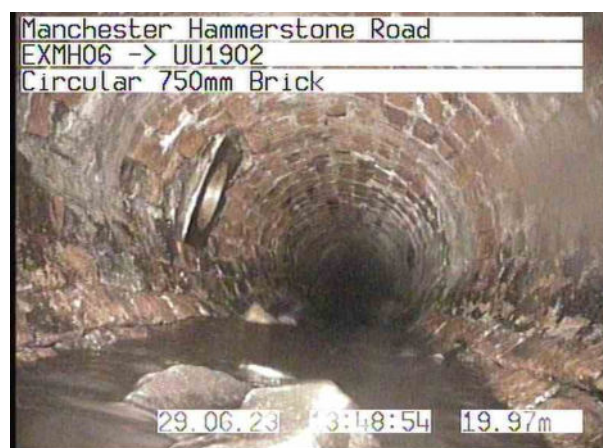
EXMH06X\_061fc6ce-03c3-4108-b9bc-a6451c6e9e0e\_20230704\_092358\_690.jpg, 00:02:00, 20.02 m  
Other obstacles, brick or masonry in invert at 6 o'clock, 10% cross-sectional area loss

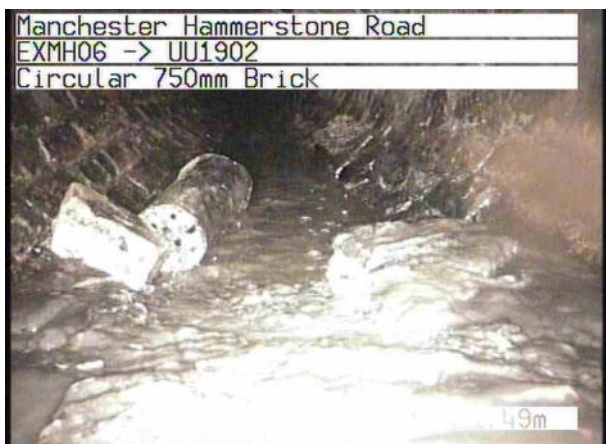
| Item No. | Inspection Direction | PLR | Client's Job Ref | Contractor's Job Ref |
|---|---|---|---|---|
| 56 | Downstream | EXMH06X | DK0363 | |

EXMH06X\_705dcd75-53f9-4874-8eb6-03ca64d7bcdd\_20230704\_092405\_783.jpg, 00:02:25, 21.52 m  
Attached deposits, encrustation from 5 o'clock to 7 o'clock, 15% cross-sectional area loss, Bricks are catching on this whilst jetting, unable to remove

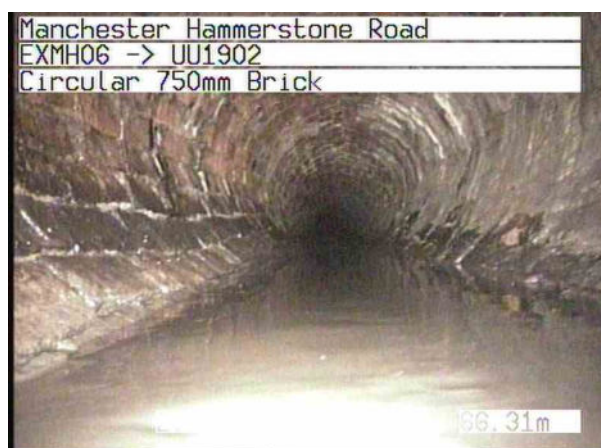
EXMH06X\_6b01fa59-4330-4891-a585-e5ad4d59d3d0\_20230704\_092429\_813.jpg, 00:07:32, 66.41 m  
Attached deposits, encrustation from 8 o'clock to 4 o'clock, 5% cross-sectional area loss, finish

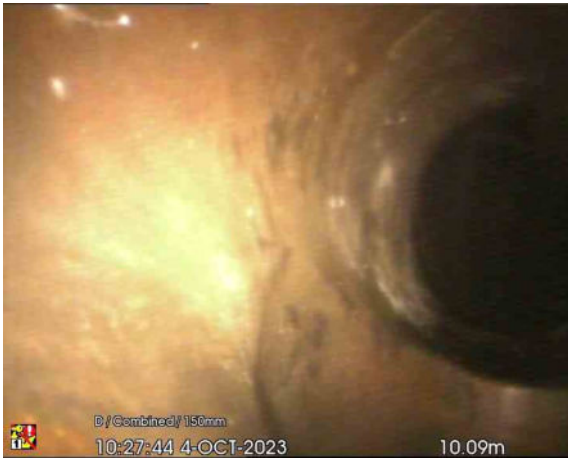
| Item No. | Inspection Direction | PLR | Client's Job Ref | Contractor's Job Ref |
|---|---|---|---|---|
| 57 | Downstream | MH25X | DK0526 ADANA | NRC WWS LTD |

MH25 DS UU2801\_10-09m\_102744.jpg, 00:01:27, 10.09 m  
Junction at 6 o'clock, 150mm dia, DROP SHAFT
