## **Schedule Of Works.**

### **Portland House**

The works relate to elevation repairs, redecoration and roofing repairs to 103a Portland Street, Manchester M1 6DF. Portland House is a Grade 2 Listed Building ( listing number 1247058) situated within The Whitworth Street Conservation Area.

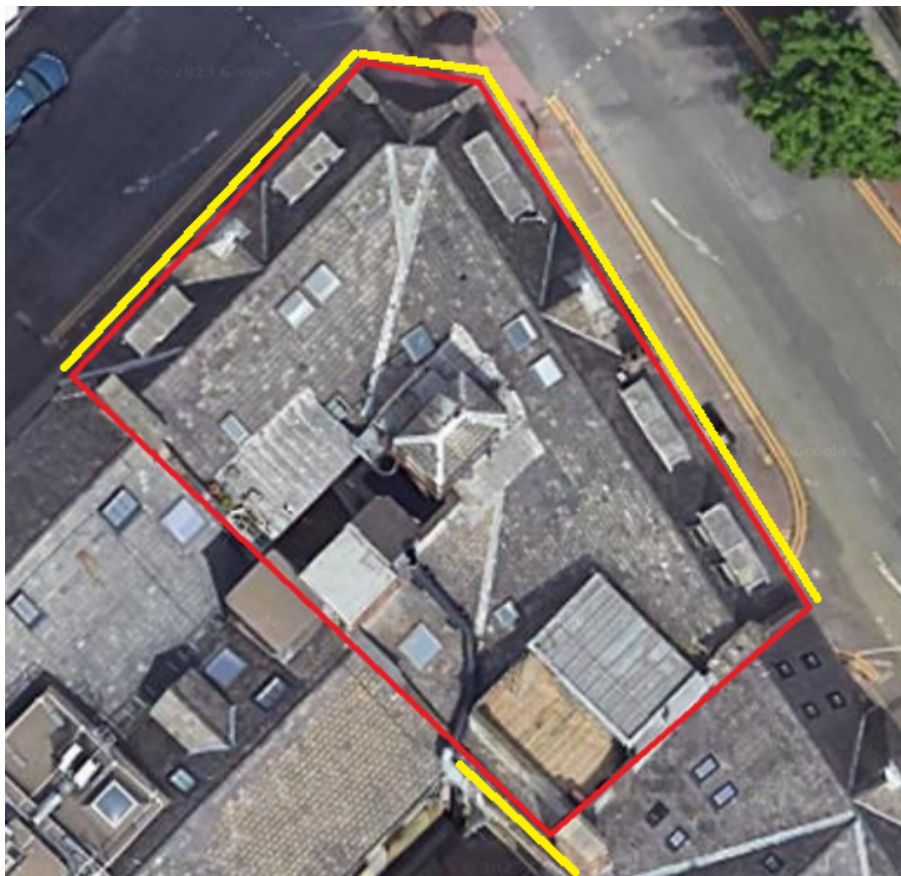
#### **Arial View Showing the Scope of Works.**

The works are divided into two areas, Elevation Works, highlighted in yellow and Roofing Works, highlighted in red. Works to the undercroft area are included in the Elevation Works.
