**STRUCTURAL SURVEY REPORT:  
621 BURNAGE LANE, MANCHESTER, M19 1WB**

RP-H1137-01-R0

**STRUCTURAL SURVEY OF:  
621 BURNAGE LANE, MANCHESTER, M19 1WB**

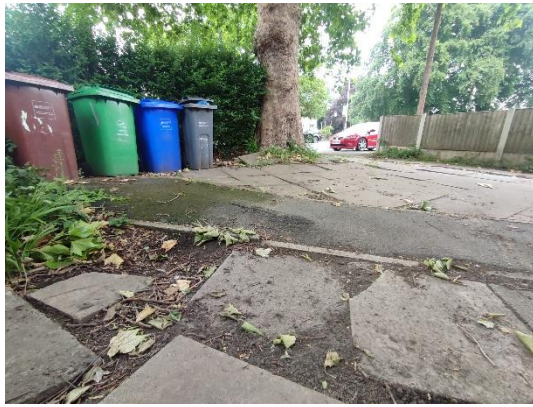
- (iv.) Significant undulations and displacements of the concrete flags linked to the trunk and lateral root growth of the subject tree were observed within the Client's property. Similar undulations and cracks to the surfacing were also observed on the pedestrian footpath adjacent to the tree. This also poses a trip hazard to the members of the public using this area.

*Photo 5 – View of raised flagstones and localised undulations in the front garden*

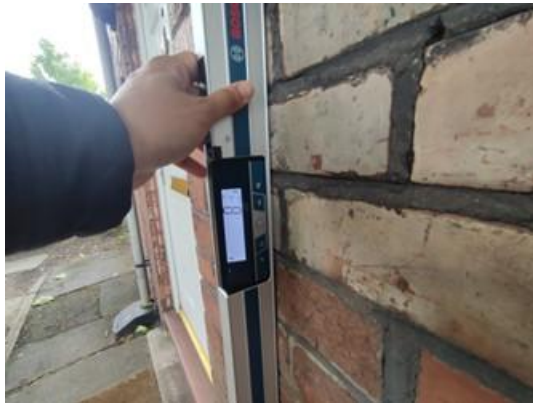
- (i.) A digital inclinometer was used to undertake verticality checks of the external elevation walls, these indicated that the walls had endured slight inclinations of up to 8mm per meter.
- (ii.) Slight separation between the front elevation wall and bay window structure was noted.
- (iii.) Slight separation between the original structure and newer rear extension was observed, however, in the absence of monitoring it is not known whether this linked to progressive ground movement or natural settlement of the new structure.
- (iv.) Diagonal stepped crack observed above the ground-floor 'segmental arch' lintel on the side elevation.
- (v.) The external brick masonry walls away from the above mentioned defects were found to be in a relatively fair condition.

*Photo 14 – Inclination of front elevation wall measured having an incline of up to 8mm per meter*

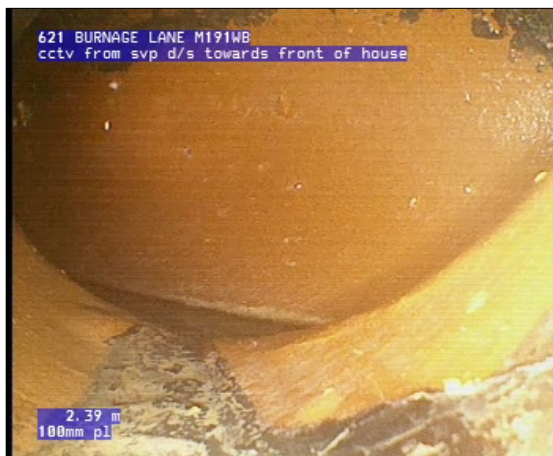
Photo: 1\_1\_9\_A.jpg, 00:00:36  
 2.39m, General remark Remarks: Joining Carrier Line

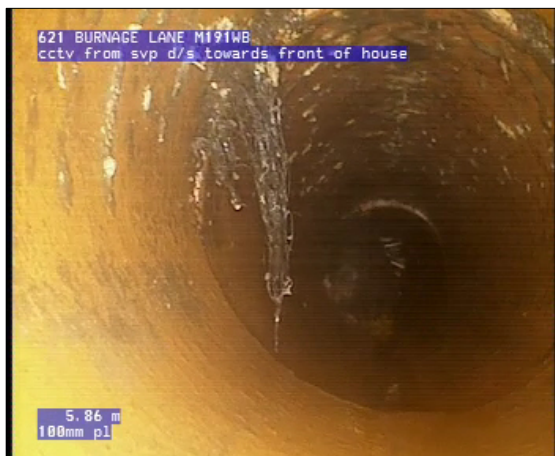
Photo: 1\_1\_13\_A.jpg, 00:00:59  
5.86m, Roots, fine at joint

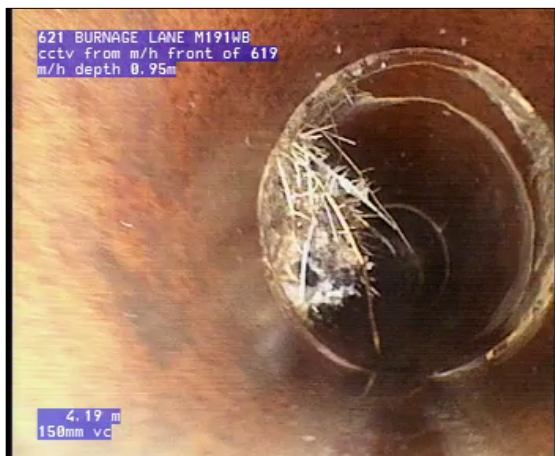
Photo: 5\_5\_36\_A.jpg, 00:00:32  
4.19m, Roots, mass at joint, 10% cross-sectional area loss

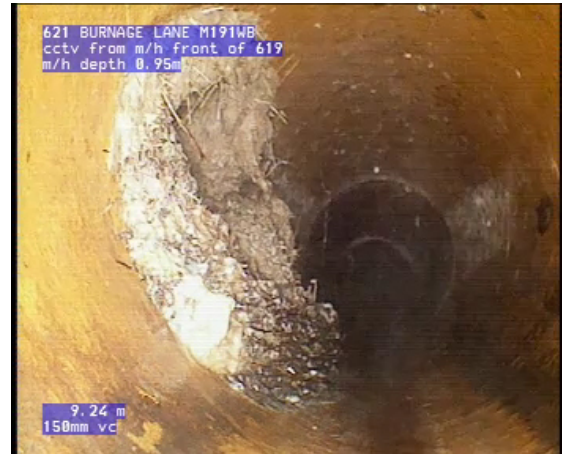
Photo: 5\_5\_43\_A.jpg, 00:01:12  
 9.24m, Junction, at 10 o'clock, diameter 100mm Remarks: Full of Roots

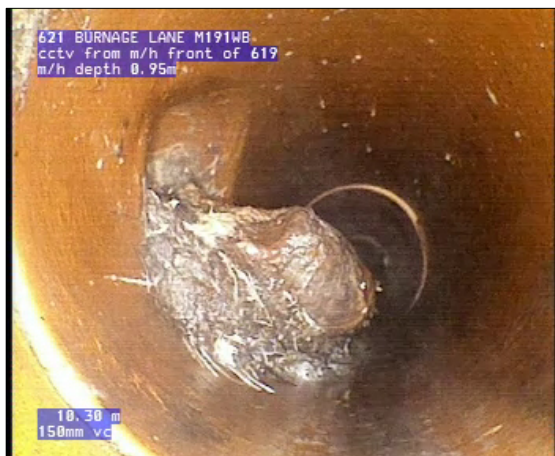
Photo: 5\_5\_44\_A.jpg, 00:01:24  
 10.3m, Junction, at 10 o'clock, diameter 100mm Remarks: Full of roots

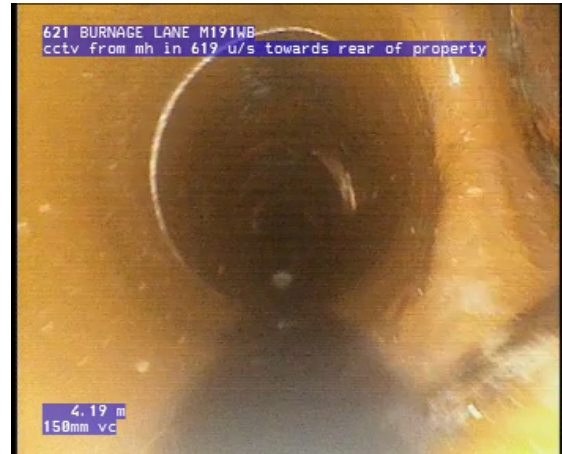
Photo: 6\_6\_53\_A.jpg, 00:00:14  
4.19m, Junction, at 3 o'clock, diameter 150mm

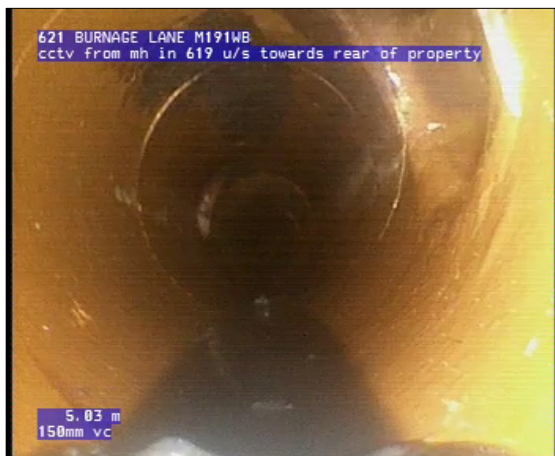
Photo: 6\_6\_54\_A.jpg, 00:00:15  
5.03m, Junction, at 2 o'clock, diameter 100mm

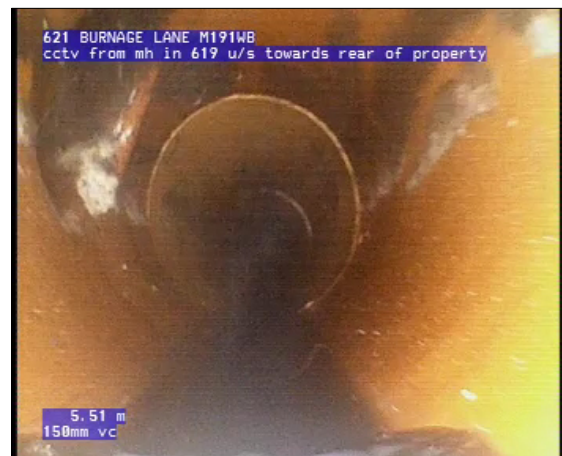
Photo: 6\_6\_55\_A.jpg, 00:00:17  
5.51m, Junction, at 10 o'clock, diameter 100mm
