Gas Membrane Installation  
Validation Report  
Triton Construction  
Trade City  
Elizabeth Street  
Cheetham Hill  
Manchester  
M8 8JJ

## Appendix 1 – Site Survey Sheets

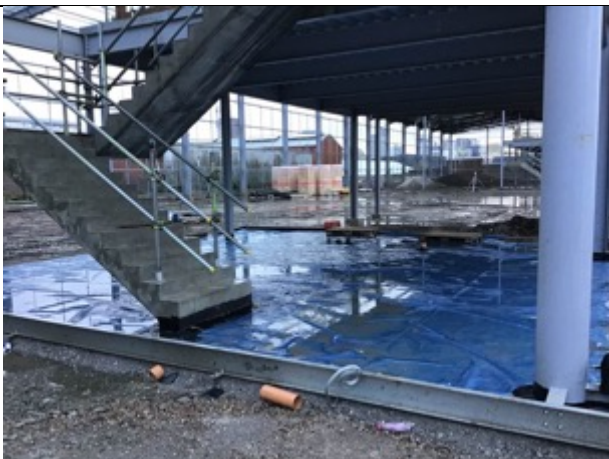
Unit 2 core area line out installation

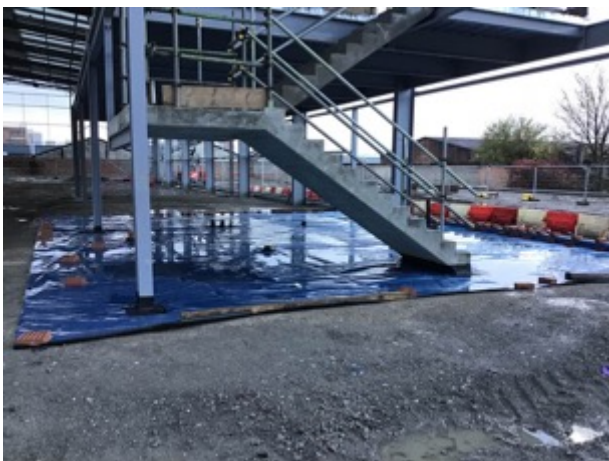
Unit 3 core area line out installation

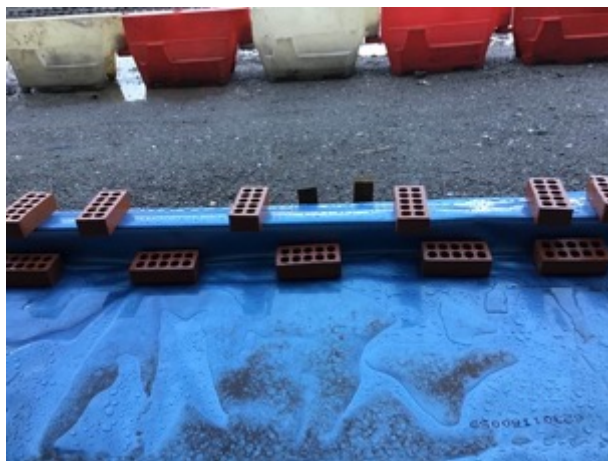
Unit 3 membrane extended over the perimeter edge

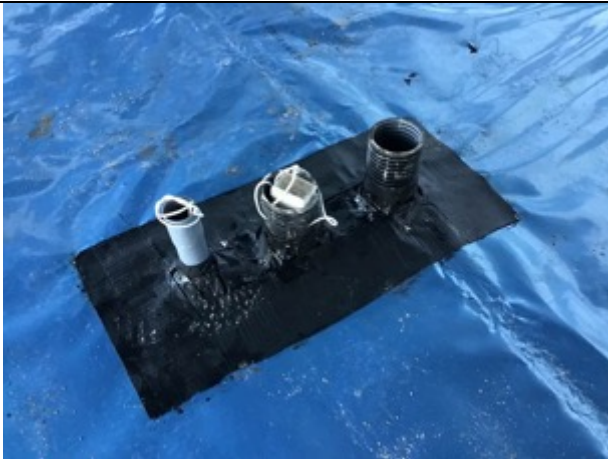
Unit 3 sealed pipe penetrations

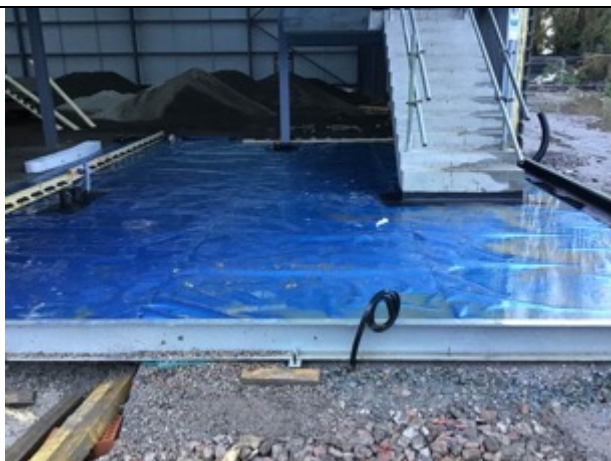
Unit 9 core area line out installation

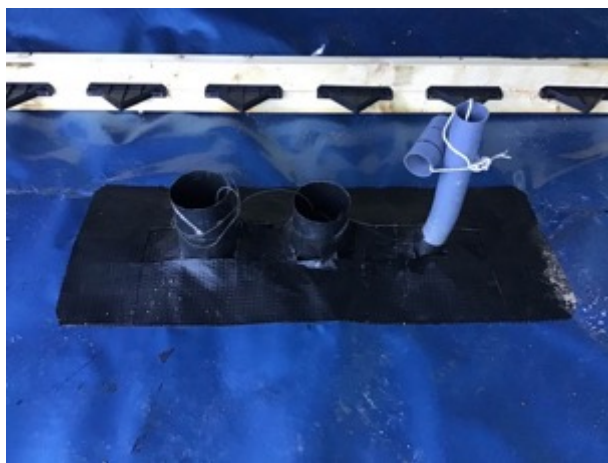
Sealed pipe penetrations

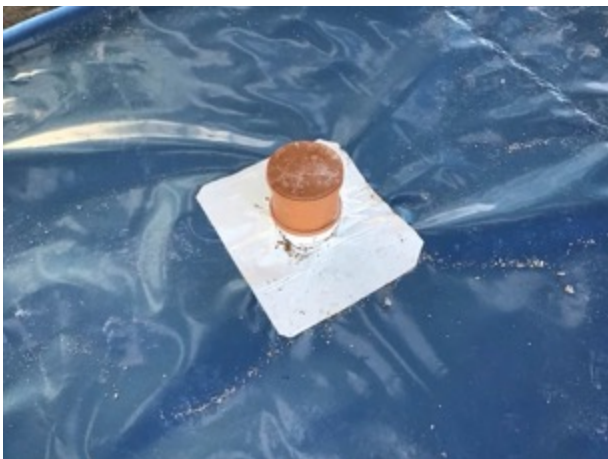
Core 7 sealed pipe penetration

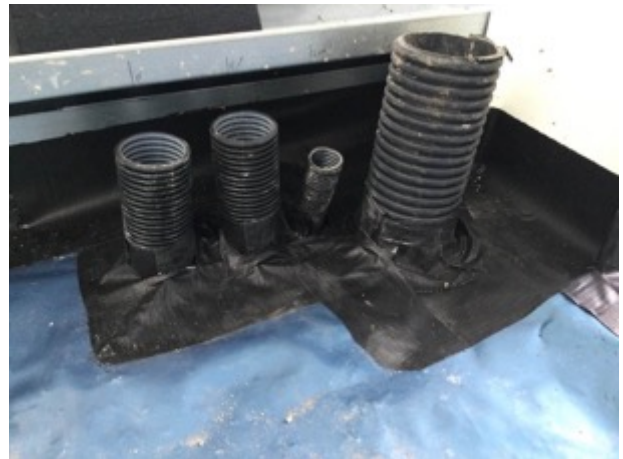
Pipe penetration details sealed using SAGM.

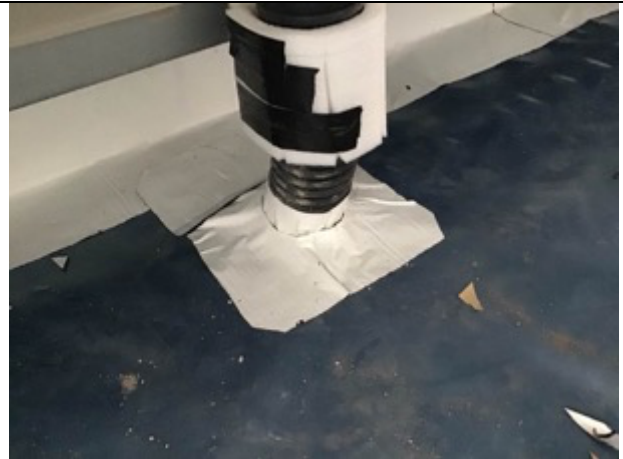
Unit 2 retro fit detailing and sealed pipe penetration

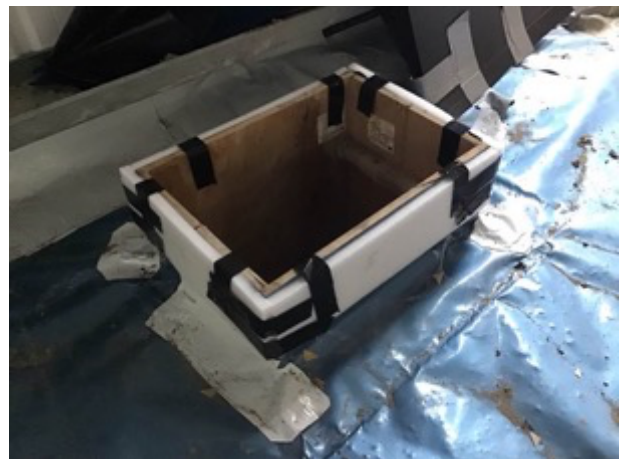
Unit 2 boxed out area

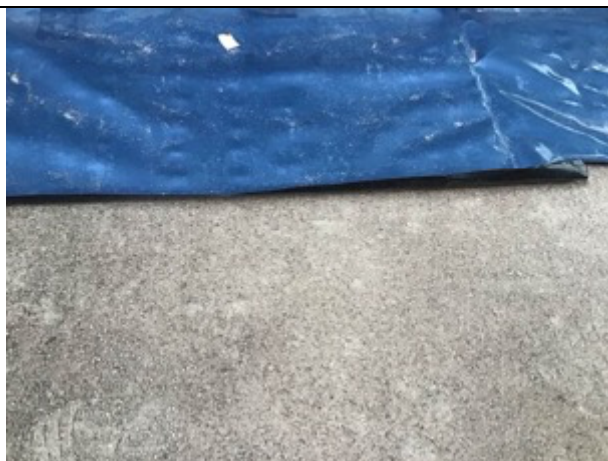
Rolled sub grade

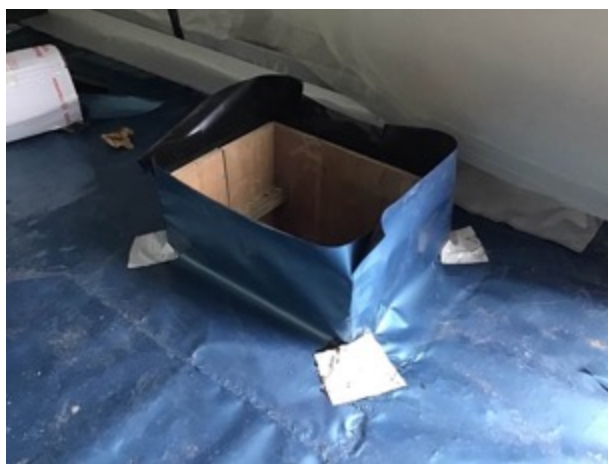
Unit 3 boxed out area

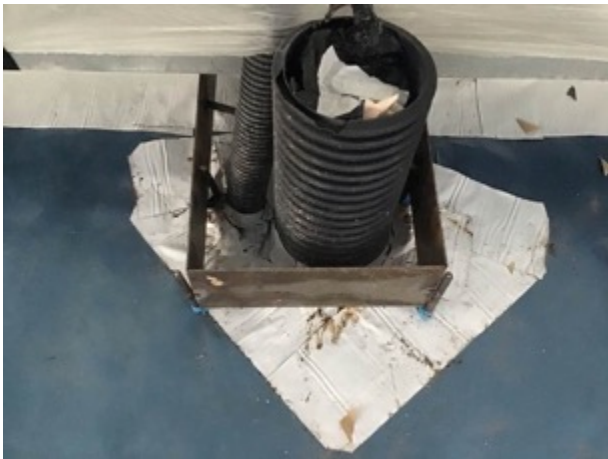
Unit 3 sealed pipe penetrations

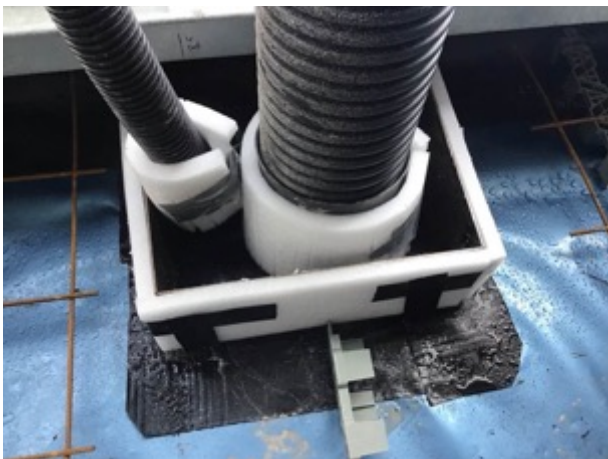
Sealed pipe penetrations

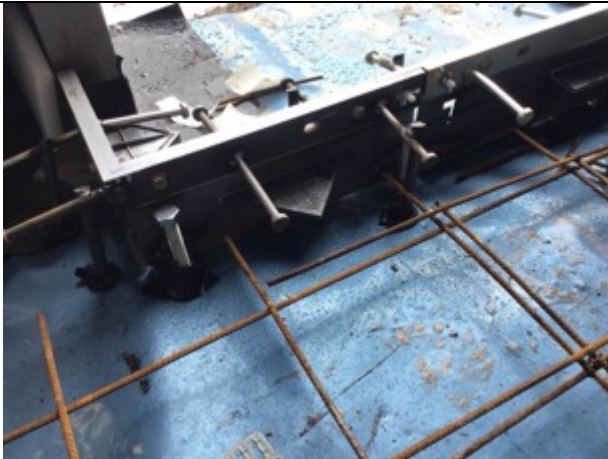
Armoured joint pins sealed using butyl tape

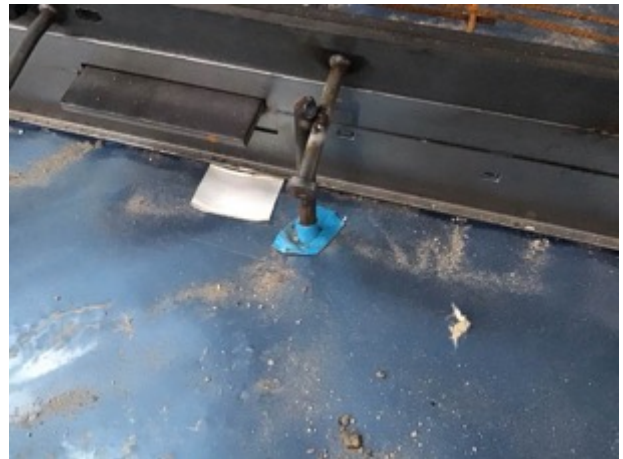
Butyl tape on armoured joint pin

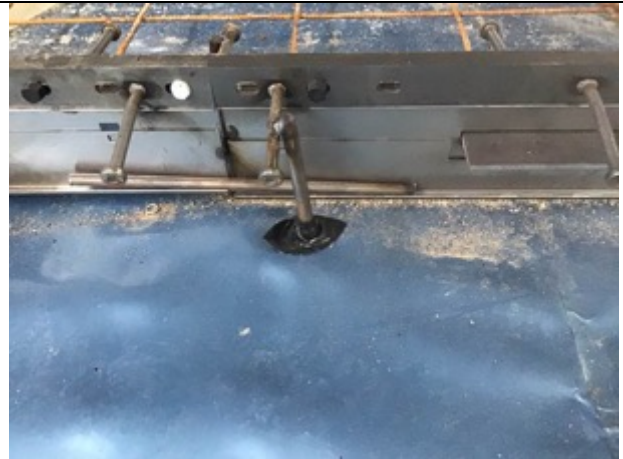
Armoured pin sealed with butyl tape

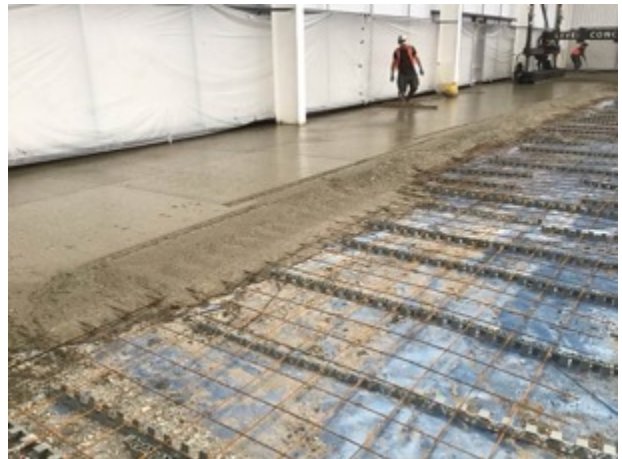
Laser screed pour

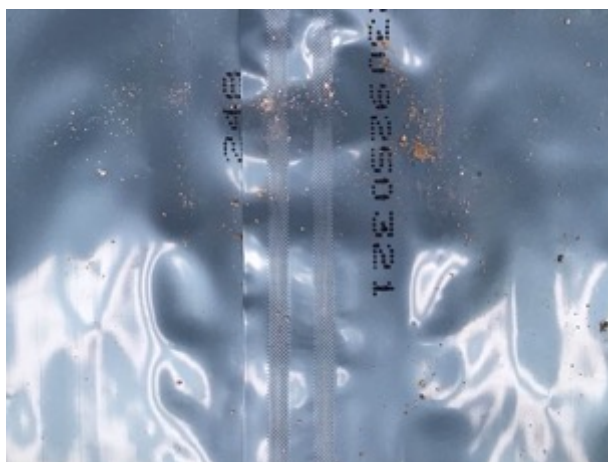
Auto weld membrane joint

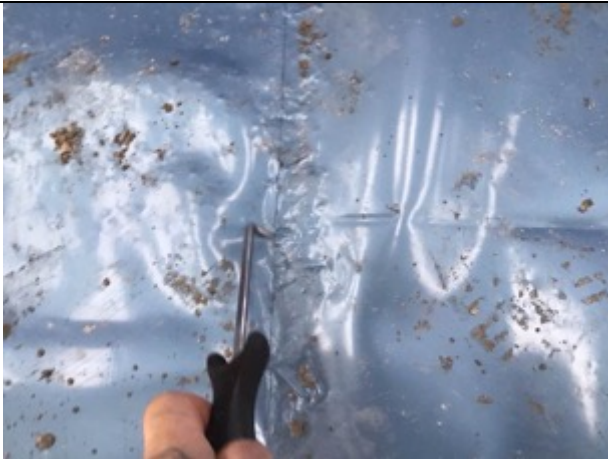
Hand weld probe testing

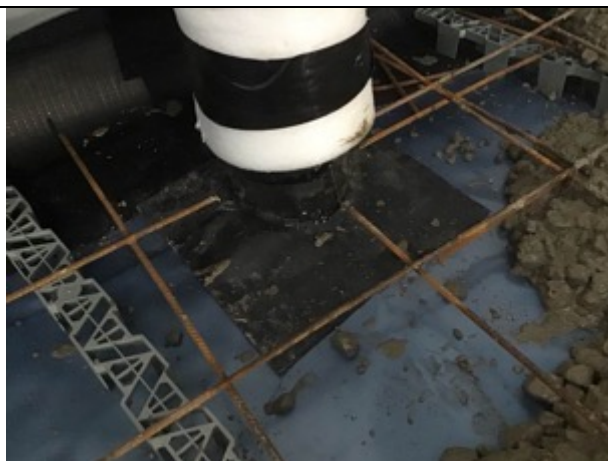
Sealed pipe penetration

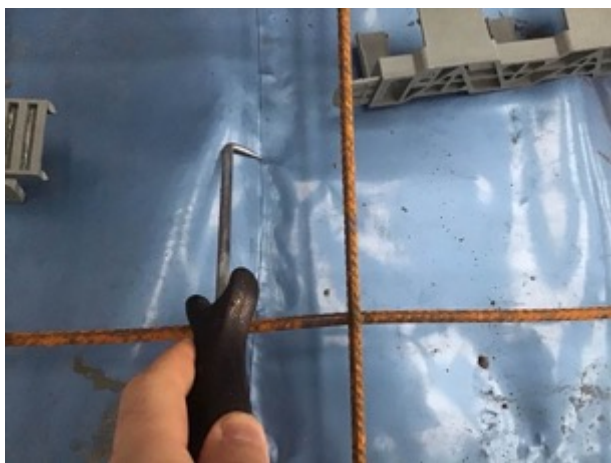
Probe test on hand weld

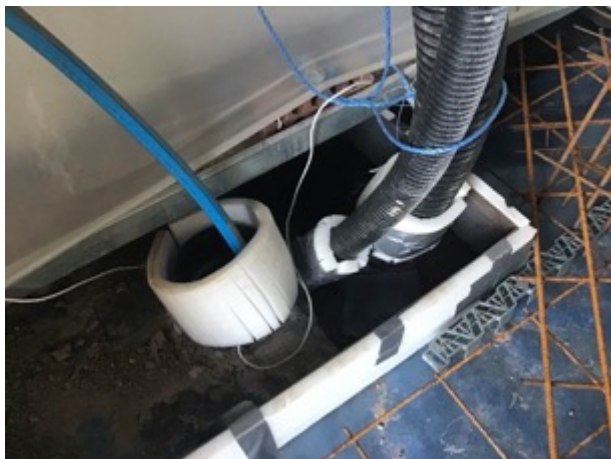
Sealed pipe penetrations

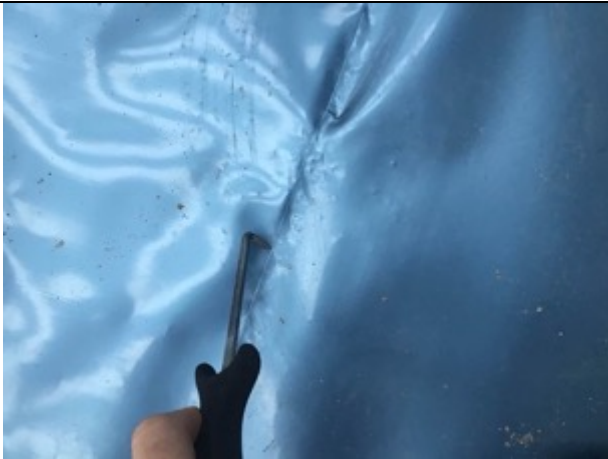
Probe test to hand weld

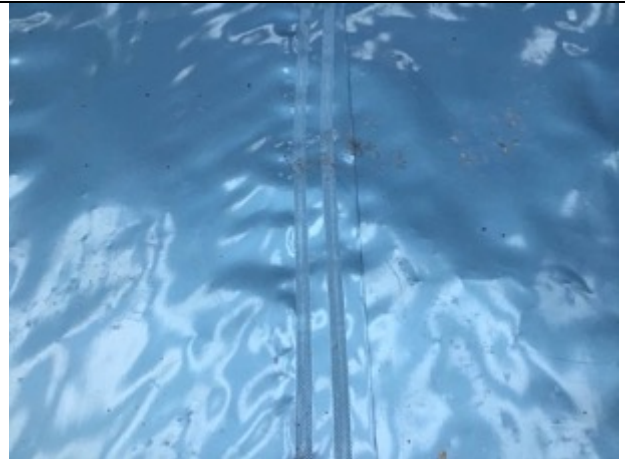
Auto weld membrane joint
