**87-97 Northmoor Road, Levenshulme Manchester, M13 5RT**

## **Compartmentation Survey Report**

| <b>Document Reference</b> | HFS.GP.NorthMoorRoad.CompartmentationSurvey.1.0 |

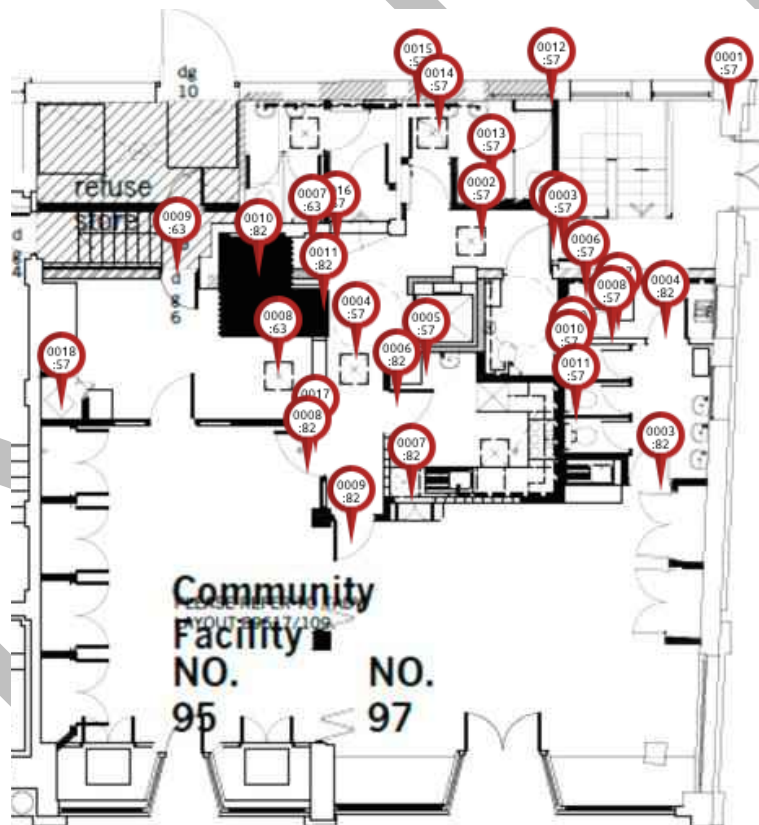
- Replacement of the entry door, which is beyond remediation
- Replacement of the ceiling hatch with a fire-rated unit
- Retention of the existing glazed wall, which, while its fire rating cannot be confirmed, offers aesthetic and practical value. Removal and replacement is not considered feasible or necessary.

In summary, the identified works are critical to ensuring the safe evacuation of the community centre. Importantly, the compartmentation between the community centre and the residential accommodation above, as well as between the neighbouring community centre, has been verified as acceptable with no remediation required.

Refer to Action plan which details works required.
