## Citylabs 4.0

## Condition 10 Drainage Scheme

# Citylabs4.0 - Drainage Maintenance Plan

Reference: L025-ARU-90-01.00-D-C-000004 – Drainage Maintenance Plan

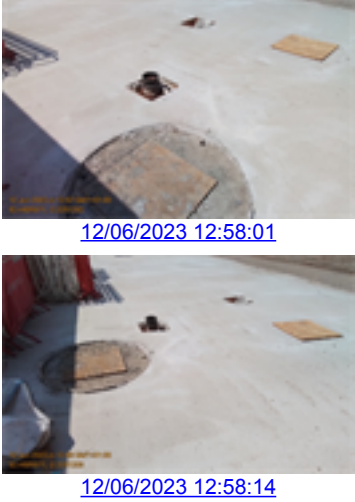
| Closure | | | | | | |
|---|---|---|---|---|---|---|
| 1 | Works adequately protected | Yes | Photo | <br><a href="#">12/06/2023 12:58:01</a><br><a href="#">12/06/2023 12:58:14</a> | temporary cover | |

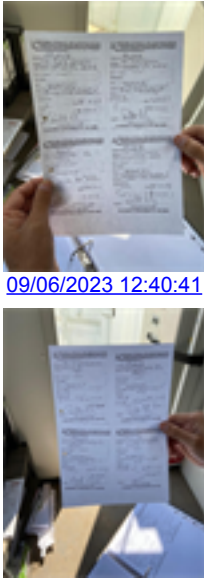
| Testing Checks 6 | | | | | | | |
|---|---|---|---|---|---|---|---|
| 1 | Check pipe bed material, initial backfill material & main backfill material & that the materials have been placed in layers & compacted as per the spec - ATTACH EVIDENCE( Delivery note/Trench filling) | Yes | N/A | <br><a href="#">09/06/2023 12:40:41</a><br><a href="#">09/06/2023 12:40:41</a> | pipe bedding material approved 25/4/23 by John pierre and Thomas Harrison | Yes | Yes |
