Osbornes Yard, Manchester

# **Contamination Delineation Investigation and Removal Validation Report**

Job Number  
**LKC231691**

Report Date  
**July 2025**

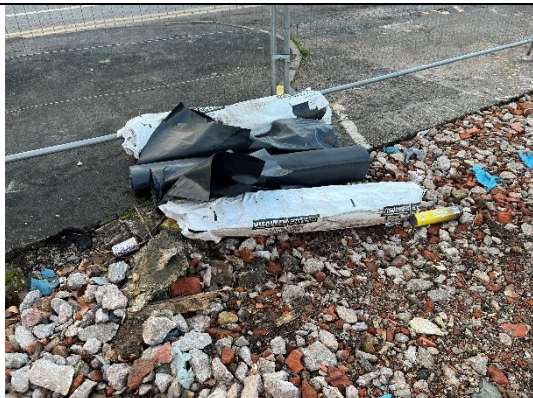
| LKC SITE DIARY | | | |
|---|---|---|---|
| Photograph 3: Visqueen ready onsite for stockpiling of contaminated material. | | Photograph 4: Areas to delineate from previous SI had been marked out and cordoned off. | |

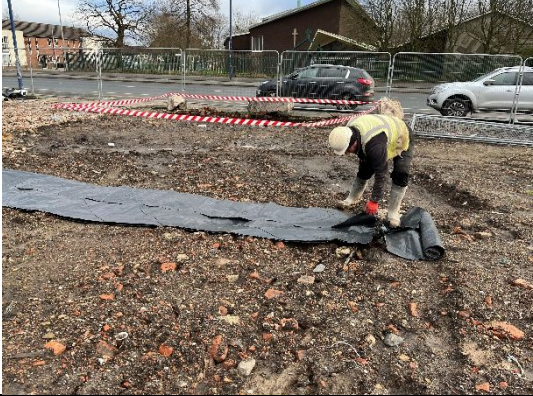
| <p><b>Photograph 5:</b> Setting up bunded area in preparation to stockpile contaminated material.</p> | <p><b>Photograph 6:</b> View of start of excavation in Area 1, site of former small fuel tank. Some dark grey HC contaminated layer and sheen of perched water noted.</p> |

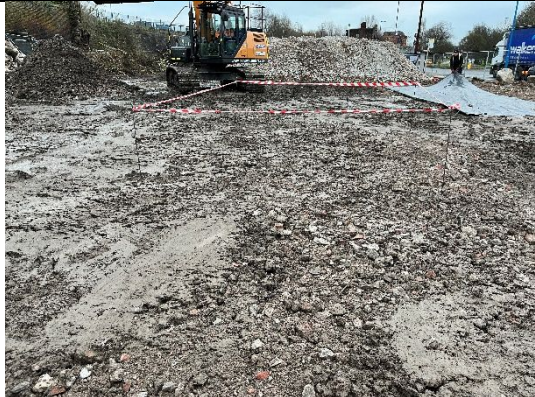
| LKC SITE DIARY | | | |
|---|---|---|---|
| Photograph 1: Setting up of second Visqueen bunded area. | | Photograph 2: Visual start of HC contaminated ground at 0.7mbgl. | |

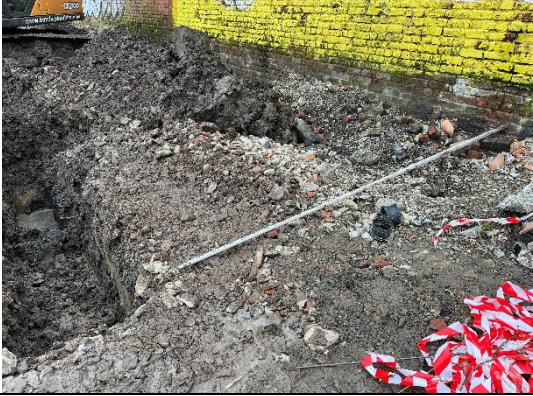
| <p><b>Photograph 7:</b> Trial trench started at the west of the site, to the rear of the former underground fuel tanks.</p> | <p><b>Photograph 8:</b> HC contamination can be seen seeping along granular layer.</p> |

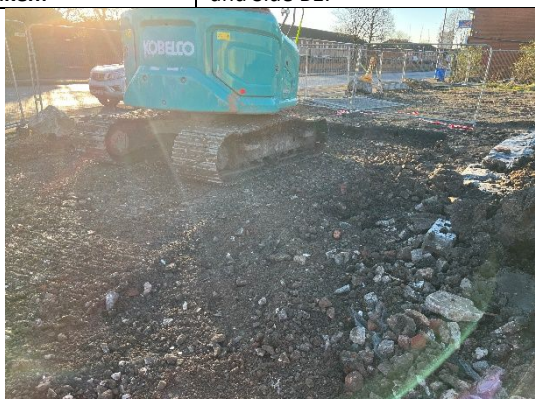
| LKC SITE DIARY | | | |
|---|---|---|---|
| Photograph 1: Area 1 backfilled with granular fill material. | | Photograph 2: Extension of trial trench in western side of site. | |
