# CCTV Report

91 Buckingham Road  
Manchester, M210QT

20/12/2024

72389CCTV-01

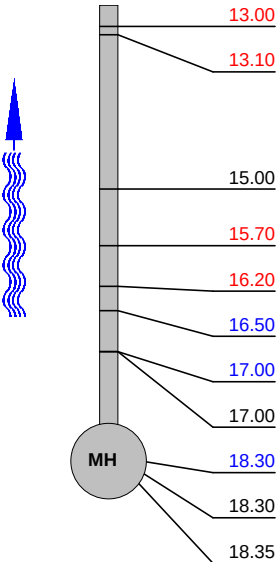
| 1:93 | position | code | observation | counter | photo | grade |
|---|---|---|---|---|---|---|
| | 13.00 | JDM | Joint displaced. Medium | 00:00:00 | 58_22a | (Struct) 1 |
| | 13.10 | JDM | Joint displaced. Medium | 00:00:00 | 59_23a | (Struct) 1 |
