Date: 1<sup>st</sup> July 2025  
Reference: 15-974 V22

## GARDEN VALIDATION – BENNETT STREET

| <b>Project Number:</b> | 15-974 |
| <b>Plots:</b> | 160-172 |

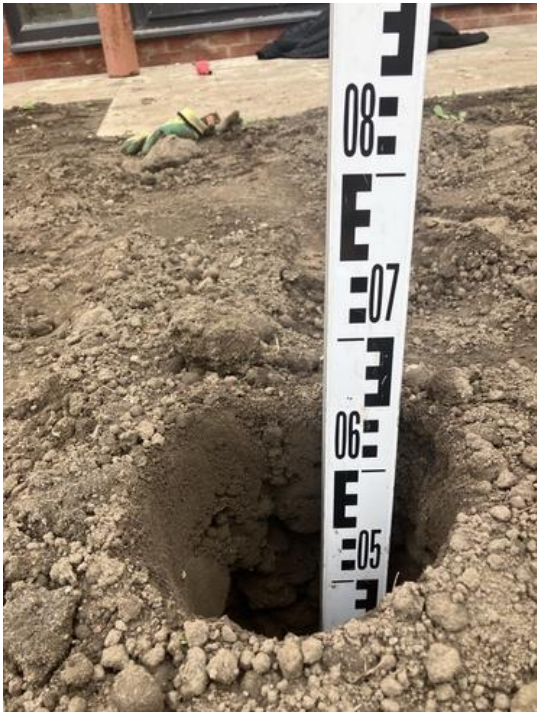
Photo 55

| Depth of Cover System at Ground Level (Photo)<br> <p>Photo 55</p> | |

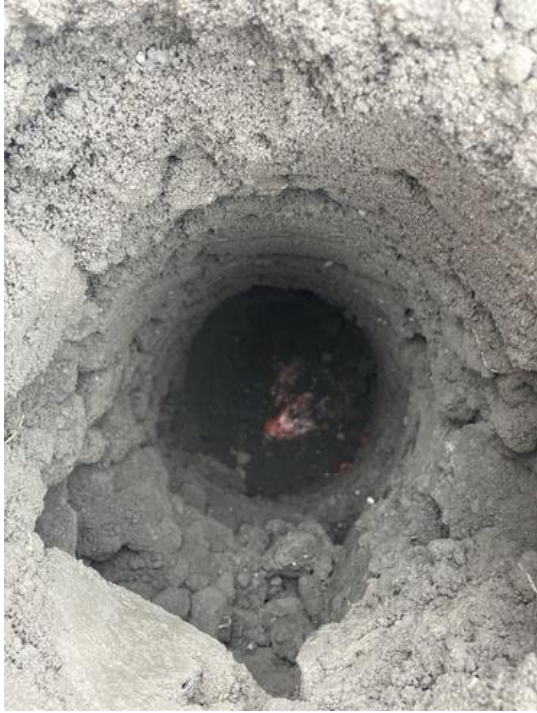
Photo 56

| Depth of Cover System in Relation to Plot (Ensure the whole plot can be seen in the photo)<br> <p>Photo 56</p> | |
