Michael BEARDWOOD  
SCP

# SCP/250744/DSR/02 - HIGHER OPENSHAW CONSERVATIVE CLUB

Monday, 21 July 2025

Prepared For Designing Architects\_A

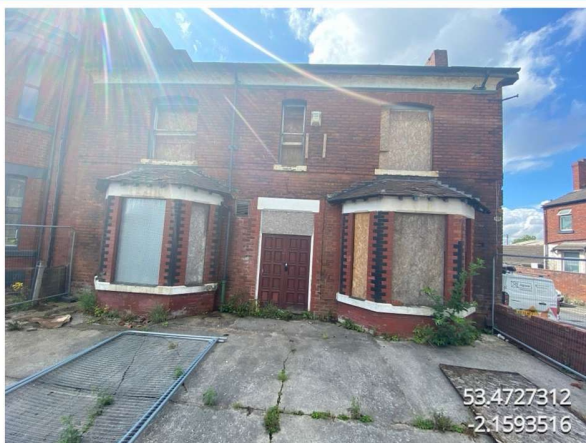
### PICTURE 15

Record of condition of existing site for the attention of all relevant parties.

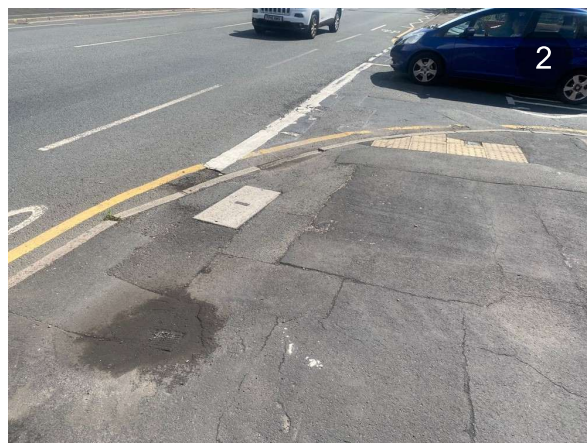
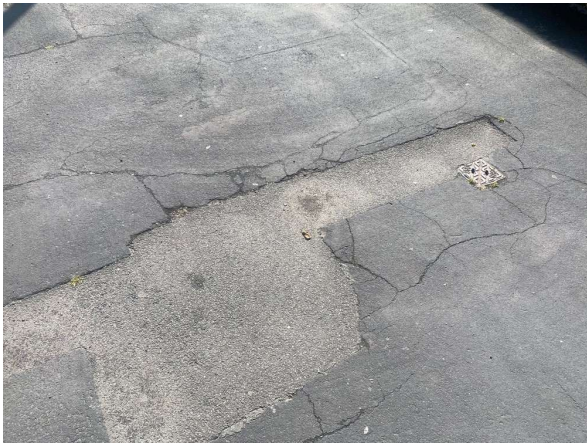
**PICTURE 19**

Footway between Capital Road & Abbey Hey Lane shows signs of previous works that have been poorly carried out, resulting in subsidence and cracking of adjacent paved area.
