# Manchester Art Gallery

Athenaeum Basement [Ref: 141639/JO/2024]  
Discharge of Condition 3c, 3d, 5a, 5b & 5c  
External Grates & Lintel Repairs  
June 2025

Project name: Manchester Art Gallery  
Project number: 9604  
Client: Manchester City Council | Manchester Art Gallery

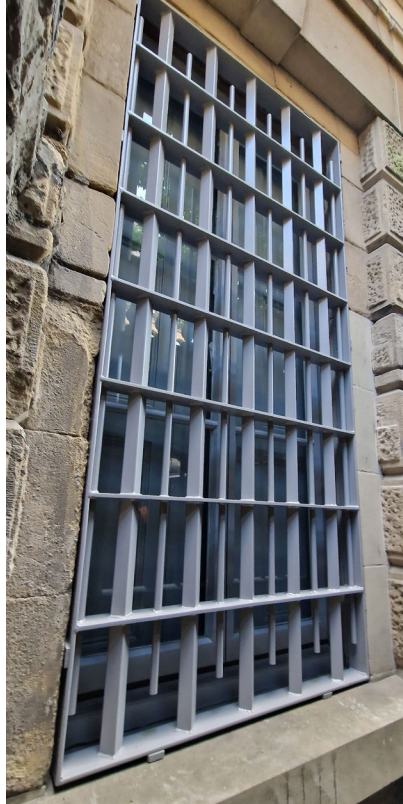
The following works apply to windows WIN-004 (George St) and WIN-010 (Princess St) where the new metal security grilles are proposed to stabilise the failed lintels. Further information on the nature of the defects to these lintels can be found in Appendix A, alongside assessment of the proposed stabilisation method in Appendix B.

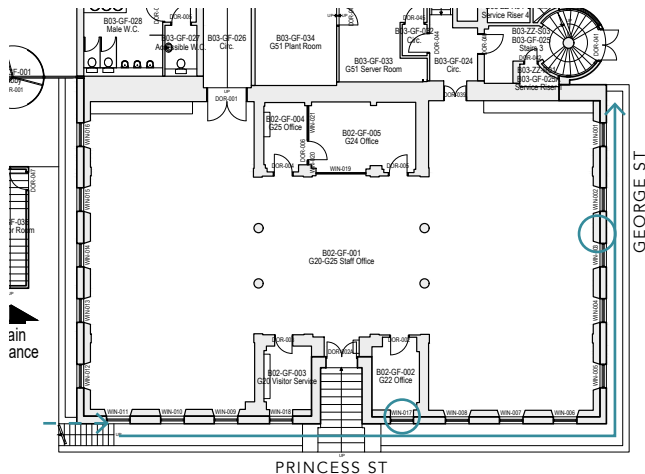
Figure 6 Lightwell access

The Princess Street and George Street lightwells can be accessed via the (gated) steps adjacent to the Back George Street entrance.
