Date: 5th June 2024  
Reference: 15-974 V7

## GAS MEMBRANE VALIDATION – BENNETT STREET

| <b>Project Name:</b> | Bennett Street |
| <b>Plot:</b> | 136-138 and 147-148 |

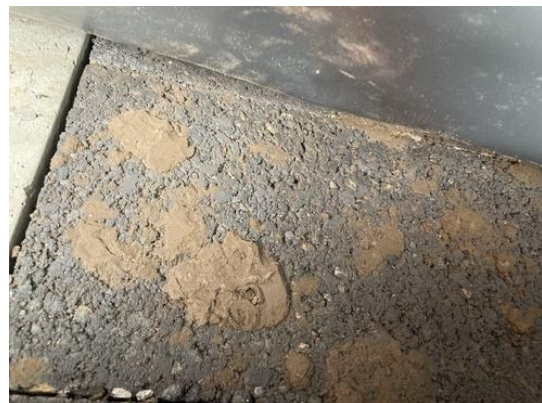
Photo 38

Slab / membrane condition (is membrane clear of snow, standing water, debris or insulation): Can membrane be fully seen and photographed – ask contractor to remove an debris so membrane can be fully seen an inspected – this is a requirement of NHBC and local authorities.
