## 68-70 Oldham Street, Manchester

### Façade Condition and Heritage Report

## Façade Condition and Heritage Report

| <b>Report Reference</b> | 2044-01 |

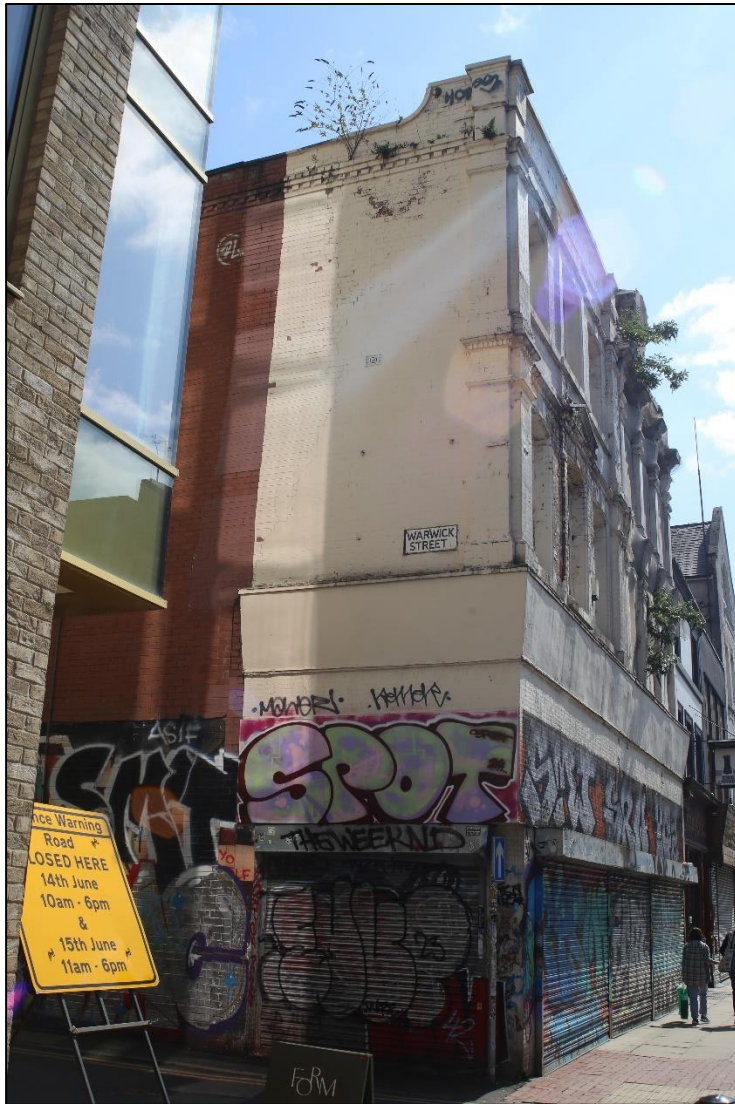
*Figure 17: General view of the north-east façade of No.70, facing south-west*

There is a subtle change in brickwork along a stepped line on the Warwick Street return wall. In this location new brickwork is poorly toothed into the historic building. This appears to coincide with an internal crack that was noted on site.

The north-eastern elevation of No.70 fronts Warwick Street and was originally constructed in a Flemish bond, however after the removal of the chimney, sections of the elevation were repaired in a stretcher bond (Figure 17). The mid-20<sup>th</sup>-century shopfront continues around the principal façade and comprises clear glass glazing with a rolled steel I-section steel beam inserted at ceiling height. The shop front is also obscured by an individually controlled galvanised steel roller shutter door (Figure 17). Above the galvanised steel hood containing the shutter mechanism is mid-20<sup>th</sup>-century tiling that was fixed to the earlier brick façade (Figure 17).

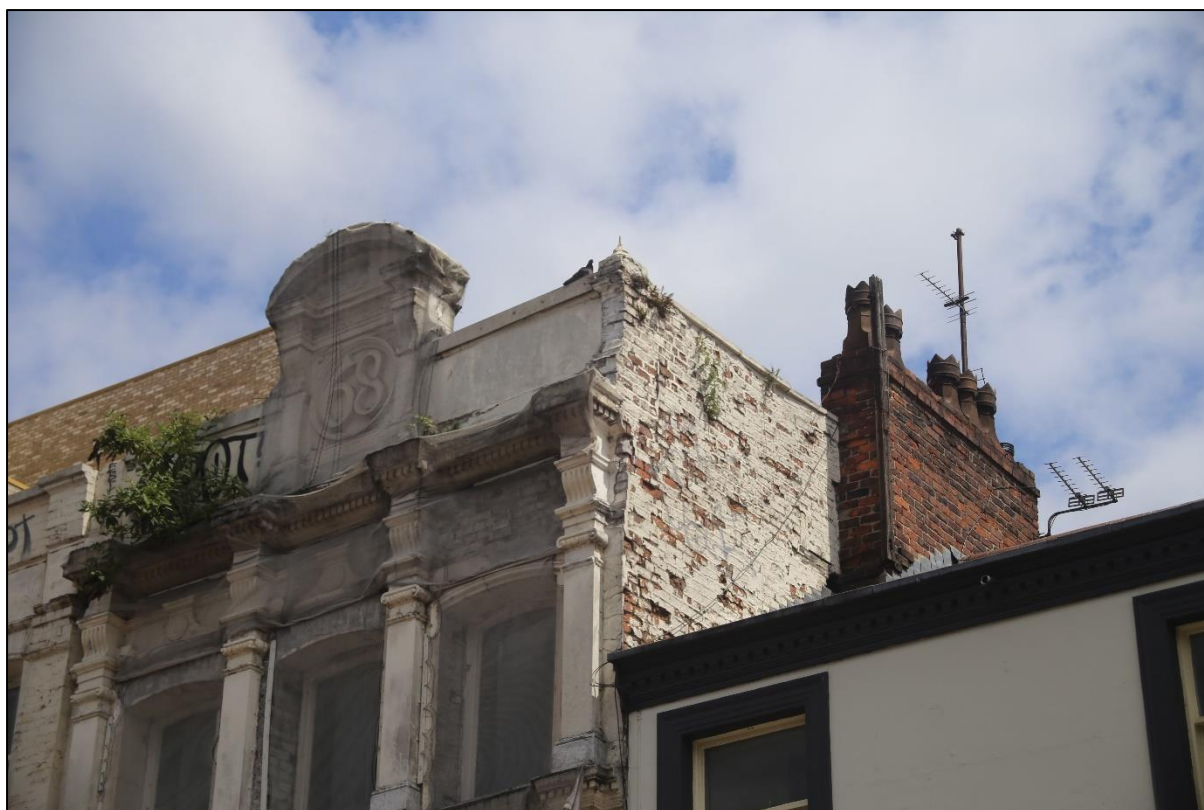
*Figure 19: General view of the south-west façade of No.68, facing east*

The south-west elevation of No.68 has largely obscured the adjoining building, the Castle Hotel, however the elements of the second floor is visible. This section was constructed in an irregular bond with flat stone copings to the parapet wall. At the centre of the property is the stretcher-bond chimney stack with five bishop chimney pots. The stack housed six pots originally, however the third pot from the north-western end had been removed and exposed the feather below (Figure 19).

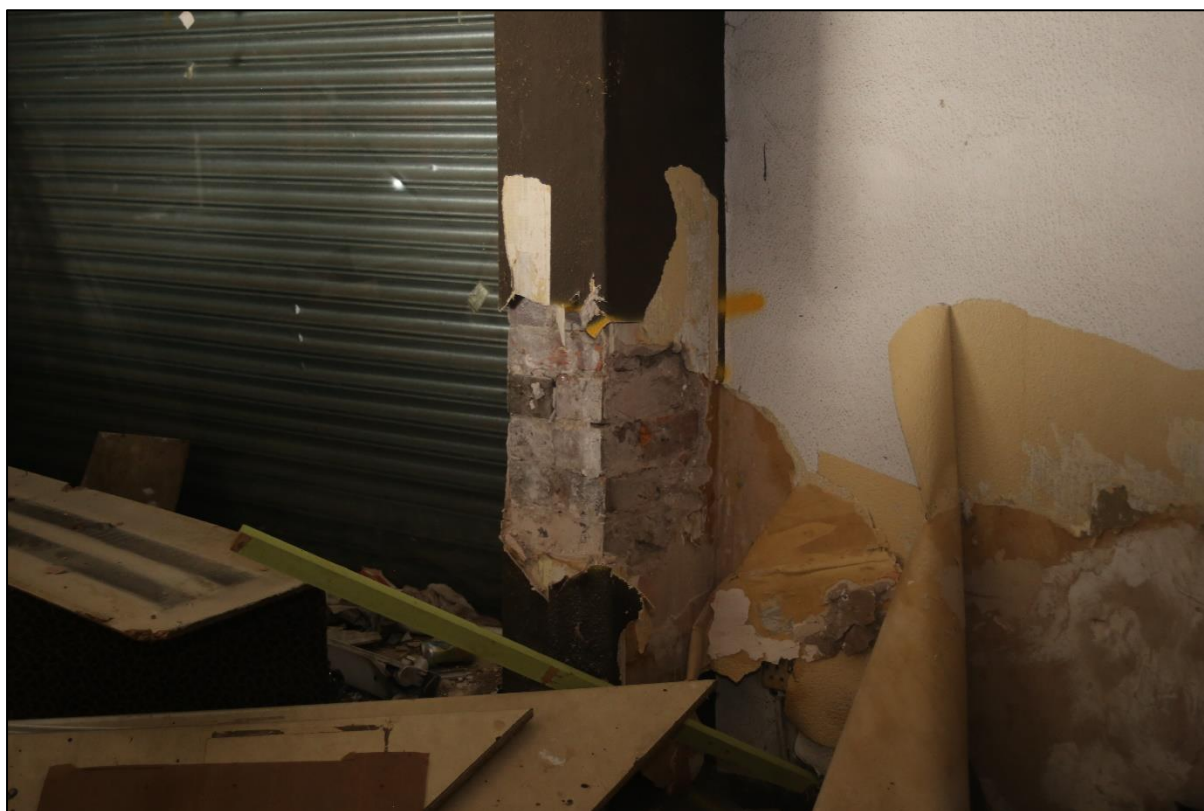
*Figure 21: Detail of the brick pier situated within the north-east wall of No.70, facing north*

Internally, the ground floor of the façade contains no historical elements of the earlier Victorian shop frontage (Figure 20). The upper floors are supported by a rolled steel I-section beam at ceiling height of the ground floor. It was not possible to record any rolling stamp to the web during the initial site visit, however doing the future soft strip programme of the properties, this might be uncovered. The only historical element that is extant is a brick pier situated to the south-east end of the north-eastern wall. This consists of a two-brick course wide pier with lime mortar that projected into the room (Figure 21).
