# CONDITIONS TO BE DISCHARGED:

## SITE INSPECTION REPORT – 29<sup>th</sup> April 2025

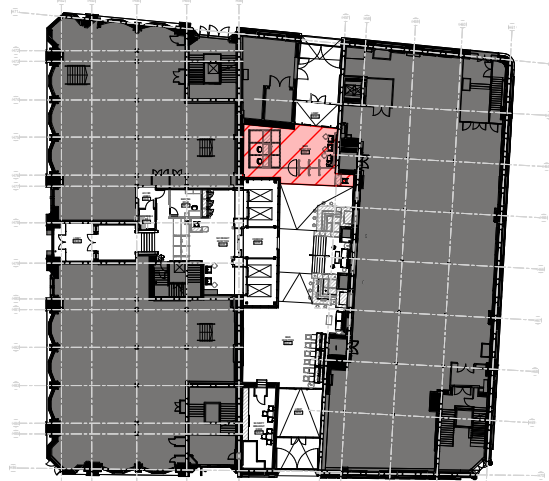
GROUND FLOOR PLAN

Extent of flooring being removed due to new underfloor heating installation, concealed speedgates base, and concealed containment routes.

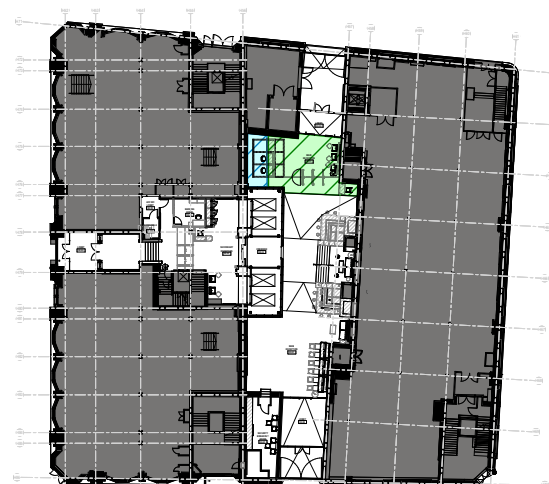
GROUND FLOOR PLAN

If a number of replacement tiles close to the 20% threshold are required, the intention is to concentrate them toward the west side of the area (marked in blue), in order to keep the main circulation route and most visible zone (marked in green) as similar to the current appearance as possible.

To ensure precise reinstatement, each tile will be numbered prior to removal, with the intention of reusing each tile in its original position. In any instance where a tile is found to be broken or unsuitable for reuse, it will be replaced with a new/existing stone tile selected to match the tone of the original material as closely as possible.

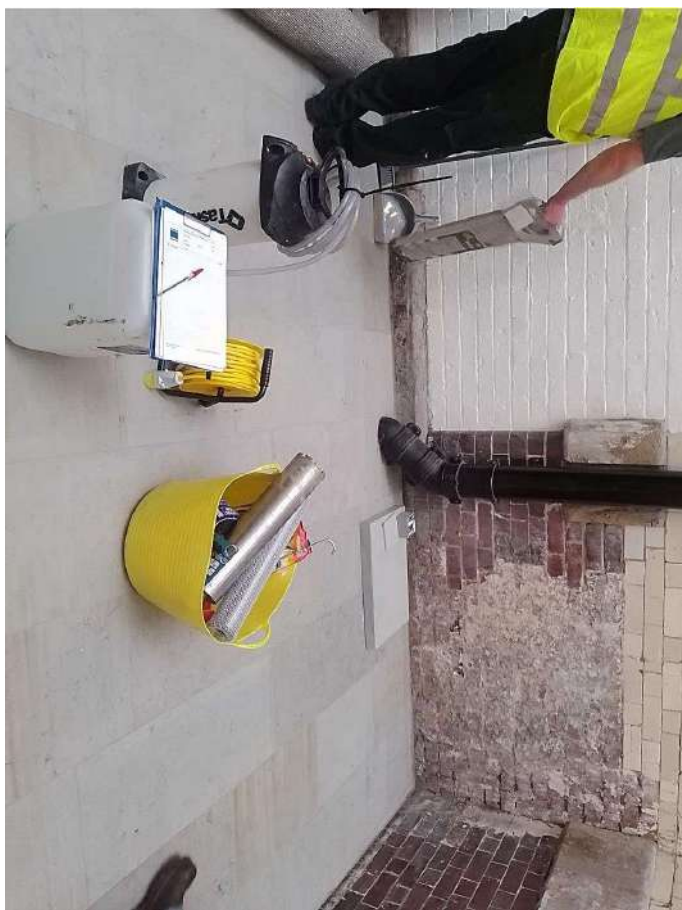
Photo 4

- 2.4 The area off works was cordoned off and furniture cleared. (Photo No. 3)
- 2.5 The slab was cat-scanned to check for buried services within the suspended floor structure. Areas where electrical cables were sensed by the equipment were marked with orange tape to define zones not to be cored due to risk. (Photo Nos. 4 & 5) Note, the cables may be a false reading or maybe below the slab, but as this could not be proven, the marked area was avoided for penetrative work. A safe zone was identified against the north wall as Appendix C and an 'X' marked as per Photo Nos. 6, 7 & 8.

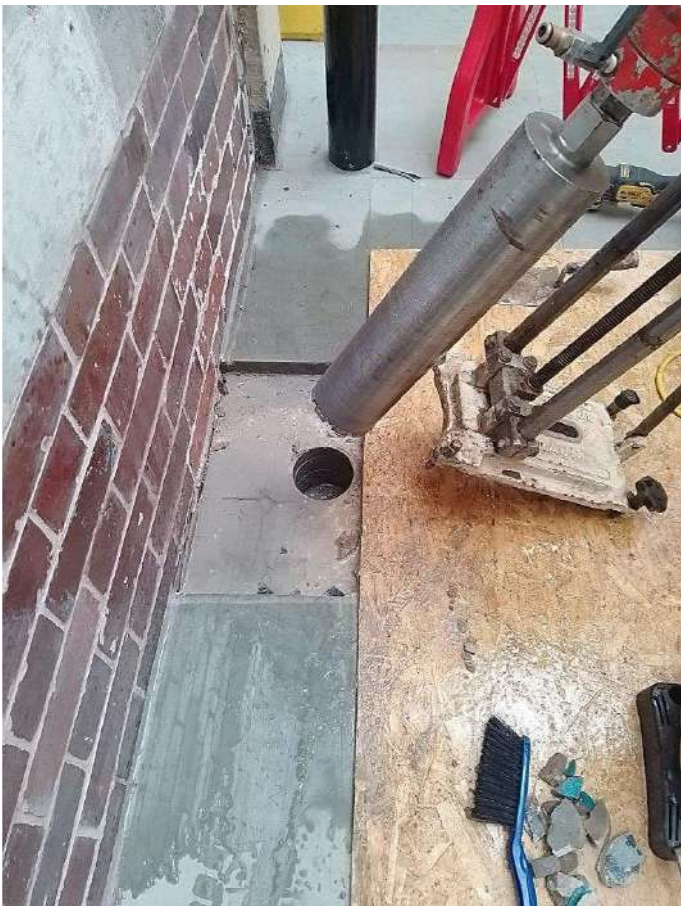
Photo 27

2.11 The core revealed the bedding was a cementitious compound layer 210mm thick. The compound appeared to be bonded to the concrete surface (60mm below FFL) underneath by a blue coloured adhesive. (Photo Nos. 22-26). The core depth was increased and verified that the concrete layer was a 60mm thick aerated sand cement screed. Close inspection of the aerated screed revealed synthetic fibre reinforcement to be present (Photo Nos. 26,33 & 34). Below the aerated screed is 50mm insulation. (Photo Nos. 28-32). Underneath the insulation a concrete surface was revealed and this was cored to a depth of 65mm and halted as this is considered to be the structural slab. The partial core was broken out and confirmed to be a non-aerated normal concrete with aggregate present. (Photo No. 31)
