# Inspection Report

Project Name: Upper Campfield  
Start Date:  
Client: T J M Projects Limited  
Jackson Street  
St Helens

| Project Name | Project Number | Project Date |
|---|---|---|
| Upper Campfield | | 20/08/2024 |

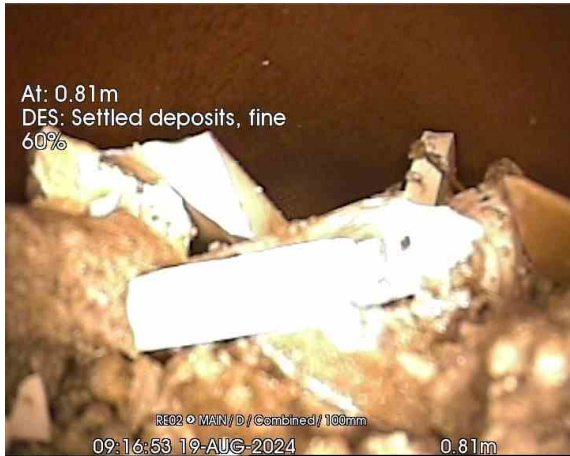
1\_0-81m\_091653.jpg, 00:00:33, 0.81 m  
Settled deposits, fine, 60% cross-sectional area loss

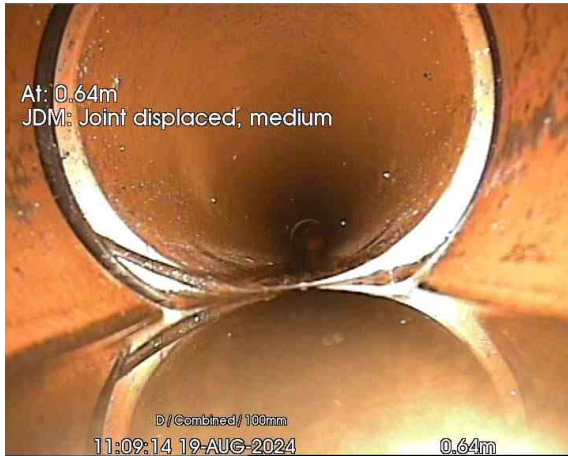
11\_0-64m\_110914.jpg, 00:00:13, 0.64 m  
Joint displaced, medium

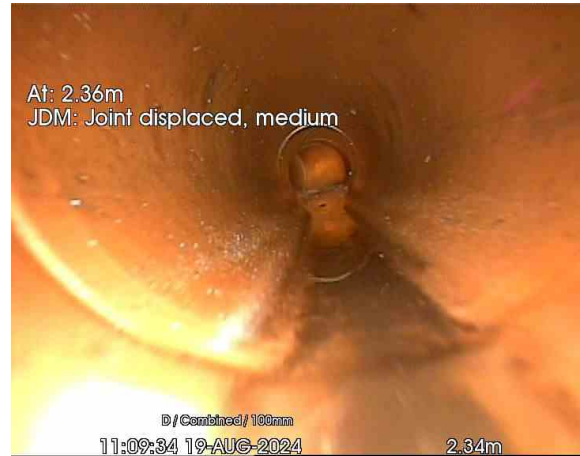
11\_2-29m\_110934.jpg, 00:00:26, 2.29 m  
Joint displaced, medium

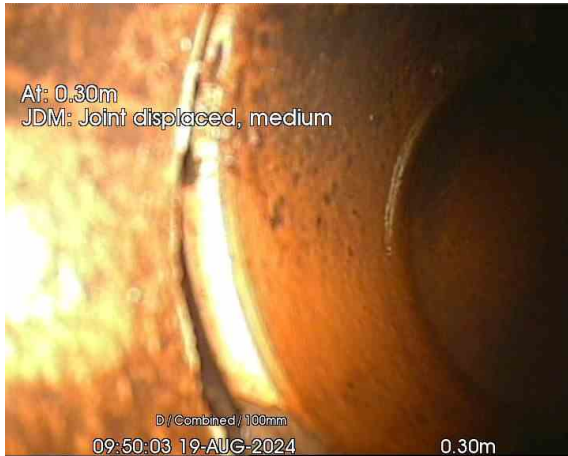
3\_0-30m\_095003.jpg, 00:00:14, 0.30 m  
Joint displaced, medium

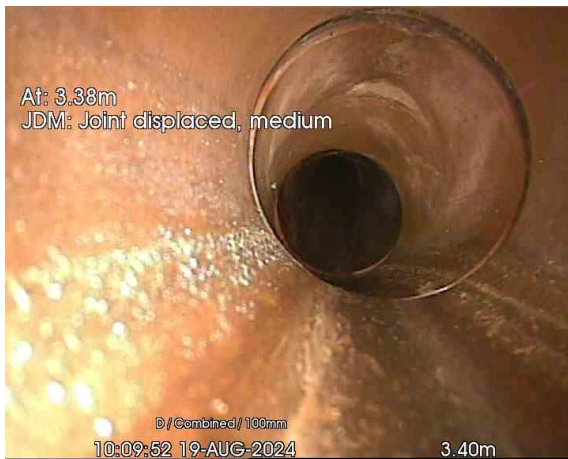
At: 3.38m  
JDM: Joint displaced, medium  
D:/Combined/100mm  
10:09:52 19-AUG-2024 3.40m  
4\_3-43m\_100952.jpg, 00:00:29, 3.43 m  
Joint displaced, medium

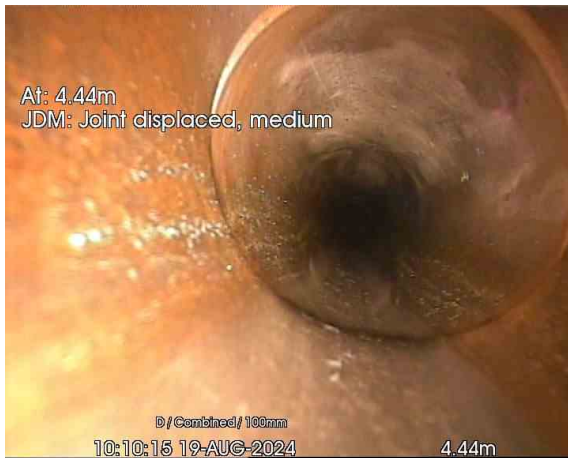
4\_4-44m\_101015.jpg, 00:00:41, 4.44 m  
Joint displaced, medium

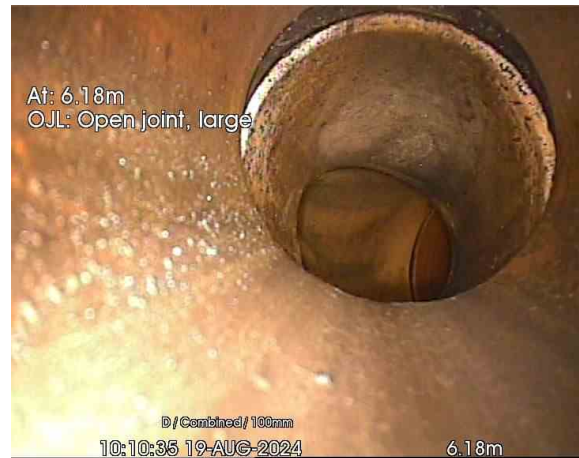
4\_6-18m\_101035.jpg, 00:00:52, 6.18 m  
Open joint, large

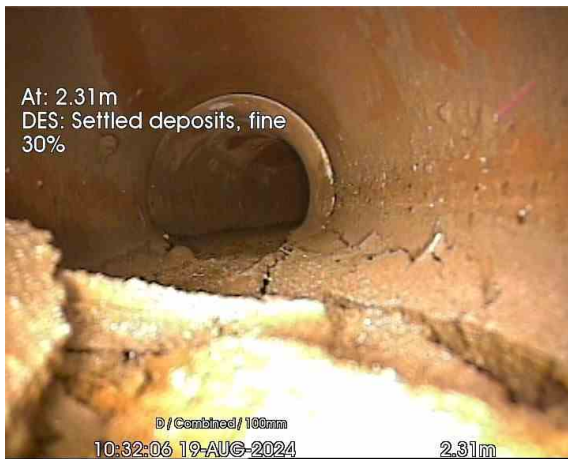
5\_2-31m\_103206.jpg, 00:00:29, 2.31 m  
Settled deposits, fine, 30% cross-sectional area loss

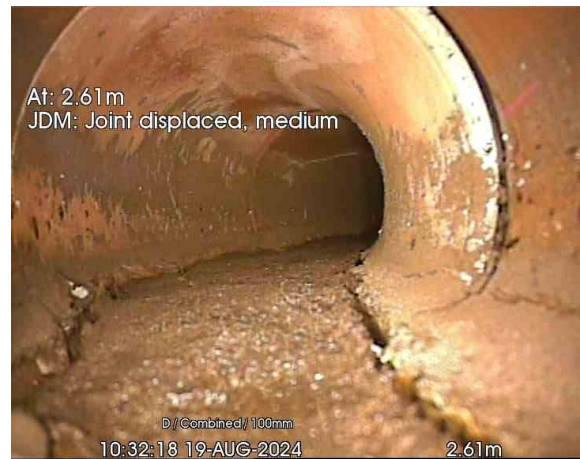
5\_2-61m\_103218.jpg, 00:00:35, 2.61 m  
Joint displaced, medium

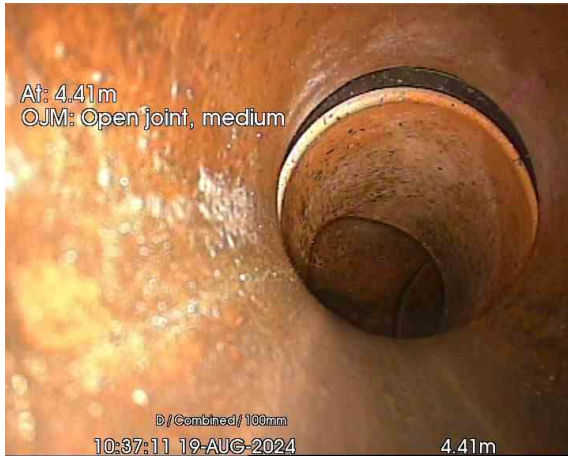
6\_4-41m\_103711.jpg, 00:00:56, 4.41 m  
Open joint, medium

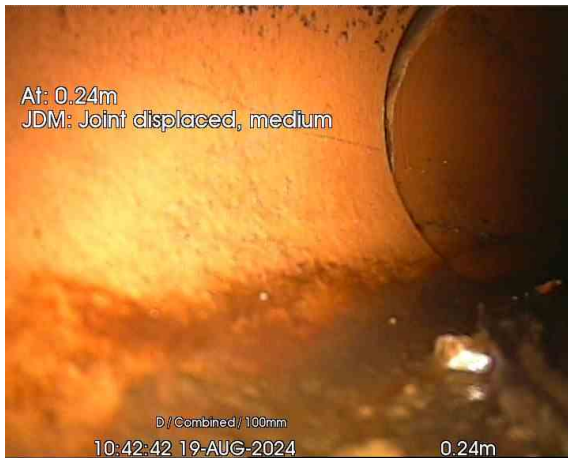
7\_0-24m\_104242.jpg, 00:00:06, 0.24 m  
Joint displaced, medium

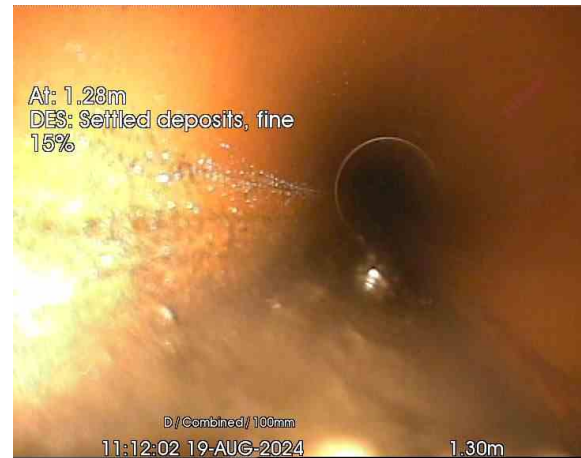
12\_1-30m\_111202.jpg, 00:00:19, 1.30 m  
Settled deposits, fine, 15% cross-sectional area loss

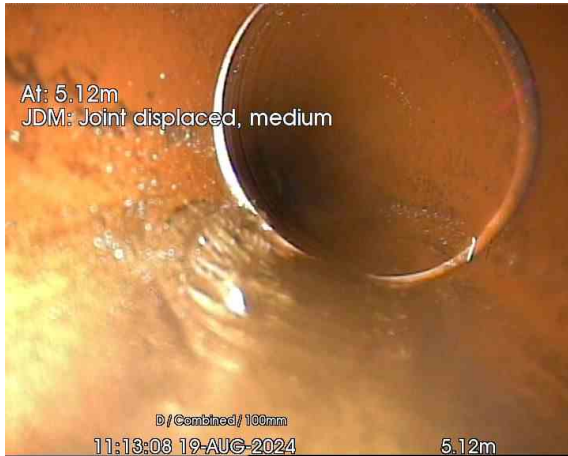
12\_5-12m\_111308.jpg, 00:01:06, 5.12 m  
Joint displaced, medium

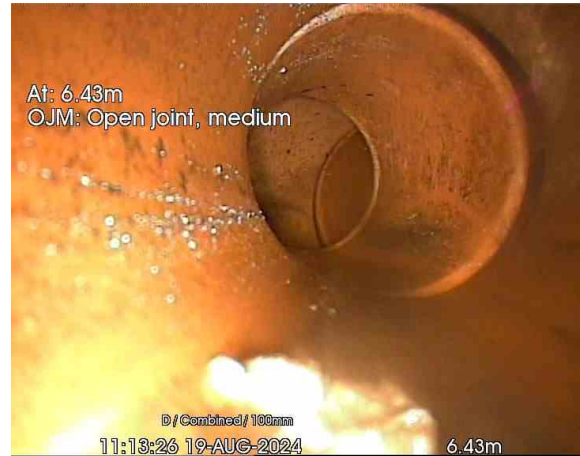
12\_6-43m\_111326.jpg, 00:01:18, 6.43 m  
Open joint, medium

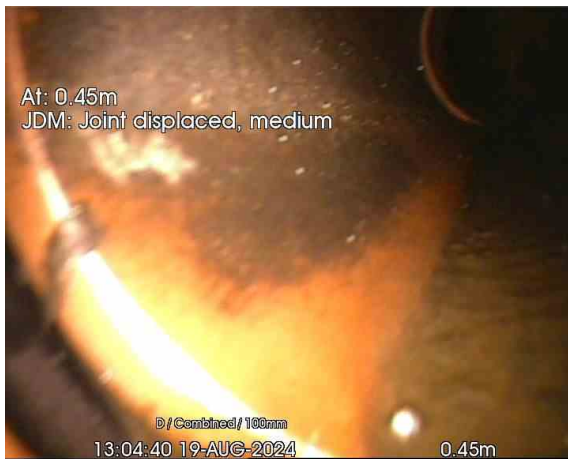
17\_0-45m\_130440.jpg, 00:00:15, 0.45 m  
Joint displaced, medium

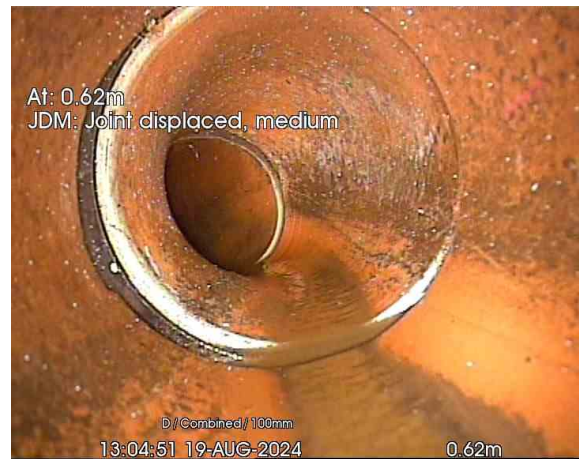
17\_0-62m\_130451.jpg, 00:00:20, 0.62 m  
Joint displaced, medium

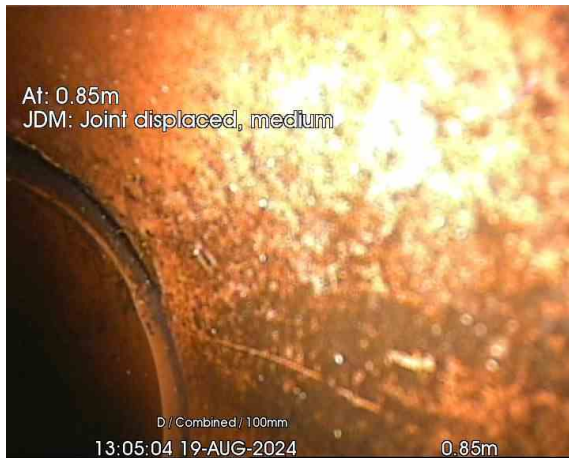
17\_0-85m\_130504.jpg, 00:00:26, 0.85 m  
Joint displaced, medium

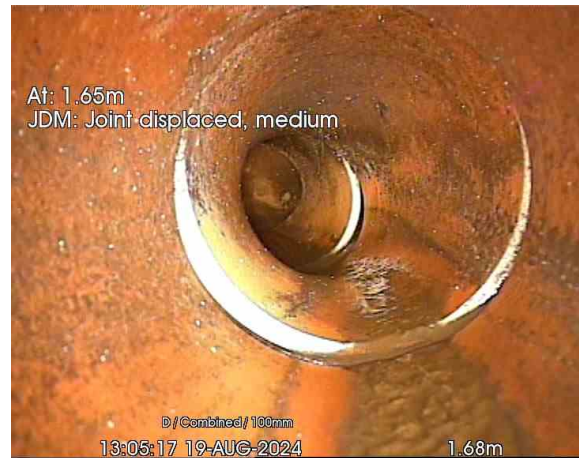
17\_1-68m\_130517.jpg, 00:00:33, 1.68 m  
Joint displaced, medium

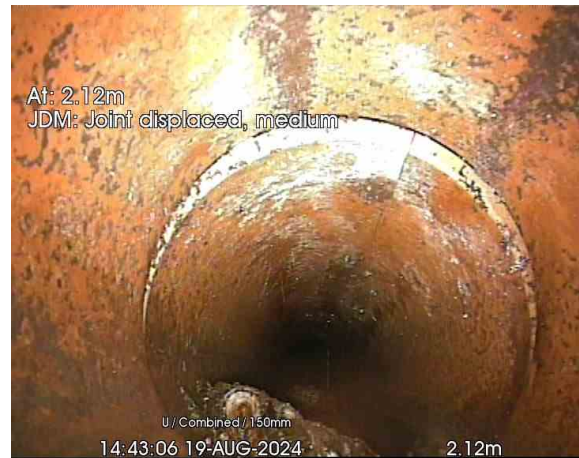
18\_2-12m\_144306.jpg, 00:00:17, 2.12 m  
Joint displaced, medium

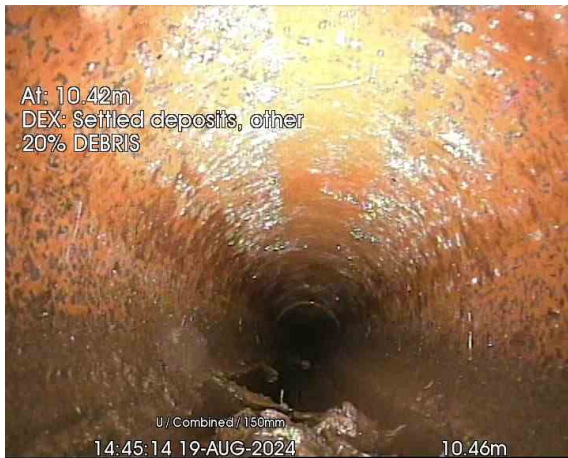
18\_10-46m\_144514.jpg, 00:01:24, 10.46 m  
Settled deposits, other, 20% cross-sectional area loss,  
DEBRIS

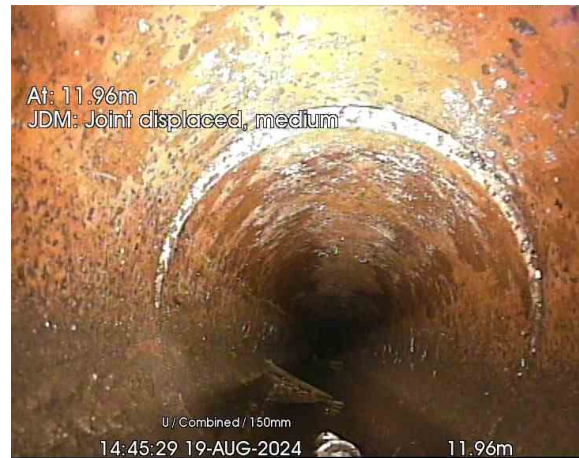
18\_11-96m\_144529.jpg, 00:01:35, 11.96 m  
Joint displaced, medium

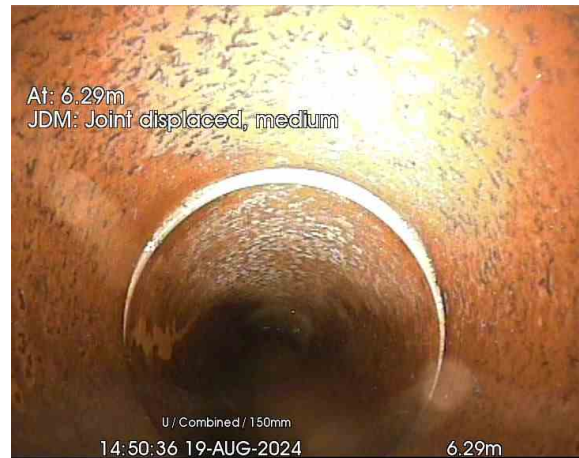
19\_6-29m\_145036.jpg, 00:01:09, 6.29 m  
Joint displaced, medium

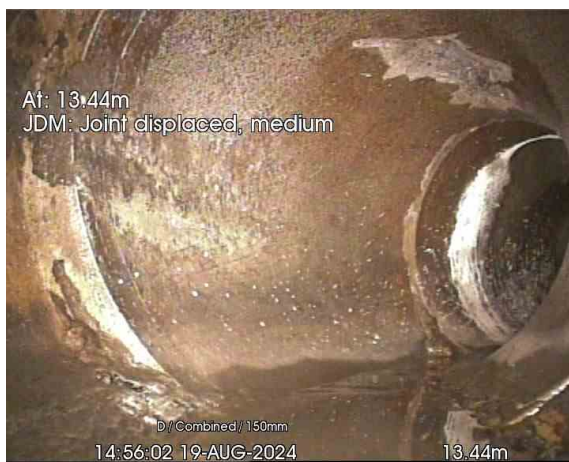
20\_13-44m\_145602.jpg, 00:01:52, 13.44 m  
Joint displaced, medium

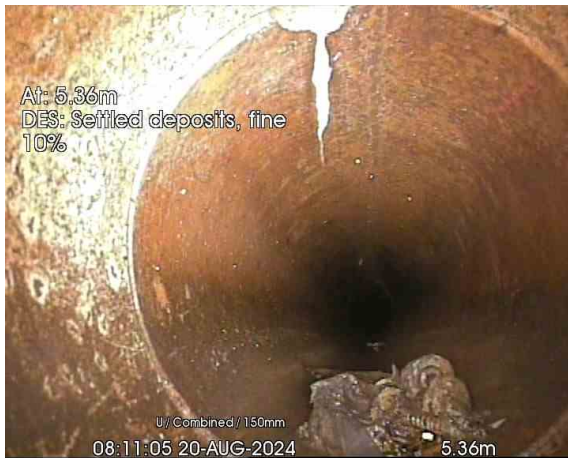
21\_5-36m\_081105.jpg, 00:00:39, 5.36 m  
Settled deposits, fine, 10% cross-sectional area loss

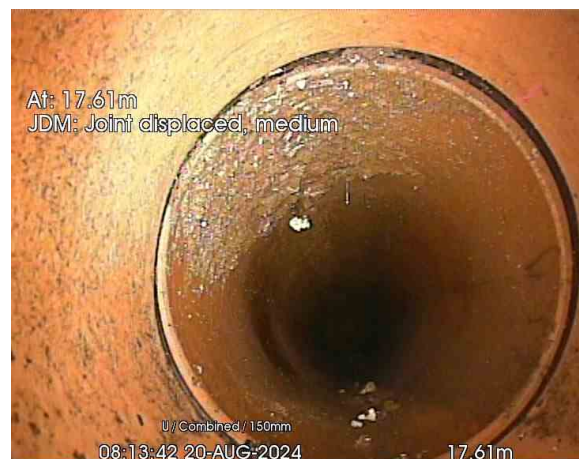
21\_17-61m\_081342.jpg, 00:02:27, 17.61 m  
Joint displaced, medium

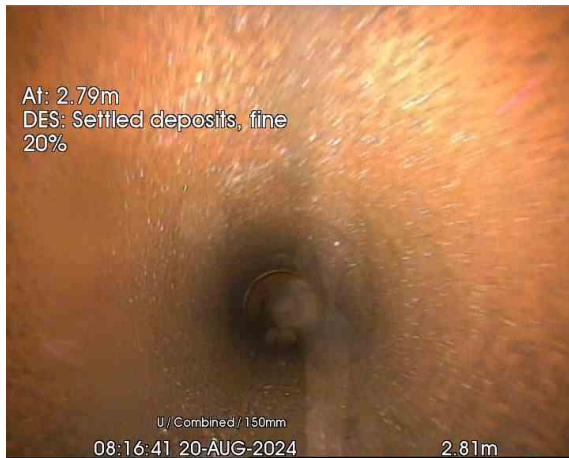
22\_2-81m\_081641.jpg, 00:00:28, 2.81 m  
Settled deposits, fine, 20% cross-sectional area loss

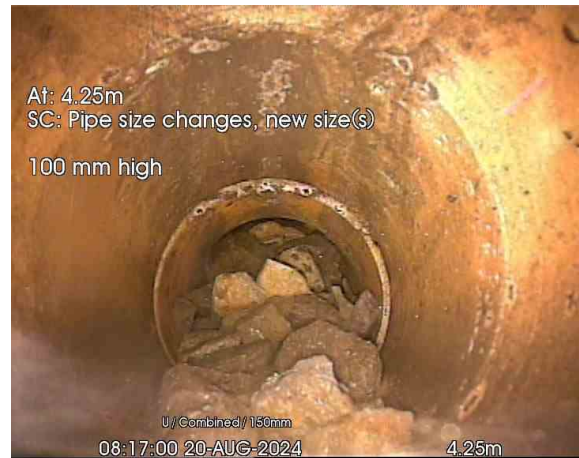
22\_4-25m\_081700.jpg, 00:00:41, 4.25 m  
Pipe size changes, new size(s), 100mm high

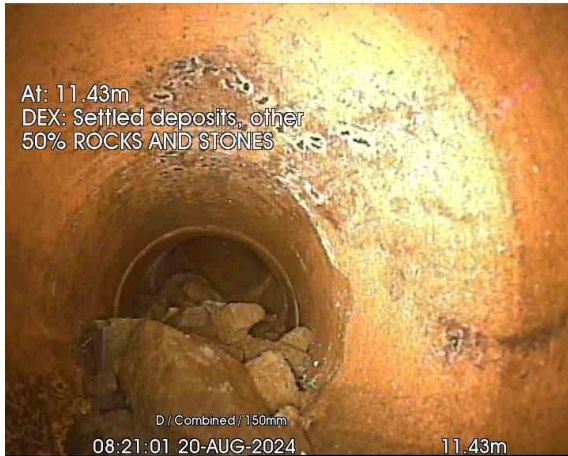
23\_11-43m\_082101.jpg, 00:01:25, 11.43 m  
Settled deposits, other, 50% cross-sectional area loss, ROCKS  
AND STONES

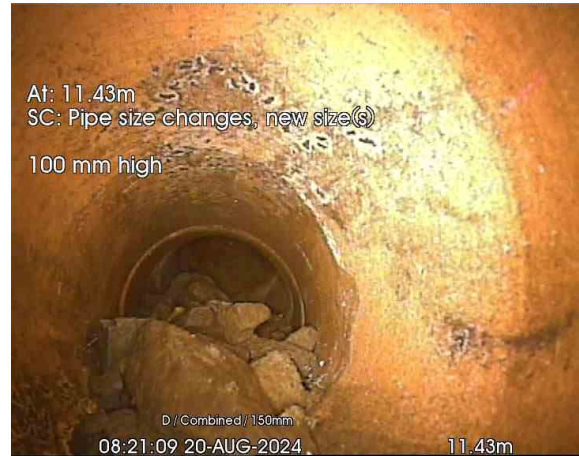
23\_11-43m\_082109.jpg, 00:01:28, 11.43 m  
Pipe size changes, new size(s), 100mm high

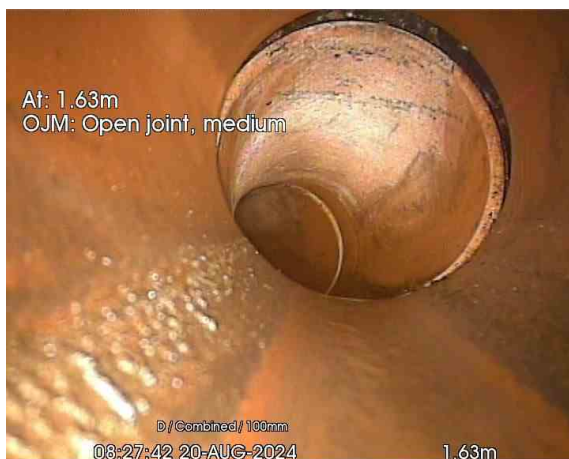
24\_1-63m\_082742.jpg, 00:00:16, 1.63 m  
Open joint, medium

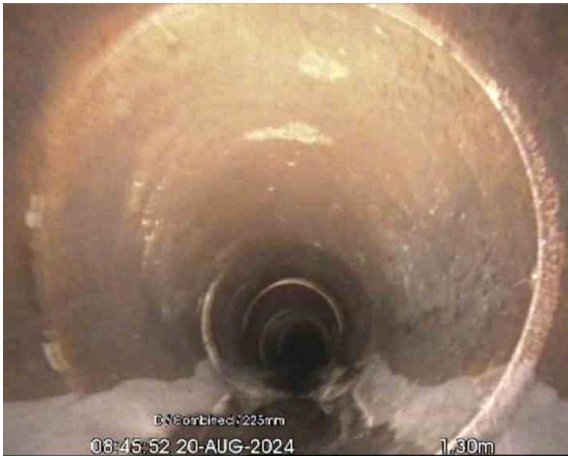
EXMH01X\_316b20f6-49c9-47a9-89c7-6b1c2c5e5027\_20240820\_111157\_865.jpg, 00:00:05, 1.30 m  
Joint displaced, medium

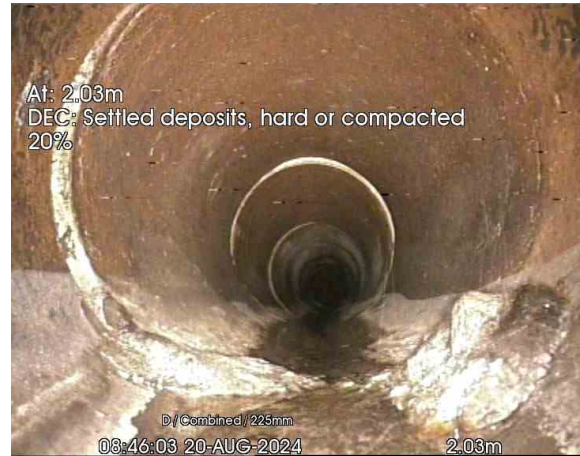
27\_2-03m\_084603.jpg, 00:00:08, 2.03 m  
Settled deposits, hard or compacted, 20% cross-sectional area loss

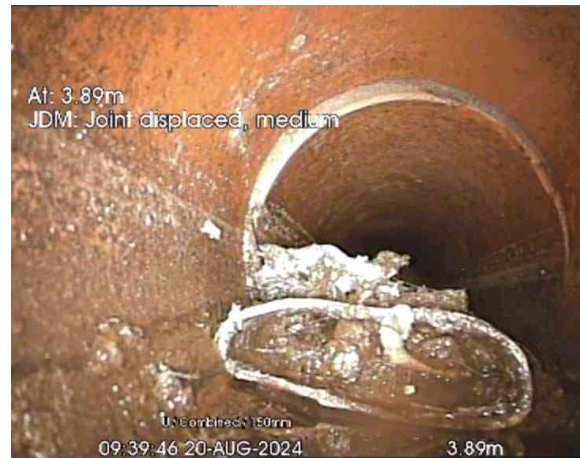
RE04X\_7c4d29cc-008c-4ad1-8582-84f3936c5463\_20240820\_111352\_621.jpg, 00:00:34, 3.89 m  
Joint displaced, medium

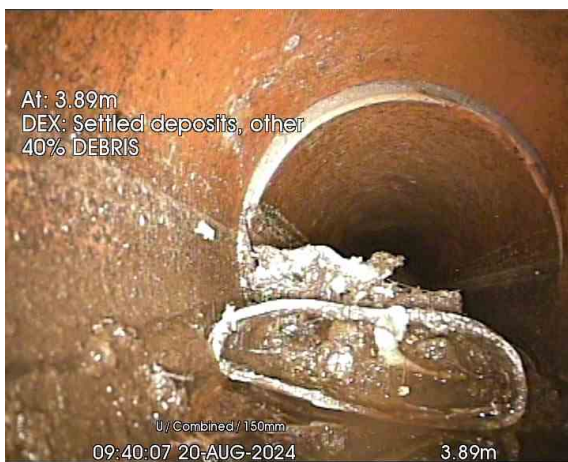
28\_3-89m\_094007.jpg, 00:00:38, 3.89 m  
Settled deposits, other, 40% cross-sectional area loss, DEBRIS

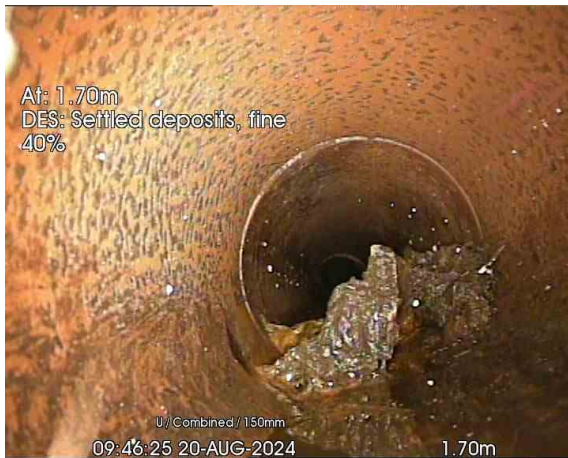
29\_1-70m\_094625.jpg, 00:00:15, 1.70 m  
Settled deposits, fine, 40% cross-sectional area loss
