# LARKE RISE, DIDSBURY - INSPECTION OF PALATINE ROAD BOUNDARY WALL

25.136

Wednesday, 11 June 2025

Larke Rise, West Didsbury, Manchester, M20 2UL

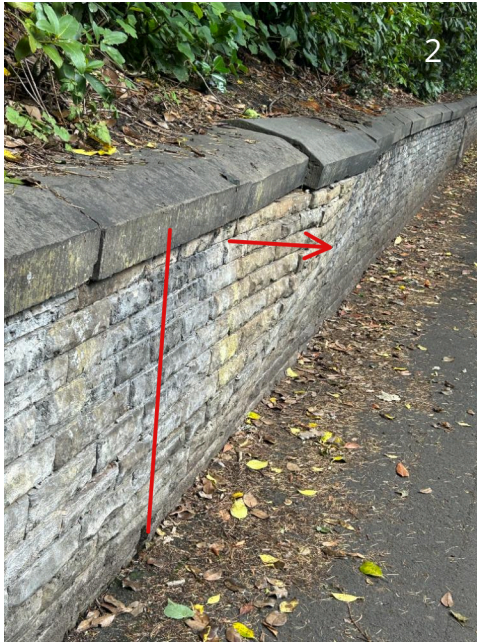
The boundary wall is a retaining wall between Larke Rise and Palatine Road is approximately 300 mm thick with solid stone coping stones, and appears to be around 100 years old. The wall shows signs of distortion in a number of places, with the most significant movement occurring in front of a very well-established lime tree of approximately 22m height, as shown in the photos below. The wall is retaining to all of its height of approximate 1.4m high and is acting as a mass retaining wall, in that the weight of the wall what retains the earth and forces from behind it. There are no weepholes in the lower third of the wall suggesting that there is some form of drainage to reduce the hydrostatic pressure of water building behind the wall. The extents of the damage are shown by the red lines shown on pic 1.

At this location, the wall has buckled on the joint of the coping stones and has bellied by approximately 100 - 120 mm from its original position. There is stepped cracking mainly through the joints of the stone to the outer skin (pic 6) and the coping stones are now misaligned. The coping stones will likely require some mechanical means of lifting as the centre one is very substantial.

Rebuilding this section of the wall would require at least three coping stones to be removed, the wall to be taken down and rebuilt using the existing stone. The foundation may be damaged and may need to be re-

built but the damage is focused higher up as though the tree is leaning on the wall rather than heaving through the foundation and splitting the wall in half. It may be possible to put a thicker, heavier inner skin of blockwork such as dense concrete trench blocks but this will only be possible if room can be made on the tree side of the wall as the front boundary line needs to be maintained. This would require cutting some of the trees root base back to create room for a thicker wall (with more mass to resist the forces from the tree).
