Bennet Street

# Cornbrook Culvert Condition Survey

Ref. 222-176

# Bennet Street Culvert Survey- Comprehensive Report and Recommendations

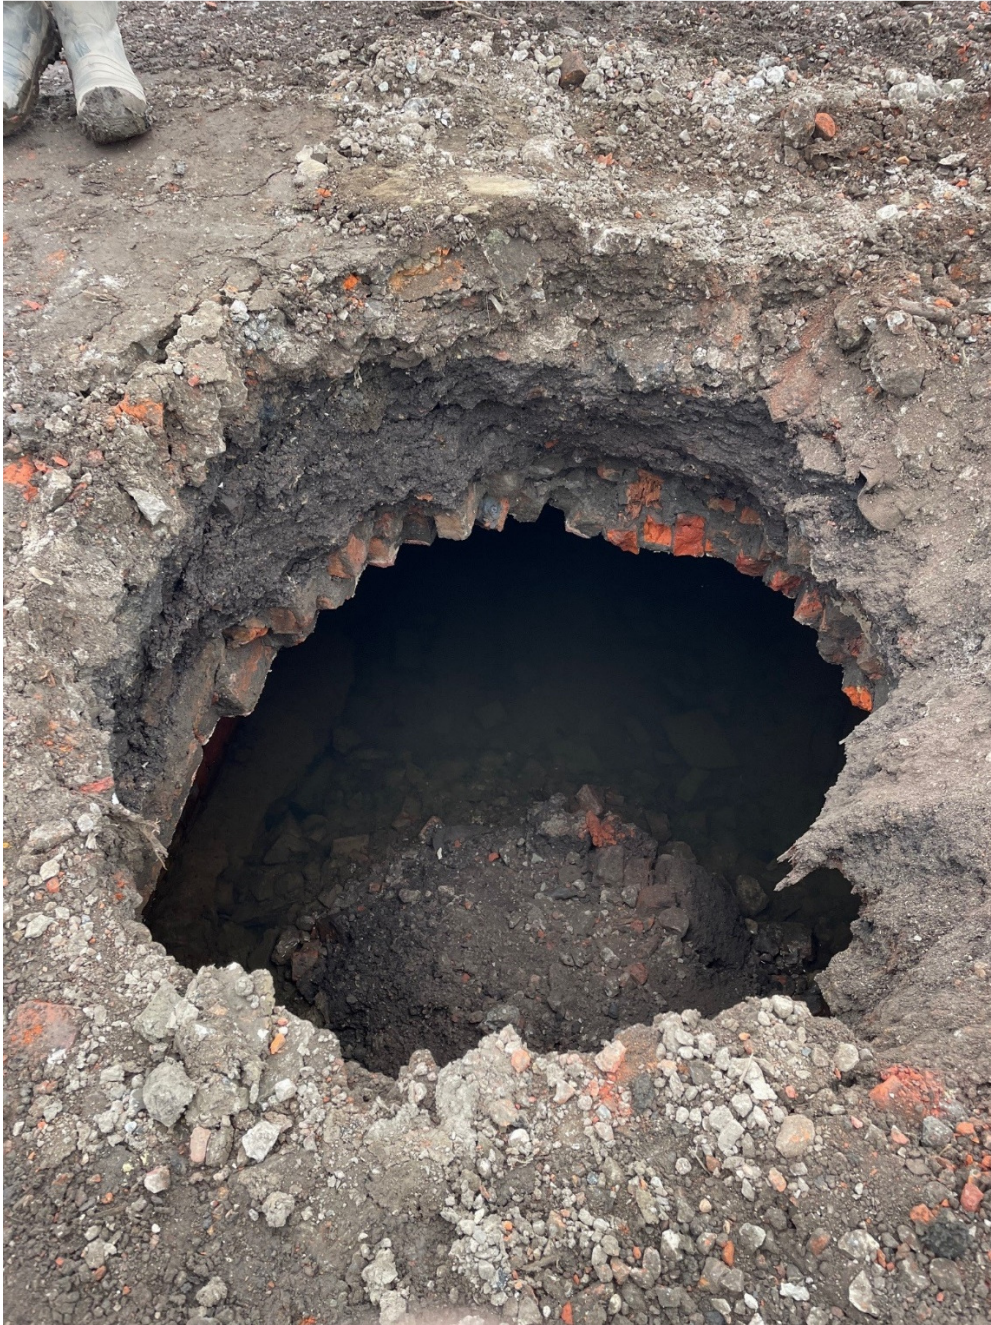
- A partial collapse of the culvert's brick archway was noted, resulting in a 1.5m diameter opening.
- The reduced ground cover above the culvert was identified as a contributing factor to the structural failure, as it limited the arch's capacity to distribute the applied loads.
- Debris and loose bricks were observed within the culvert, but it was confirmed that water flow remained largely unobstructed at the time of inspection.
- Ground investigations revealed a layer of site fill material, approximately 500mm thick, above a stiff clay layer encountered at a depth of approximately 1m. The clay stratum provided sufficient bearing capacity for the proposed remedial measures.
