Date: 22nd October 2024  
Reference: 15-974 V16

## GAS MEMBRANE VALIDATION – BENNETT STREET

| <b>Project Name:</b> | Bennett Street |
| <b>Plot:</b> | 91-94, 97, 98 |

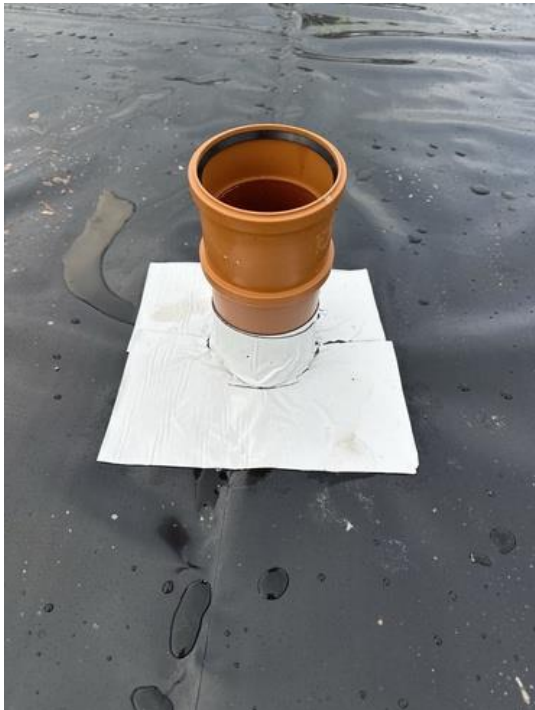
Photo 70

| Slab / membrane condition (is membrane clear of snow, standing water, debris or insulation): Can membrane be fully seen and photographed – ask contractor to remove an debris so membrane can be fully seen an inspected – this is a requirement of NHBC and local authorities. | Pass |
