Date: 30th October 2024  
Reference: 15-974 V17

## GAS MEMBRANE VALIDATION – BENNETT STREET

| <b>Project Number:</b> | 15-974 |
| <b>Plot:</b> | 99-100 and 91-92 garages |

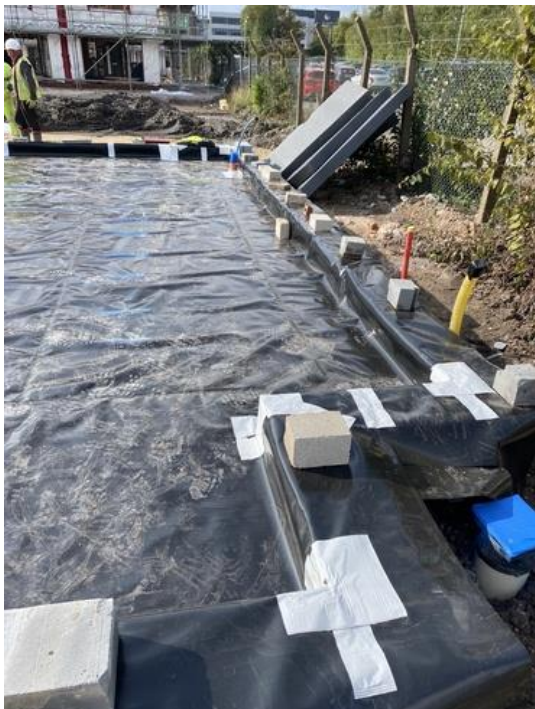
Photo 3

| <p>Gas Membrane Condition: Open punctures, tears, rips, stretching, Presence of debris, Repairs, Signs of weakness such as raised or sunken indentations, Protection plan in place to restrict access to lain gas membrane? IF FAIL DESCRIPTION IN ACTIONS AND PHOTOS REQUIRED</p> <div> </div> <div> <p>Photo 3</p> <p>Photo 4</p> <p>Photo 5</p> <p>Photo 6</p> </div> | Pass |

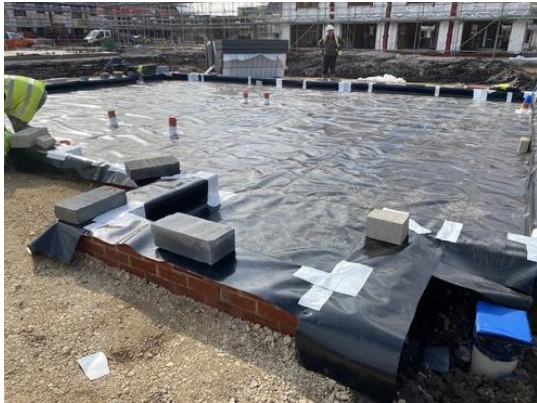
Photo 29

**Condition of sub-grade and underside of gas membrane: Check that the subgrade does not contain rough/uneven surfaces, is appropriately clean and that there are no hard/sharp objects. That protective sand blinding or geotextile (if specified) is present and meets the design criteria. ( Lift back the membrane and photo the subfloor)**

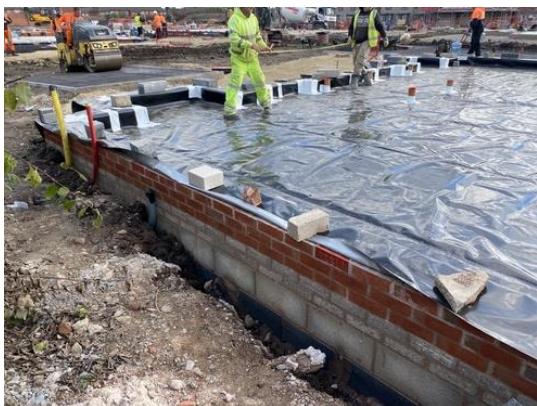
Photo 31

Slab / membrane condition (is membrane clear of snow, standing water, debris or insulation): Can membrane be fully seen and photographed – ask contractor to remove an debris so membrane can be fully seen an inspected – this is a requirement of NHBC and local authorities.

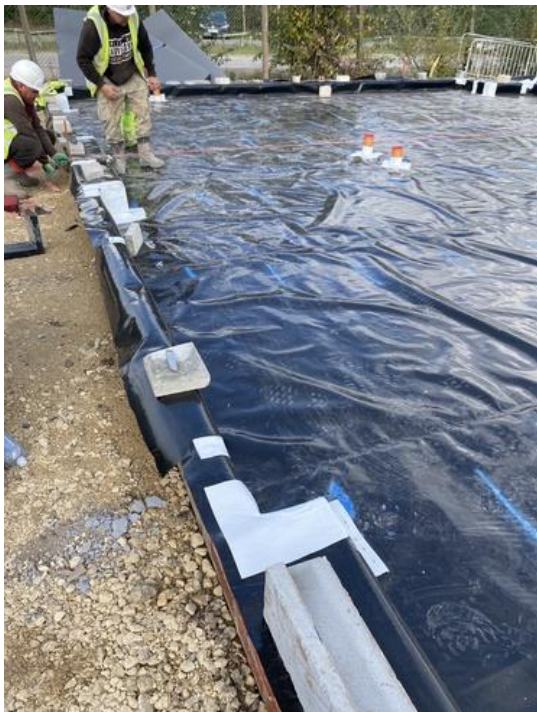
Photo 37

| Gas Membrane Condition: Open punctures, tears, rips, stretching, Presence of debris, Repairs, Signs of weakness such as raised or sunken indentations, Protection plan in place to restrict access to laid gas membrane? IF FAIL DESCRIPTION IN ACTIONS AND PHOTOS REQUIRED | | Pass |

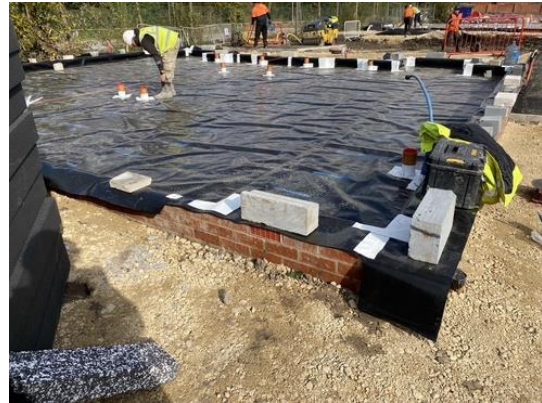
Photo 68

Slab / membrane condition (is membrane clear of snow, standing water, debris or insulation): Can membrane be fully seen and photographed – ask contractor to remove an debris so membrane can be fully seen an inspected – this is a requirement of NHBC and local authorities.

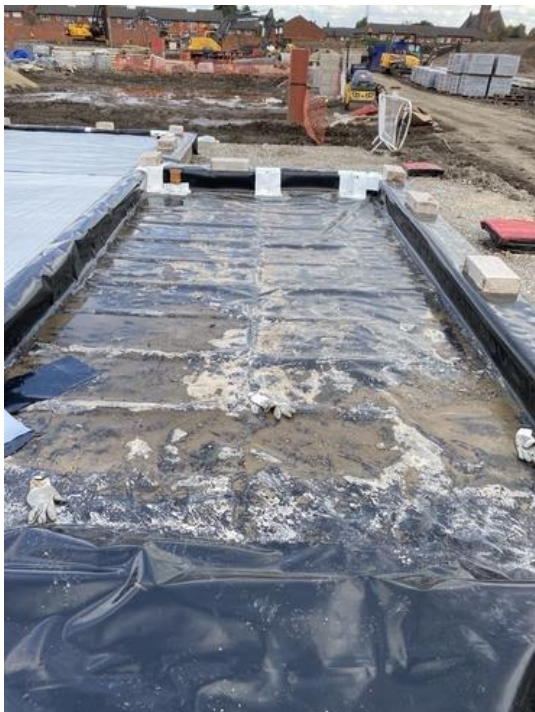
Photo 75

| <p>Gas Membrane Condition: Open punctures, tears, rips, stretching, Presence of debris, Repairs, Signs of weakness such as raised or sunken indentations, Protection plan in place to restrict access to lain gas membrane? IF FAIL DESCRIPTION IN ACTIONS AND PHOTOS REQUIRED</p> <p>Photo 74      Photo 75</p> | | Pass |
