**Aldi Store, Victoria  
Road East, Moston**

**Surface Water Drainage  
Verification Report**

**9104-SWF-XX-XX-TR-C-0202**

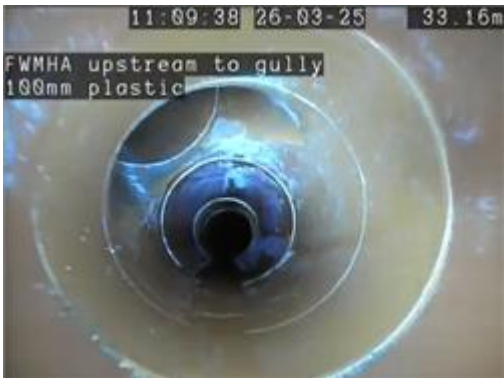
| Pos | Video Ref | Code | Description | Image |
|---|---|---|---|---|
| 33.16m | 0:01:48 | JN | Junction at 11 o'clock: 100mm Diameter | <p>Image Provided - Ref: 1_9</p> |

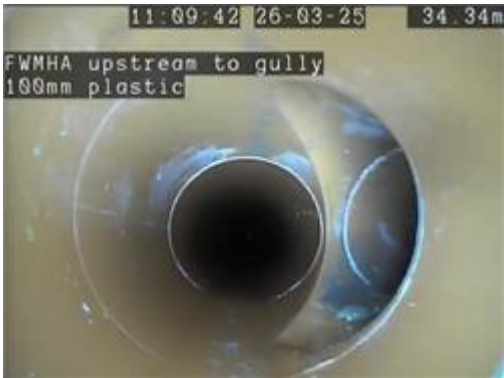
| Pos | Video Ref | Code | Description | Image |
|---|---|---|---|---|
| 34.34m | 0:01:52 | JN | Junction at 03 o'clock: 100mm Diameter | <p>Image Provided - Ref: 1_10</p> |

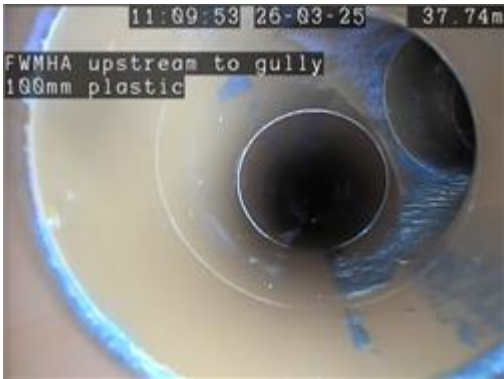
| Pos | Video Ref | Code | Description | Image |
|---|---|---|---|---|
| 37.74m | 0:02:04 | JN | Junction at 02 o'clock: 100mm Diameter | <p>Image Provided - Ref: 1_11</p> |

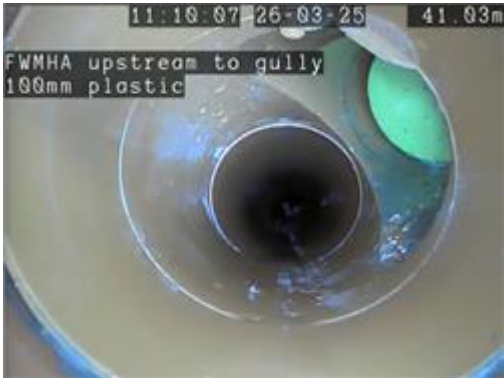
| Pos | Video Ref | Code | Description | Image |
|---|---|---|---|---|
| 41.03m | 0:02:17 | JN | Junction at 02 o'clock: 100mm Diameter | <p>Image Provided - Ref: 1_12</p> |

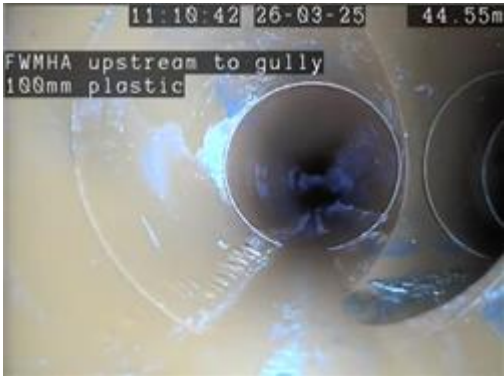
| Pos | Video Ref | Code | Description | Image |
|---|---|---|---|---|
| 44.55m | 0:02:44 | JN | Junction at 03 o'clock: 100mm Diameter | <p>Image Provided - Ref: 1_14</p> |

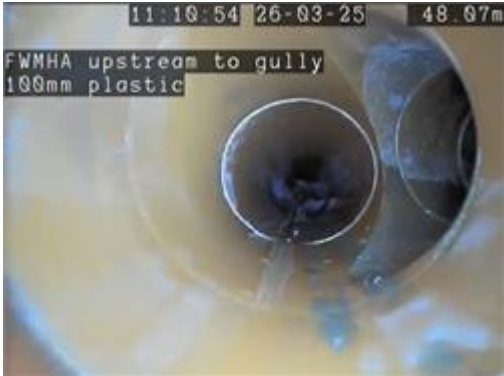
| Pos | Video Ref | Code | Description | Image |
|---|---|---|---|---|
| 48.07m | 0:02:55 | JN | Junction at 03 o'clock: 100mm Diameter | <p>Image Provided - Ref: 1_15</p> |

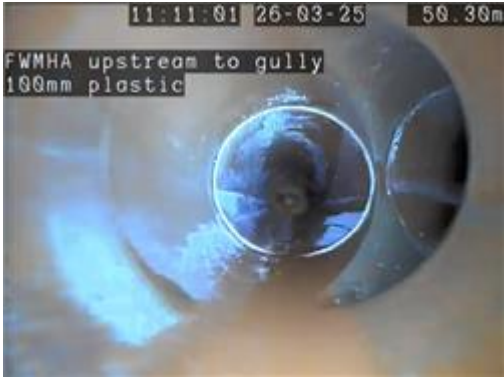
| Pos | Video Ref | Code | Description | Image |
|---|---|---|---|---|
| 50.30m | 0:03:03 | JN | Junction at 03 o'clock: 100mm Diameter | <p>Image Provided - Ref: 1_16</p> |

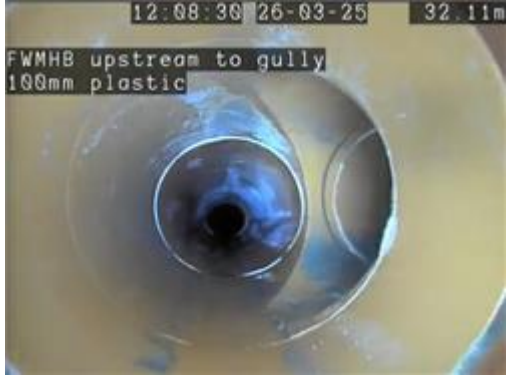
| Pos | Video Ref | Code | Description | Image |
|---|---|---|---|---|
| 32.11m | 0:01:51 | JN | Junction at 03 o'clock: 100mm Diameter | <p>Image Provided - Ref: 6_2</p> |

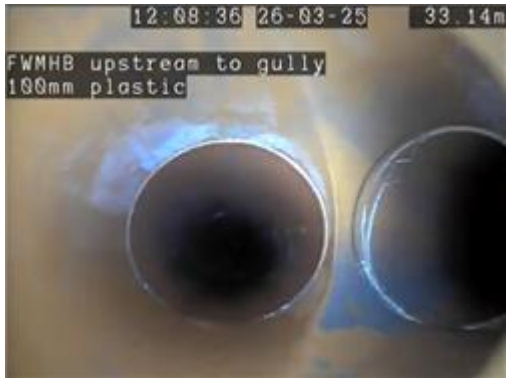
| Pos | Video Ref | Code | Description | Image |
|---|---|---|---|---|
| 33.14m | 0:01:57 | JN | Junction at 03 o'clock: 100mm Diameter | <p>Image Provided - Ref: 6_3</p> |

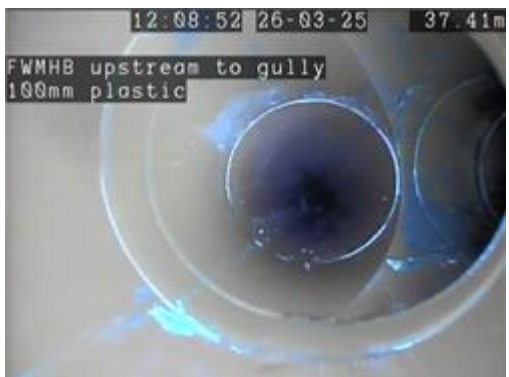
| Pos | Video Ref | Code | Description | Image |
|---|---|---|---|---|
| 37.41m | 0:02:13 | JN | Junction at 03 o'clock: 100mm Diameter | <p>Image Provided - Ref: 6_4</p> |

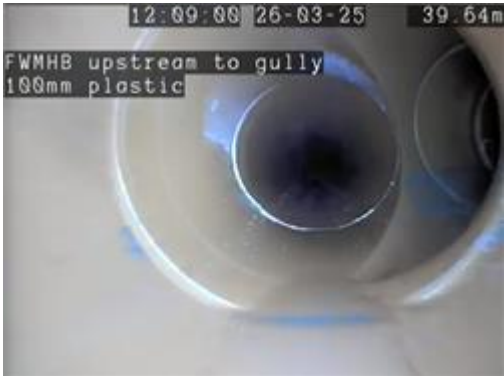
| Pos | Video Ref | Code | Description | Image |
|---|---|---|---|---|
| 39.64m | 0:02:22 | JN | Junction at 03 o'clock: 100mm Diameter | <p>Image Provided - Ref: 6_5</p> |

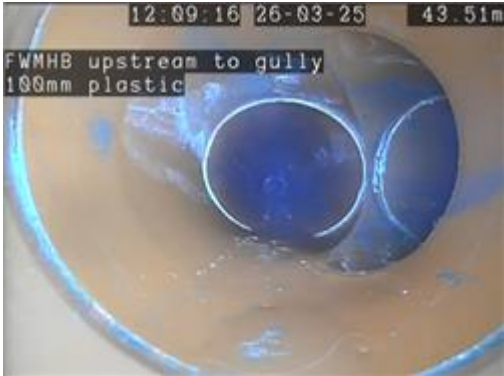
| Pos | Video Ref | Code | Description | Image |
|---|---|---|---|---|
| 43.51m | 0:02:37 | JN | Junction at 03 o'clock: 100mm Diameter | <p>Image Provided - Ref: 6_6</p> |

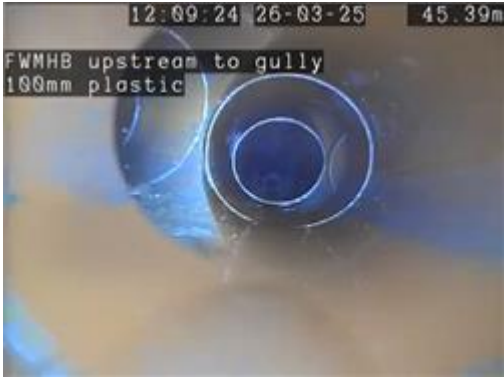
| Pos | Video Ref | Code | Description | Image |
|---|---|---|---|---|
| 45.39m | 0:02:51 | JN | Junction at 09 o'clock: 100mm Diameter | <p>Image Provided - Ref: 6_7</p> |

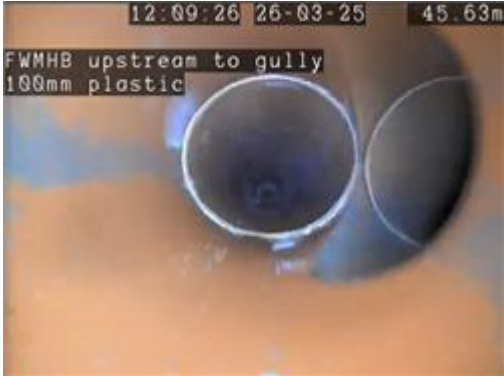
| Pos | Video Ref | Code | Description | Image |
|---|---|---|---|---|
| 45.63m | 0:02:47 | JN | Junction at 03 o'clock: 100mm Diameter | <p>Image Provided - Ref: 6_8</p> |

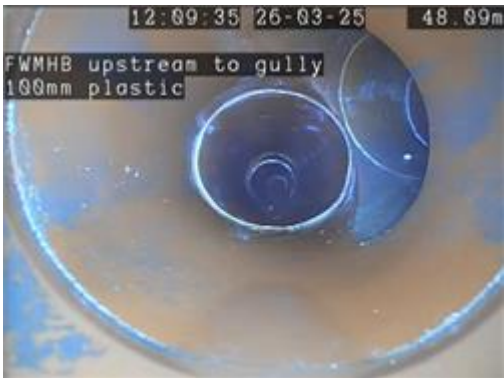
| Pos | Video Ref | Code | Description | Image |
|---|---|---|---|---|
| 48.09m | 0:02:56 | JN | Junction at 03 o'clock: 100mm Diameter | <p>Image Provided - Ref: 6_9</p> |

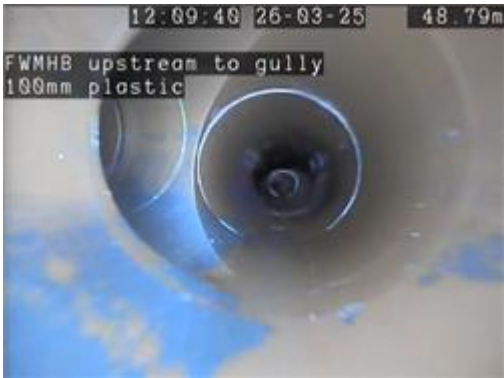
| Pos | Video Ref | Code | Description | Image |
|---|---|---|---|---|
| 48.79m | 0:03:06 | JN | Junction at 09 o'clock: 100mm Diameter | <p>Image Provided - Ref: 6_10</p> |

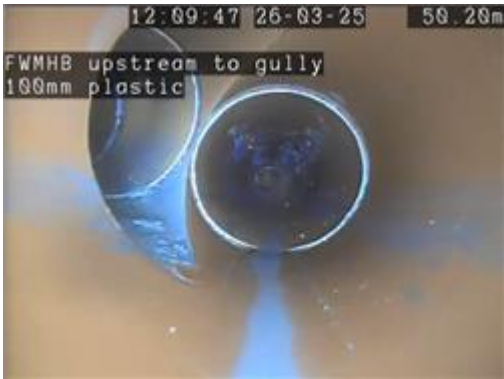
| Pos | Video Ref | Code | Description | Image |
|---|---|---|---|---|
| 50.20m | 0:03:19 | JN | Junction at 09 o'clock: 100mm Diameter | <p>Image Provided - Ref: 6_11</p> |

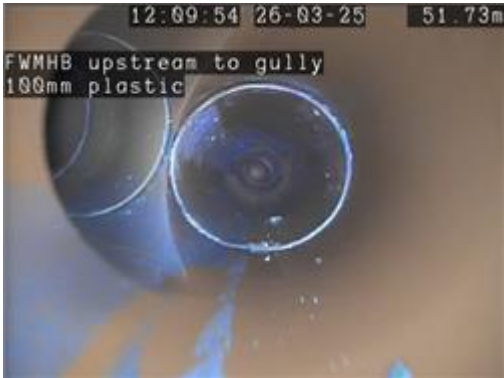
| Pos | Video Ref | Code | Description | Image |
|---|---|---|---|---|
| 51.73m | 0:03:33 | JN | Junction at 09 o'clock: 100mm Diameter | <p>Image Provided - Ref: 6_12</p> |

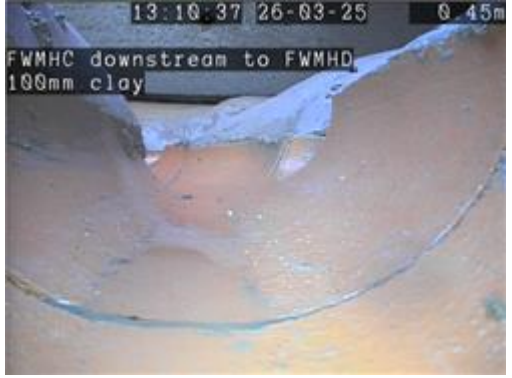
| Pos | Video Ref | Code | Description | Image |
|---|---|---|---|---|
| 00.45m | | MHF | Finish node type, manhole FWMHD | <p>Image Provided - Ref: 7_9999</p> |

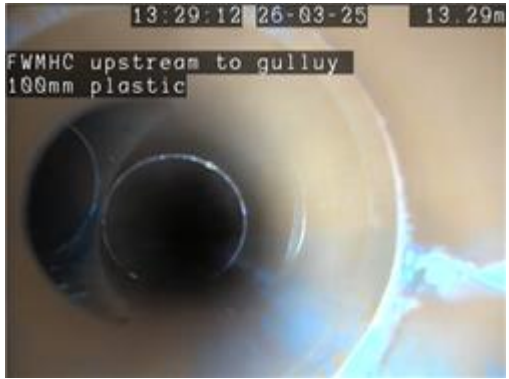
| Pos | Video Ref | Code | Description | Image |
|---|---|---|---|---|
| 13.29m | 0:01:04 | JN | Junction at 09 o'clock: 100mm Diameter | <p>Image Provided - Ref: 8_2</p> |

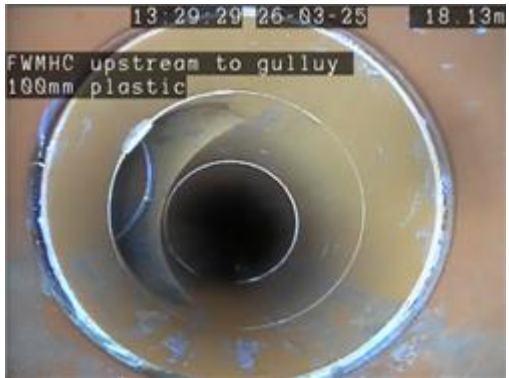
| Pos | Video Ref | Code | Description | Image |
|---|---|---|---|---|
| 18.13m | 0:01:20 | JN | Junction at 09 o'clock: 100mm Diameter | <p>Image Provided - Ref: 8_3</p> |

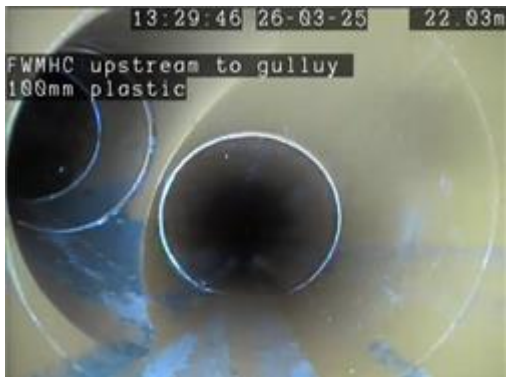
| Pos | Video Ref | Code | Description | Image |
|---|---|---|---|---|
| 22.03m | 0:01:37 | JN | Junction at 09 o'clock: 100mm Diameter | <p>Image Provided - Ref: 8_4</p> |

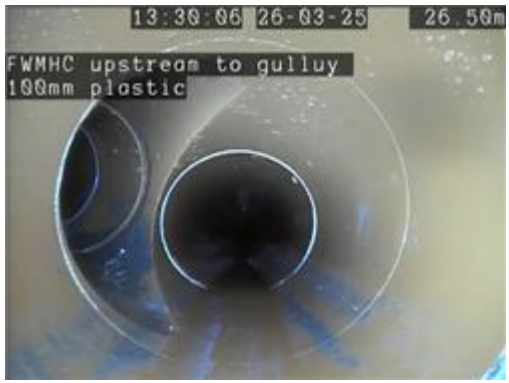
| Pos | Video Ref | Code | Description | Image |
|---|---|---|---|---|
| 26.50m | 0:01:57 | JN | Junction at 09 o'clock: 100mm Diameter | <p>Image Provided - Ref: 8_5</p> |

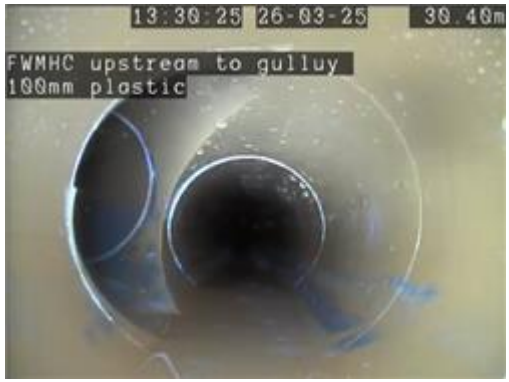
| Pos | Video Ref | Code | Description | Image |
|---|---|---|---|---|
| 30.40m | 0:02:16 | JN | Junction at 09 o'clock: 100mm Diameter | <p>Image Provided - Ref: 8_6</p> |

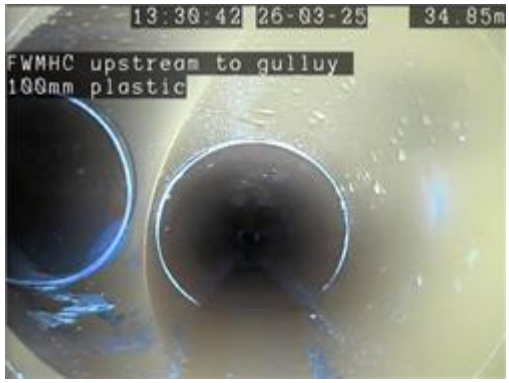
| Pos | Video Ref | Code | Description | Image |
|---|---|---|---|---|
| 34.85m | 0:02:40 | JN | Junction at 09 o'clock: 100mm Diameter | <p>Image Provided - Ref: 8_7</p> |

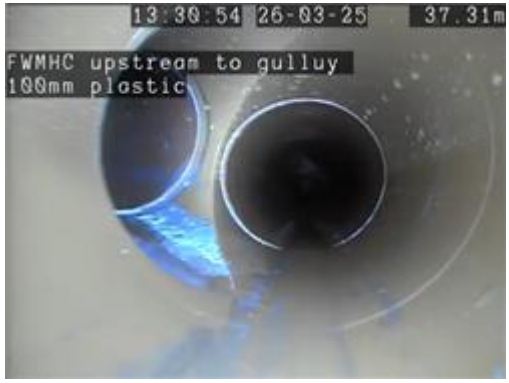
| Pos | Video Ref | Code | Description | Image |
|---|---|---|---|---|
| 37.31m | 0:02:45 | JN | Junction at 09 o'clock: 100mm Diameter | <p>Image Provided - Ref: 8_8</p> |

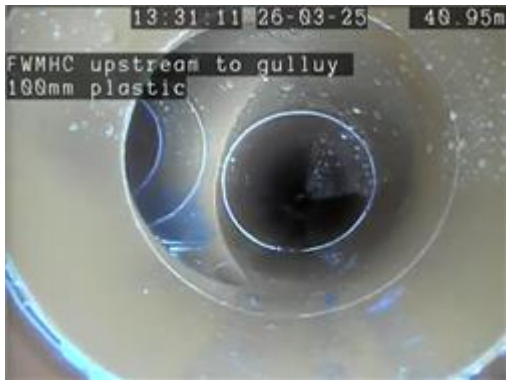
| Pos | Video Ref | Code | Description | Image |
|---|---|---|---|---|
| 40.95m | 0:03:14 | JN | Junction at 09 o'clock: 100mm Diameter | <p>Image Provided - Ref: 8_9</p> |

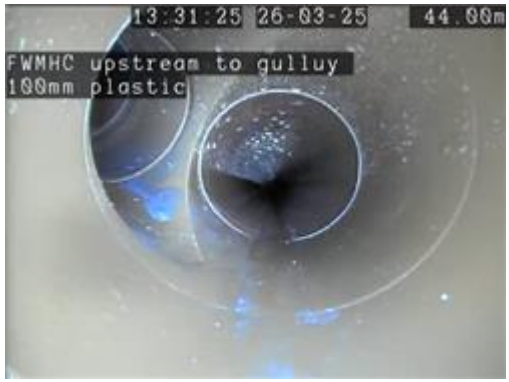
| Pos | Video Ref | Code | Description | Image |
|---|---|---|---|---|
| 44.00m | 0:03:17 | JN | Junction at 10 o'clock: 100mm Diameter | <p>Image Provided - Ref: 8_10</p> |

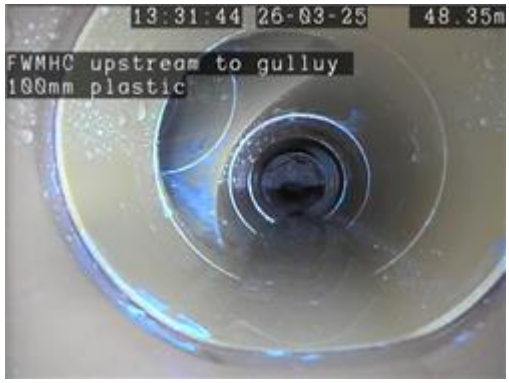
| Pos | Video Ref | Code | Description | Image |
|---|---|---|---|---|
| 48.35m | 0:03:35 | JN | Junction at 09 o'clock: 100mm Diameter | <p>Image Provided - Ref: 8_11</p> |

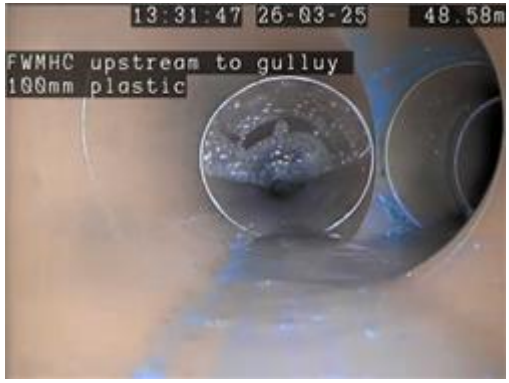
| Pos | Video Ref | Code | Description | Image |
|---|---|---|---|---|
| 48.58m | 0:03:38 | JN | Junction at 03 o'clock: 100mm Diameter | <p>Image Provided - Ref: 8_12</p> |

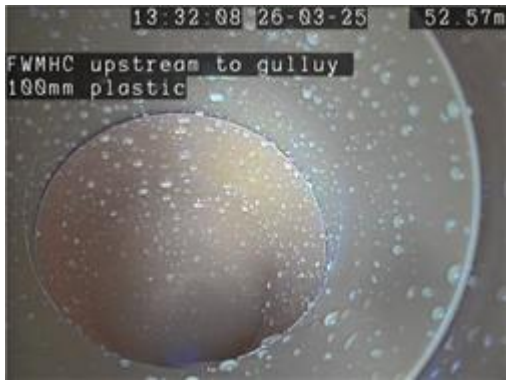
| Pos | Video Ref | Code | Description | Image |
|---|---|---|---|---|
| 52.57m | | MHF | Finish node type, manhole GULLY | <p>Image Provided - Ref: 8_9999</p> |

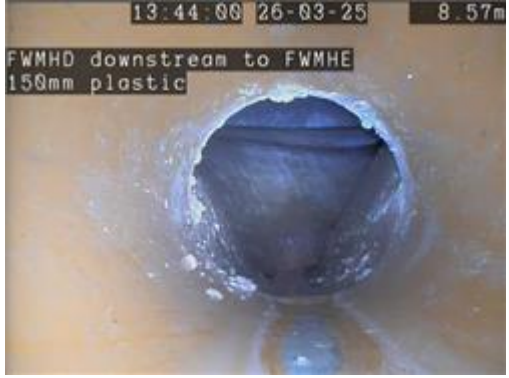
| Pos | Video Ref | Code | Description | Image |
|---|---|---|---|---|
| 08.57m | | MHF | Finish node type, manhole FWMHE | <p>Image Provided - Ref: 9_9999</p> |

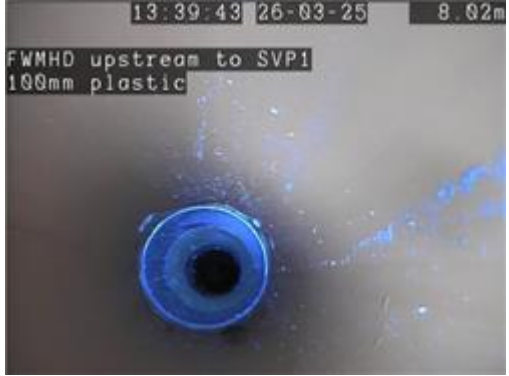
| Pos | Video Ref | Code | Description | Image |
|---|---|---|---|---|
| 08.02m | | MHF | Finish node type, manhole SVP1 | <p>Image Provided - Ref: 10_9999</p> |

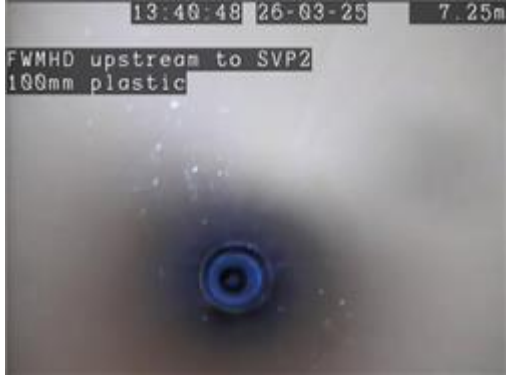
| Pos | Video Ref | Code | Description | Image |
|---|---|---|---|---|
| 07.25m | | MHF | Finish node type, manhole SVP2 | <p>Image Provided - Ref: 11_9999</p> |

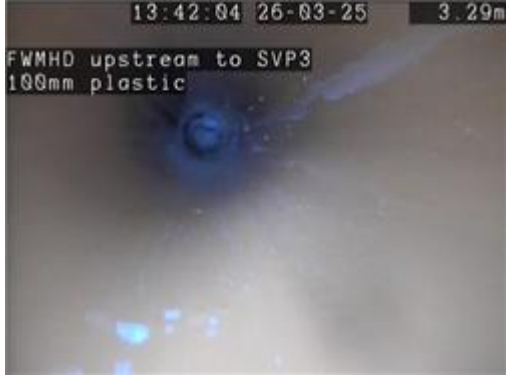
| Pos | Video Ref | Code | Description | Image |
|---|---|---|---|---|
| 03.29m | | MHF | Finish node type, manhole SVP3 | <p>Image Provided - Ref: 12_9999</p> |

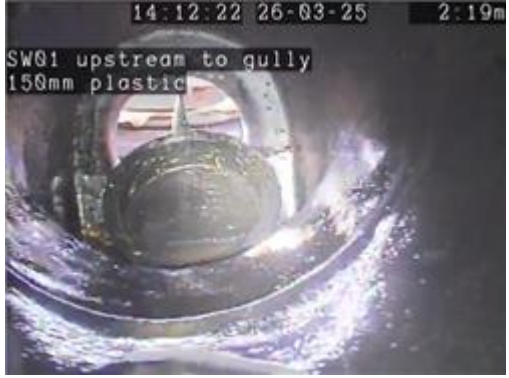
| Pos | Video Ref | Code | Description | Image |
|---|---|---|---|---|
| 02.19m | | MHF | Finish node type, manhole GULLY | <p>Image Provided - Ref: 13_9999</p> |

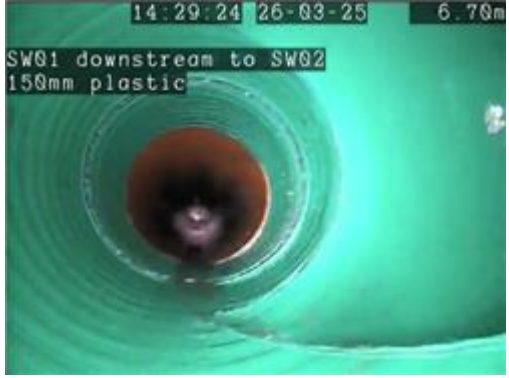
| Pos | Video Ref | Code | Description | Image |
|---|---|---|---|---|
| 06.70m | 0:00:32 | JN | Junction at 03 o'clock: 150mm Diameter | <p>Image Provided - Ref: 14_2</p> |

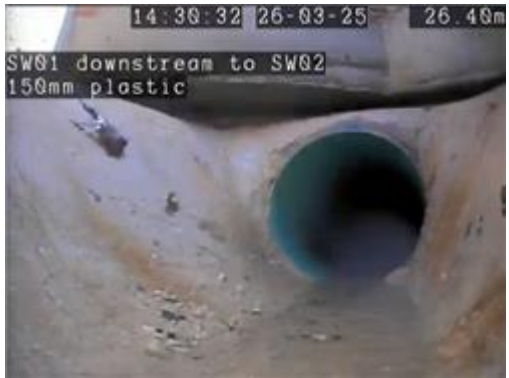
| Pos | Video Ref | Code | Description | Image |
|---|---|---|---|---|
| 26.40m | | MHF | Finish node type, manhole SW02 | <p>Image Provided - Ref: 14_9999</p> |

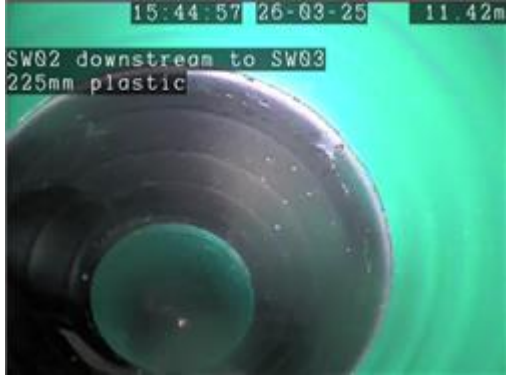
| Pos | Video Ref | Code | Description | Image |
|---|---|---|---|---|
| 11.42m | 0:00:46 | JN | Junction at 09 o'clock: 150mm Diameter | <p>Image Provided - Ref: 15_2</p> |

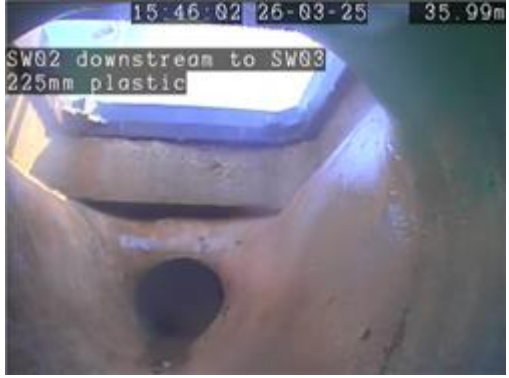
| Pos | Video Ref | Code | Description | Image |
|---|---|---|---|---|
| 35.99m | | MHF | Finish node type, manhole SW03 | <p>Image Provided - Ref: 15_9999</p> |

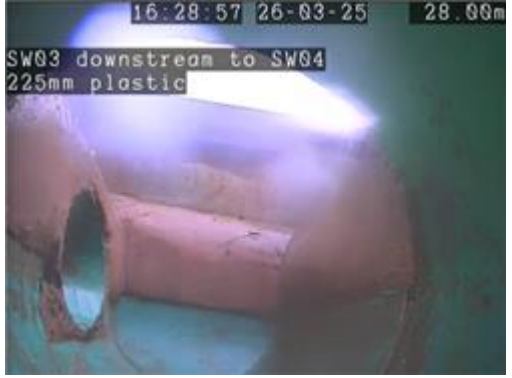
| Pos | Video Ref | Code | Description | Image |
|---|---|---|---|---|
| 28.00m | | MHF | Finish node type, manhole SW04 | <p>Image Provided - Ref: 16_9999</p> |

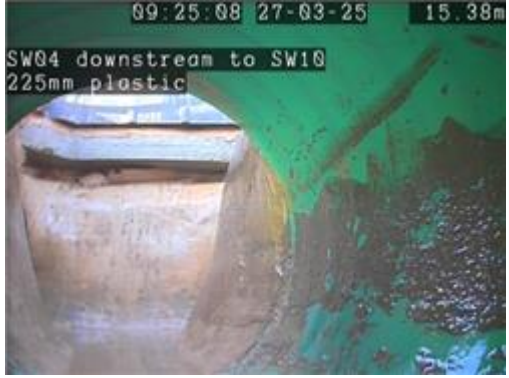
| Pos | Video Ref | Code | Description | Image |
|---|---|---|---|---|
| 15.38m | | MHF | Finish node type, manhole SW10 | <p>Image Provided - Ref: 17_9999</p> |

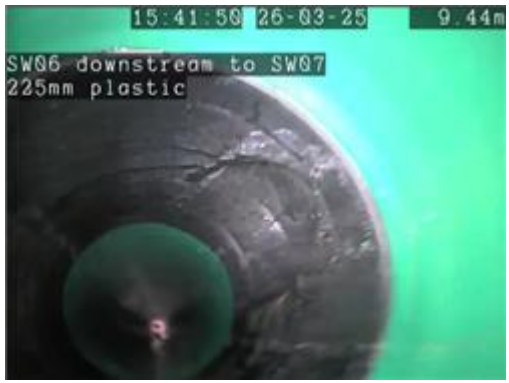
| Pos | Video Ref | Code | Description | Image |
|---|---|---|---|---|
| 09.44m | 0:00:39 | JN | Junction at 02 o'clock: 150mm Diameter | <p>Image Provided - Ref: 19_2</p> |

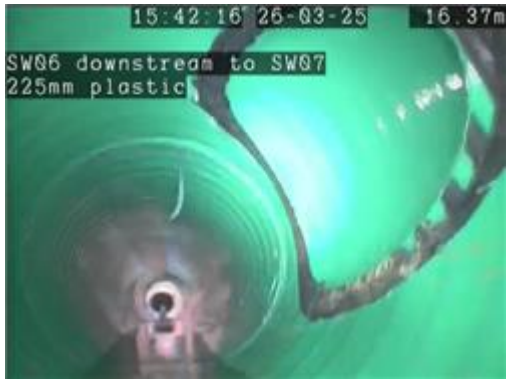
| Pos | Video Ref | Code | Description | Image |
|---|---|---|---|---|
| 16.37m | 0:01:05 | JN | Junction at 02 o'clock: 150mm Diameter | <p>Image Provided - Ref: 19_3</p> |

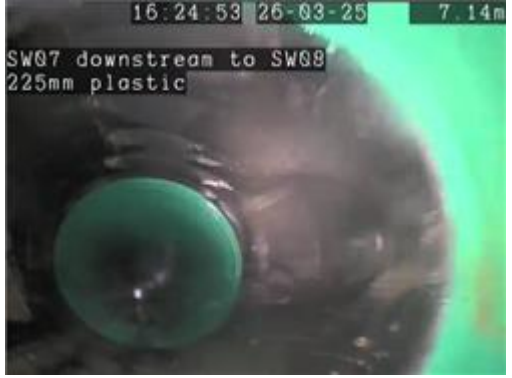
| Pos | Video Ref | Code | Description | Image |
|---|---|---|---|---|
| 07.14m | 0:00:30 | JN | Junction at 03 o'clock: 150mm Diameter | <p>Image Provided - Ref: 20_2</p> |

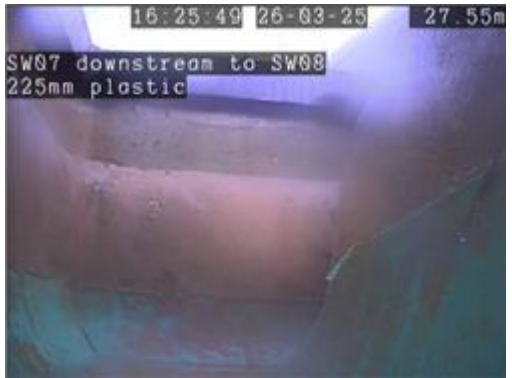
| Pos | Video Ref | Code | Description | Image |
|---|---|---|---|---|
| 27.55m | | MHF | Finish node type, manhole SW08 | <p>Image Provided - Ref: 20_9999</p> |

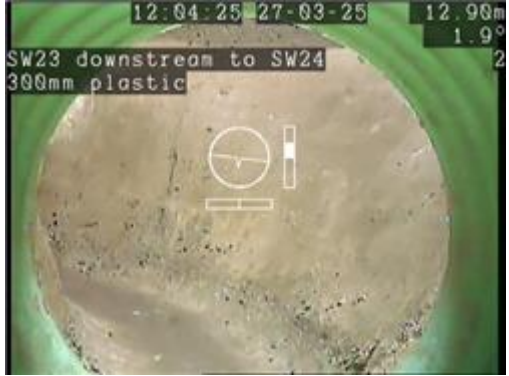
| Pos | Video Ref | Code | Description | Image |
|---|---|---|---|---|
| 12.90m | | MHF | Finish node type, manhole SW24 | <p>Image Provided - Ref: 42_9999</p> |

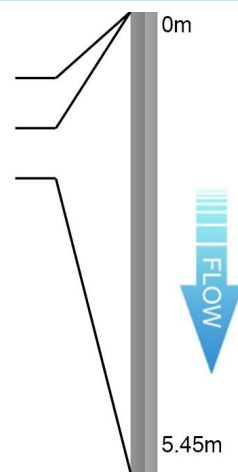
| Position | Code | Description | CD | Pic | Video Ref | |
|---|---|---|---|---|---|--|
| 05.45m | MHF | Finish node type, manhole | | 43_9 | | |

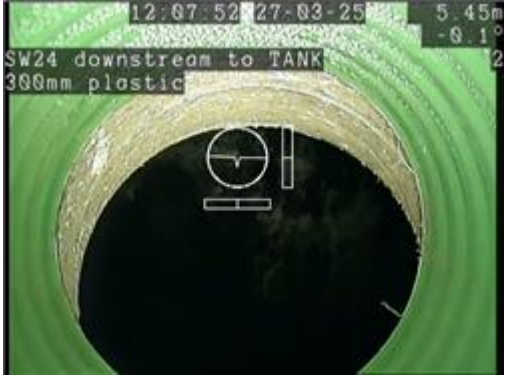
| Pos | Video Ref | Code | Description | Image |
|---|---|---|---|---|
| 05.45m | | MHF | Finish node type, manhole TANK | <p>Image Provided - Ref: 43_9999</p> |
