| <b>Project:</b> | William Kay House, The University of Manchester | |
| <b>WML reference number:</b> | 12023R-WML-XX-ZZ-RP-S-5001 | 17 <sup>th</sup> February 2025 |

| <b>Survey Brief:</b> | Structural condition survey in advance of proposed refurbishment project |

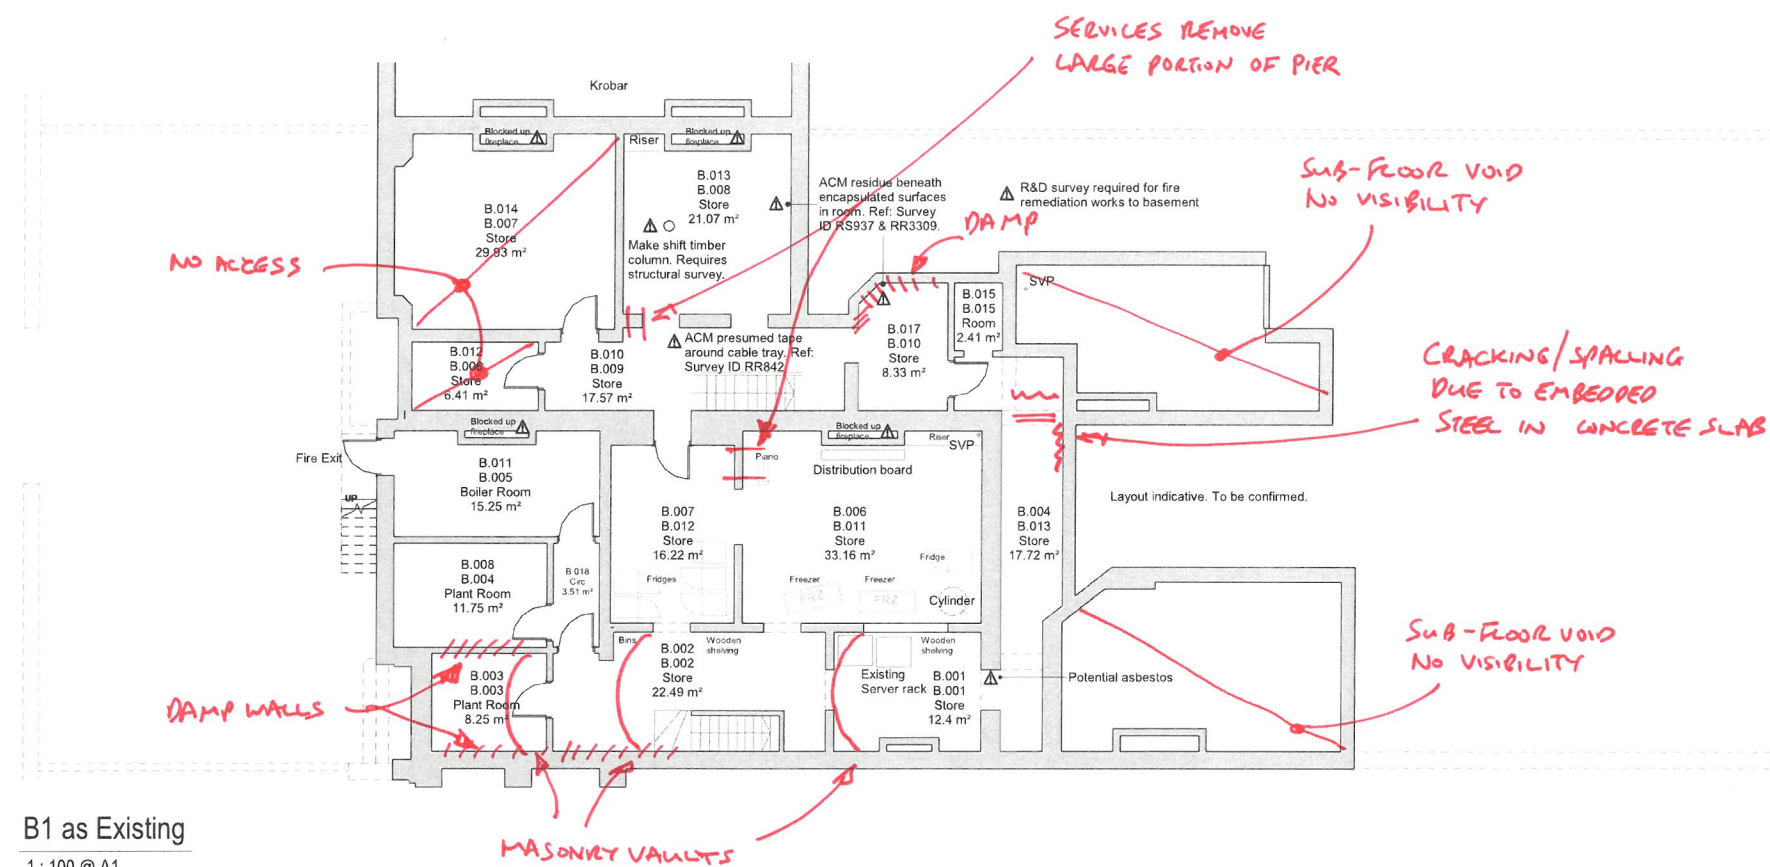
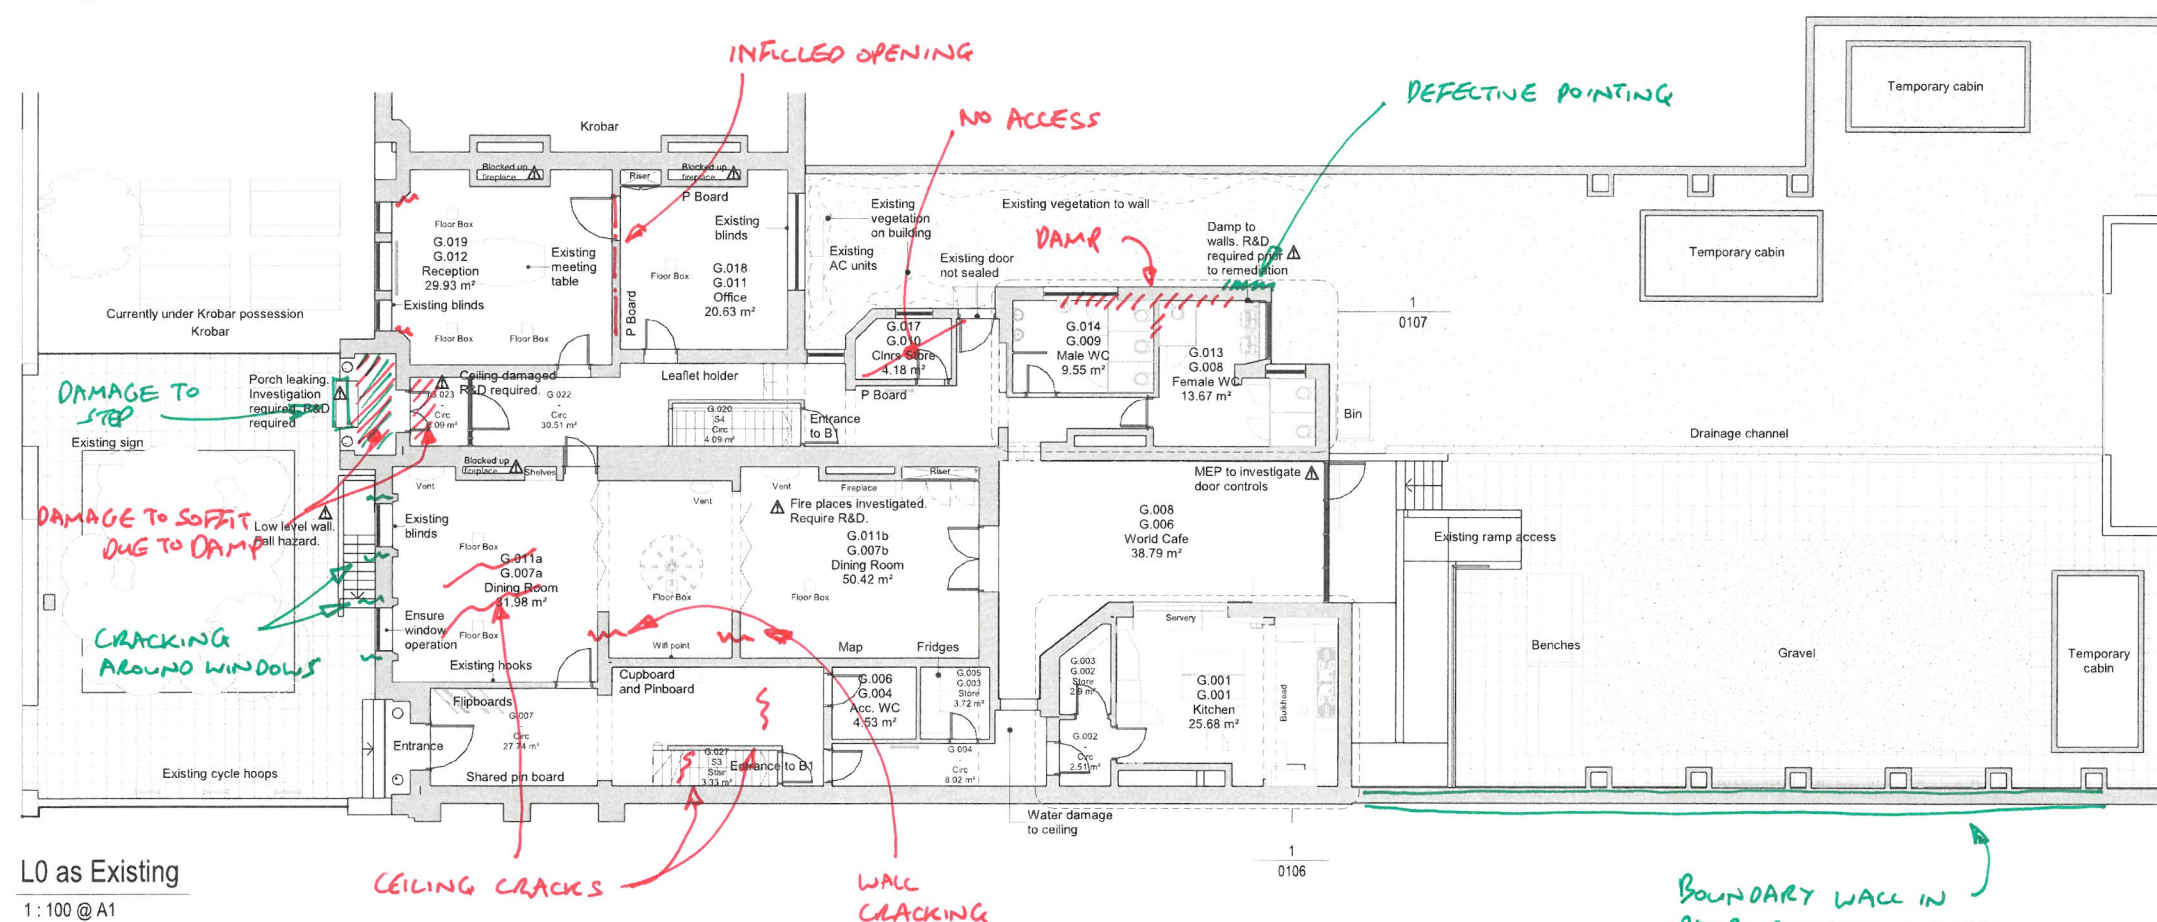
- A timber column has been installed in the basement room B.013/B.008. The column is formed from a pair of timbers bolted together and appears to be an engineered solution (photo 17). The purpose of the column is not clear as the location does not appear to align with any structure above.

- Current proposals for the basement do not require the timber post to be removed. The post appears to be in good condition and as such it is suggested that it should remain.
