**Trial Holes Undertaken 08<sup>th</sup> May 2024**

**The Brunswick  
97 Piccadilly  
Manchester  
M1 2DB**

**TRUST PUBS**

**Document Ref: EQ92-HV-XX-XX-RP-S-0003**

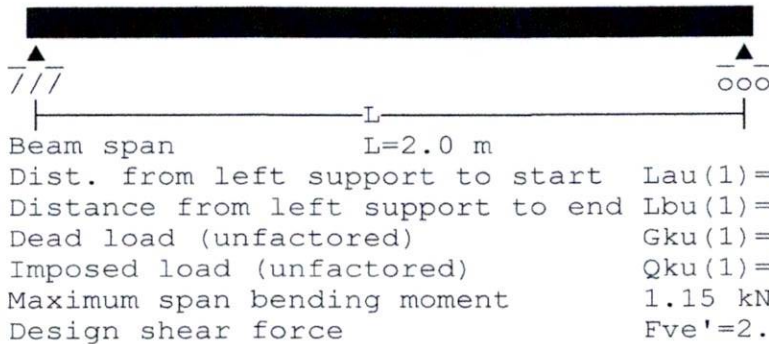
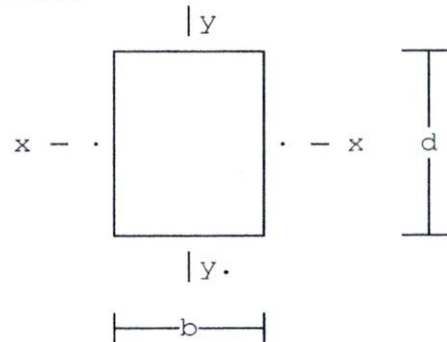
Location: Area 2 over Kitchen Store

Design axial load (+ve compress)  $F_a=0.5$  kN  
 Depth of section  $d=150$  mm  
 Width of section  $b=75$  mm  
 Eff length for bending about xx  $L_{ex}=2000$  mm  
 Eff length for bending about yy  $L_{ey}=1000$  mm  
 Length of bearing  $l_b=75$  mm  
 From BS5268-2 Table 18, bearing is  $< 75$  mm from joist end.  
 Bearing Modification factor  $K_4=1.0$   
 Strength class C16 to Table 8  
 Timber service class adopted  $tmclass=2$   
 Timber service class modification factor  $K_2=1$  as Table 16.  
 Duration of loading  $K_3=1$   
 Depth factor  $K_7=(300/d)^{0.11}=1.0792$   
 Load-sharing modification factor  $K_8=1.1$   
 Modification factor  $K_{12}=(0.5+(1+\eta)*C/2)-((0.5+(1+\eta)*C/2)^2-C)^{0.5}=0.75531$   
 No notches exist at the support  $K_5=1.0$   
 Interaction factor  $factor=\sigma/(\sigma_{ad}*bsmf)+\sigma_{ca}/\sigma_{cad}=0.65895$

Member: 150 mm x 75 mm  
Strength class C16 to Table 8  
Moisture service class 2  
Bending stress 4.0889 N/mm<sup>2</sup>  
Permissible bending 6.2919 N/mm<sup>2</sup>  
Comp Stress @ Mids. 0.044444 N/mm<sup>2</sup>  
Permiss compression 5.6498 N/mm<sup>2</sup>  
Interaction factor 0.65895  
Deflection 4.255 mm  
Limiting deflection 6 mm  
Shear stress 0.30667 N/mm<sup>2</sup>  
Permissible shear 0.737 N/mm<sup>2</sup>  
Bearing stress 0.40889 N/mm<sup>2</sup>  
Permissible bearing 2.42 N/mm<sup>2</sup>

- 5.2.1. **Area over Cellar, Area 1** – Complete replacement of floor
- 5.2.2. **Area over Kitchen Stoor, Area 2** – Floor to be retained, however allow a provisional sum for some strengthen / making good works in this area.

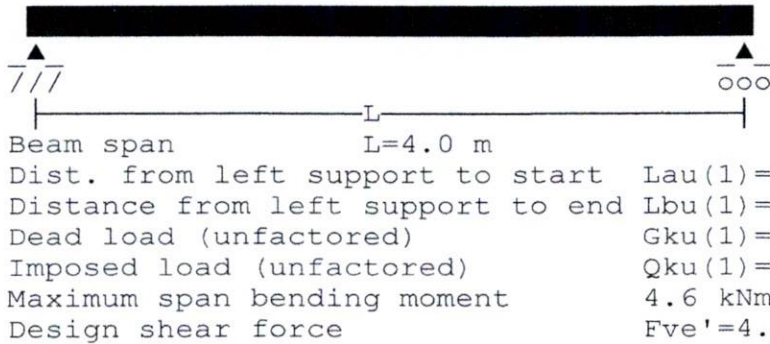
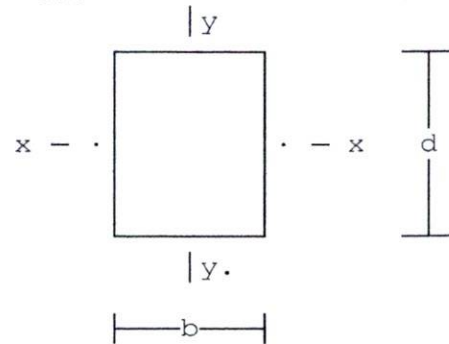
Location: New Timber Section over Cellar

Design axial load (+ve compress)  $Fa=0.5$  kN  
Depth of section  $d=250$  mm  
Width of section  $b=75$  mm  
Eff length for bending about xx  $L_{ex}=4000$  mm  
Eff length for bending about yy  $L_{ey}=600$  mm  
Length of bearing  $l_b=75$  mm  
From BS5268-2 Table 18, bearing is  $< 75$  mm from joist end.  
Bearing Modification factor  $K4=1.0$   
Strength class C24 to Table 8  
Timber service class adopted  $tmclass=2$   
Timber service class modification factor  $K2=1$  as Table 16.  
Duration of loading  $K3=1$   
Depth factor  $K7=(300/d)^{0.11}=1.0203$   
Load-sharing modification factor  $K8=1.1$   
Modification factor  $K12=(0.5+(1+\eta)*C/2)-((0.5+(1+\eta)*C/2)^2-C)^{0.5}=0.69854$   
No notches exist at the support  $K5=1.0$   
Interaction factor  $factor=\sigma/(\sigma_{ad}*bsmf)+\sigma_{ca}/\sigma_{cad}=0.70477$

Member: 250 mm x 75 mm  
Strength class C24 to Table 8  
Moisture service class 2  
Bending stress 5.888 N/mm<sup>2</sup>  
Permissible bending 8.4171 N/mm<sup>2</sup>  
Comp Stress @ Mids. 0.026667 N/mm<sup>2</sup>  
Permiss compression 6.0703 N/mm<sup>2</sup>  
Interaction factor 0.70477  
Deflection 11.558 mm  
Limiting deflection 12 mm  
Shear stress 0.368 N/mm<sup>2</sup>  
Permissible shear 0.781 N/mm<sup>2</sup>  
Bearing stress 0.81778 N/mm<sup>2</sup>  
Permissible bearing 2.64 N/mm<sup>2</sup>

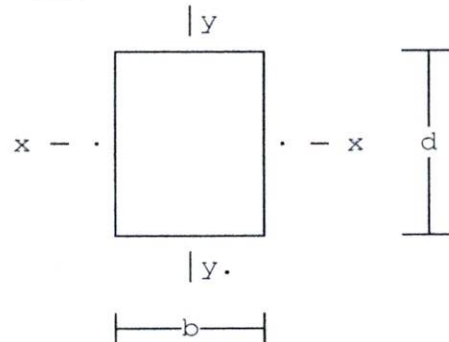
Location: New Timber over hallway

Member: 200 mm x 75 mm  
Strength class C24 to Table 8  
Moisture service class 2  
Bending stress 5.3 N/mm<sup>2</sup>  
Permissible bending 8.6263 N/mm<sup>2</sup>  
Comp Stress @ Mids. 0.033333 N/mm<sup>2</sup>  
Permiss compression 7.196 N/mm<sup>2</sup>  
Interaction factor 0.61946  
Deflection 3.191 mm  
Limiting deflection 6 mm  
Shear stress 0.38 N/mm<sup>2</sup>  
Permissible shear 0.781 N/mm<sup>2</sup>  
Bearing stress 0.67556 N/mm<sup>2</sup>  
Permissible bearing 2.64 N/mm<sup>2</sup>

- 5.2.3. **Area over Halfway, Area 3, and Area and Rear of Bar, Area 4** - Complete replacement of floor. Also note that this will require the removal and reinstatement of the bar.
