# structural planning report

Rylands Building, Manchester  
CD9 Properties (Manchester) Limited

Project Title: Rylands Building, Manchester  
Client: CD9 Properties (Manchester) Limited  
Project No: 196002

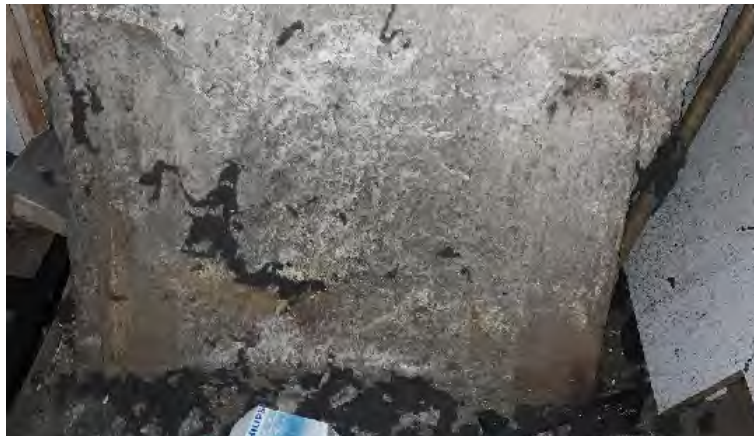
Figure 1: Gusset Plate - Basement

At basement level, a number of columns are noted to have flared bases and heads in perpendicular directions. The last line of columns with flared bases appears to be along the perimeter of the initial construction phase, noted as Section 1 on the original planning drawings. It is thought that these columns may be providing lateral stability in the temporary state of the building being constructed. It is known from degraded columns at basement level that the flared bases encompass gusset plates. The gusset plate measured at basement level, shown in Figure 1, was approximately 110 mm in width.

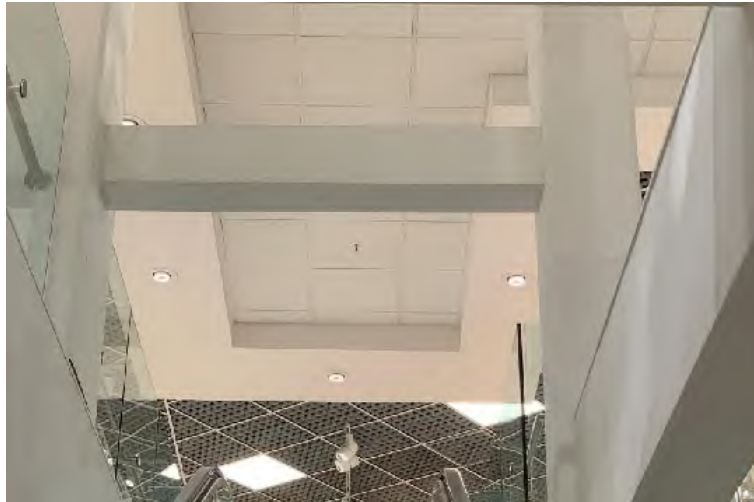
Figure 2: Escalators - Third Floor

A structural intervention by Debenhams around 1977 saw additional holes cut through the floor plates to make way for escalators. To introduce the escalators, an additional column was introduced which passes through the centre of the escalators. This column appears to be from basement through third, though it is not mapped on the survey drawings. The column is restrained at every floor level parallel to the escalators but is only restrained at third floor and ground floor level perpendicular to this. The perpendicular restraint is shown in Figure 2 and Figure 3.
