## Hammerstone Road Depot, Manchester

# Discharge of Planning Condition 11

**Curtins Ref: HRD-CUR-00-XX-T-RE-006**

**Project****Project Name:** Adana Hammerstone Rd Goreton Manchester projects**Project Description:** WinCan Import in Miraculix Standard**Project Date:** 17/10/2023**Inspection Standard:** MSCC5 Sewers & Drainage GB (SRM5 Scoring)

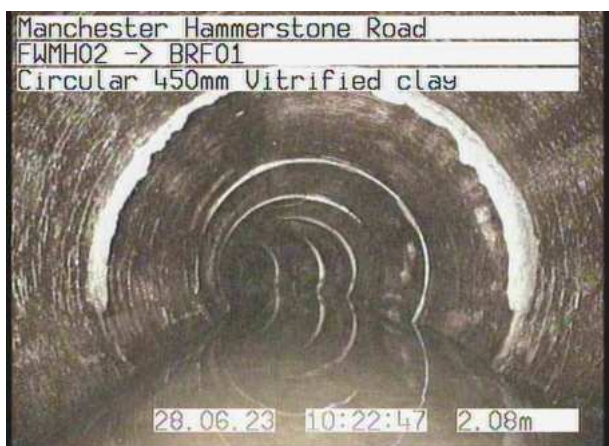
FWMH02X\_a7ce946b-a5c9-424a-86eb-51f0a8fcff04\_20230628\_102921\_045.jpg, 00:00:59, 2.08 m  
Attached deposits, encrustation at joint from 8 o'clock to 4 o'clock, 10% cross-sectional area loss

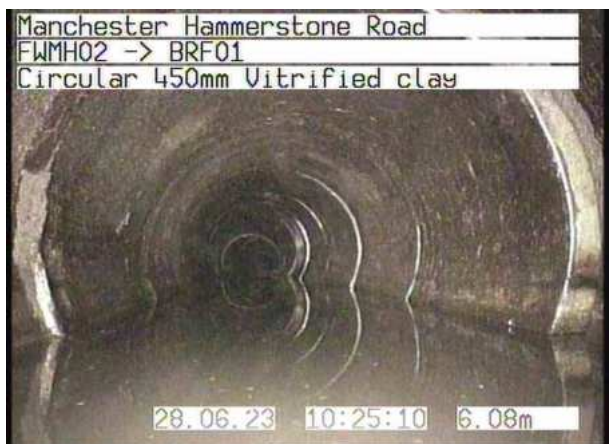
| Scale: 1:135 | Position [m] | Code | Observation | MPEG | Photo | Grade |
|---|---|---|---|---|---|---|
| | 6.09 | B | Broken pipe at 9 o'clock | 00:03:27 | FWMH02X_843432e1-3587-4e | 4 |

FWMH02X\_843432e1-3587-4ec5-aad0-246872d8816d\_2023  
0704\_092046\_828.jpg, 00:03:27, 6.09 m  
Broken pipe at 9 o'clock

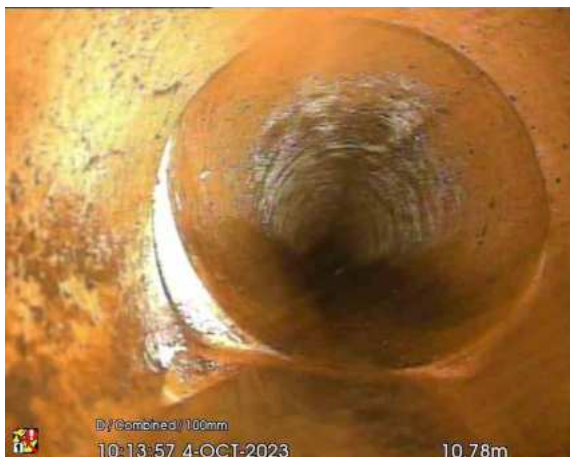
MH24 DS\_10-78m\_101357.jpg, 00:00:41, 10.78 m  
Joint displaced, medium

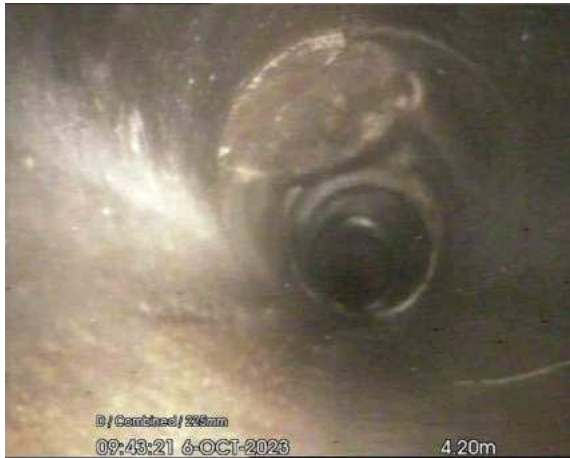
| Scale: | 1:93 | Position [m] | Code | Observation | MPEG | Photo | Grade |
|---|---|---|---|---|---|---|---|
| | | | H | Hole in drain or sewer from 9 o'clock to 2 o'clock: POOR REPAIR | 00:00:22 | MH C1 DS_4-20m_094321.j | |

MH C1 DS\_4-20m\_094321.jpg, 00:00:22, 4.20 m  
Hole in drain or sewer from 9 o'clock to 2 o'clock, POOR  
REPAIR

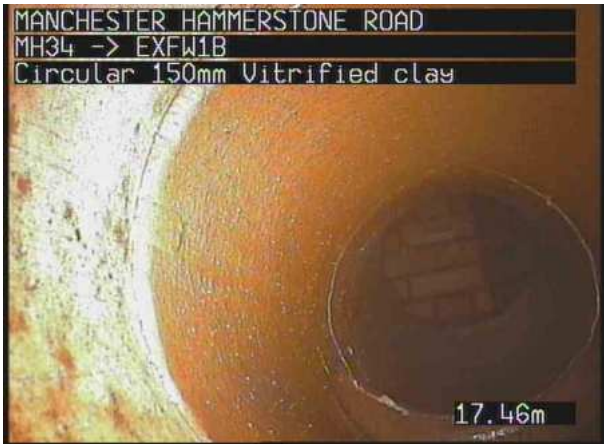
| Code | Observation | MPEG | Photo | Grade |
|---|---|---|---|---|
| FC | Fracture, circumferential from 12 o'clock to 12 o'clock: ON BACKDROP | 00:01:20 | MH34X_0<br>941c1a5-6<br>953-41b3- | 3 / 2 |

MH34X\_0941c1a5-6953-41b3-8a84-c1a6191d4dc4\_2023082  
2\_125832\_514.jpg, 00:01:20, 17.46 m  
Fracture, circumferential from 12 o'clock to 12 o'clock, ON  
BACKDROP

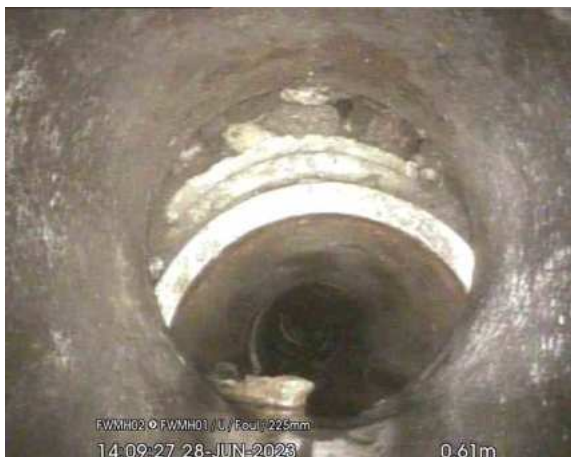
FWMH02 US FWMH01\_0-61m\_140927.jpg, 00:00:15, 0.61 m  
Joint displaced, large

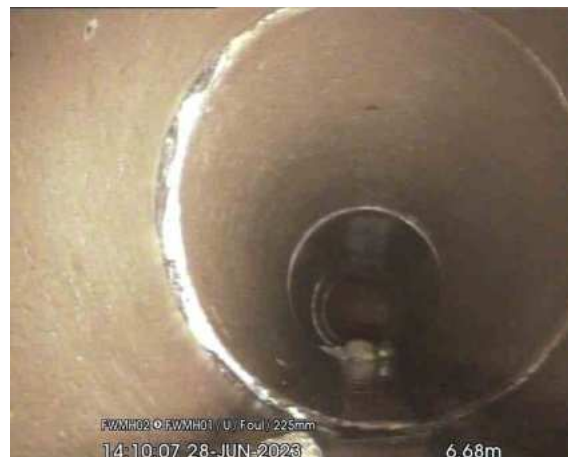
FWMH01X\_fca69c75-ec5f-4891-b983-80ffa3de1089\_20230704\_091625\_459.jpg, 00:00:43, 6.68 m  
Settled deposits, coarse, 5% cross-sectional area loss

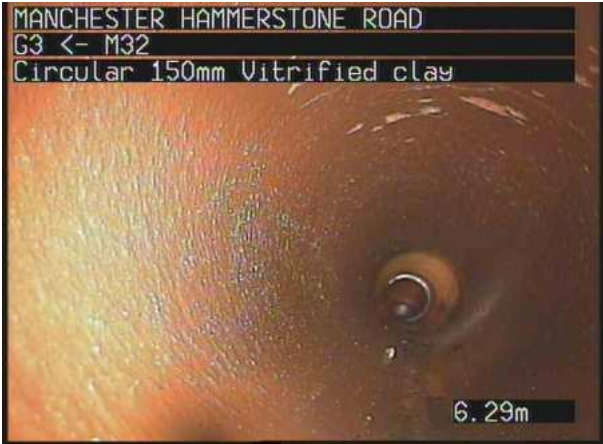
G3X\_0aa1f7fa-6cd4-4596-b480-e012c28a25d0\_20230822\_14  
5216\_936.jpg, 00:00:42, 6.29 m  
Surface damage, spalling from 10 o'clock to 2 o'clock

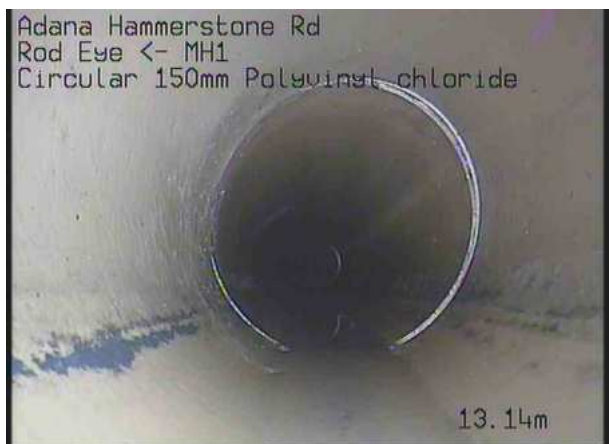
Rod  
EyeX\_89df72d6-3b80-41c3-8f57-19804605fbd5\_20231002\_1  
10348\_578.jpg, 00:01:22, 13.14 m  
Deformed sewer or drain, 30%

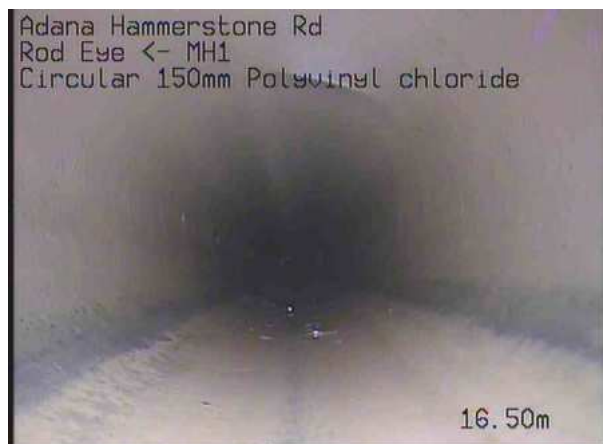
Rod  
EyeX\_ccd54a6e-8f3a-4a5b-afef-6d8136f2e6f5\_20231002\_110  
406\_458.jpg, 00:01:41, 16.50 m  
Deformed sewer or drain, 5%

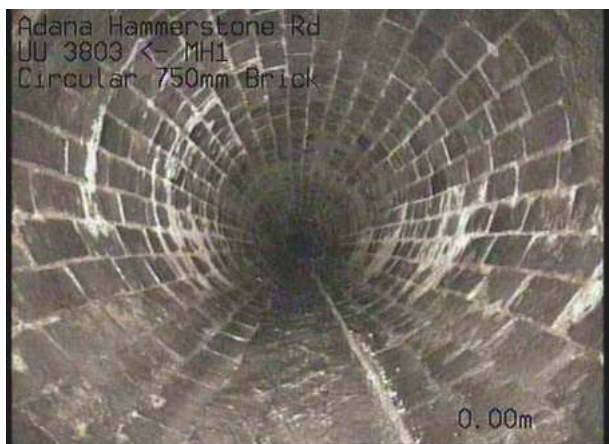
UU  
3803X\_7c4fe95a-6172-400c-8e55-e9b46b12f59b\_20230929\_110556\_997.jpg, 00:00:17, 0.00 m  
General remark, rope running along invert

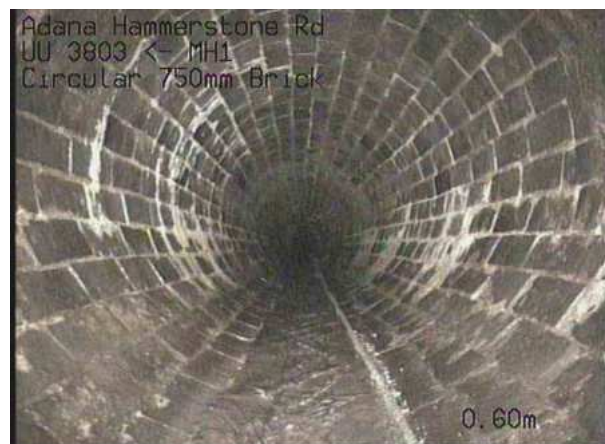
UU  
3803X\_eca04b50-e131-4dfe-8786-ba9a1bf9edd0\_20230929\_110618\_260.jpg, 00:00:38, 0.60 m  
Attached deposits, encrustation from 7 o'clock to 5 o'clock, 5% cross-sectional area loss, start, Patchy

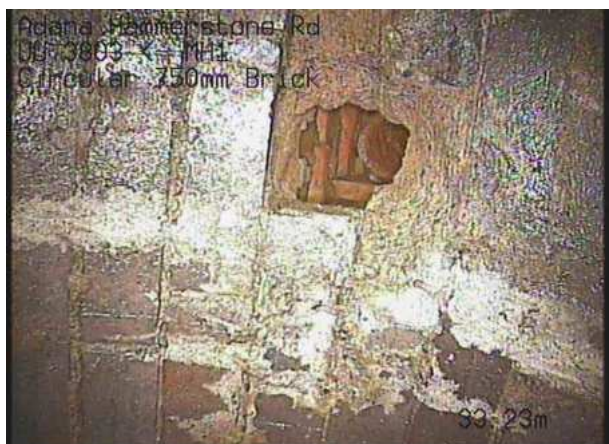
3803X\_eff886a3-9245-4379-9a54-673bd7d69ebb\_20230929\_110956\_482.jpg, 00:04:17, 33.23 m

Connection defective, connecting pipe is damaged at 12 o'clock, 150mm dia, saddle to main missing

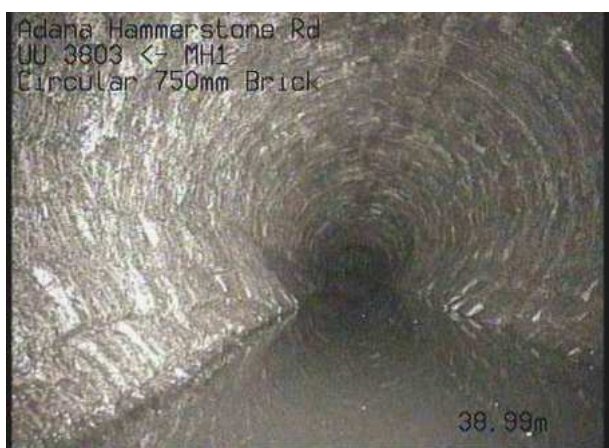
3803X\_99a6e569-ced3-4896-b8c2-f3ac361cc375\_20230929\_111207\_657.jpg, 00:06:28, 38.99 m

Attached deposits, encrustation from 7 o'clock to 5 o'clock, 10% cross-sectional area loss, change, Patchy

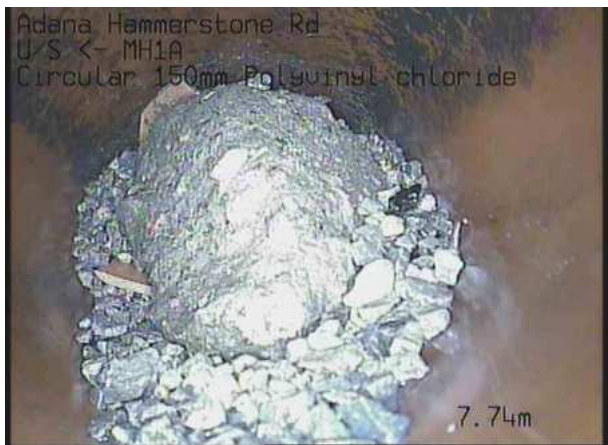
U\_SX\_551ced77-9085-490f-9a3d-03c1825fe094\_20231002\_1  
11536\_088.jpg, 00:01:23, 7.74 m

Collapsed drain or sewer, 95% cross-sectional area loss

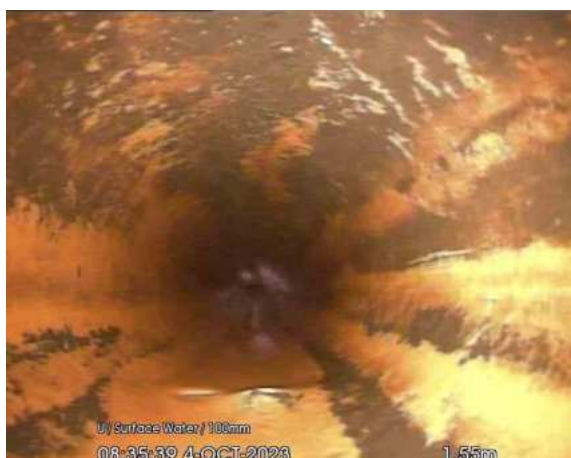
MH3 US RWP\_1-55m\_083539.jpg, 00:00:12, 1.55 m  
Deformed sewer or drain, 15%

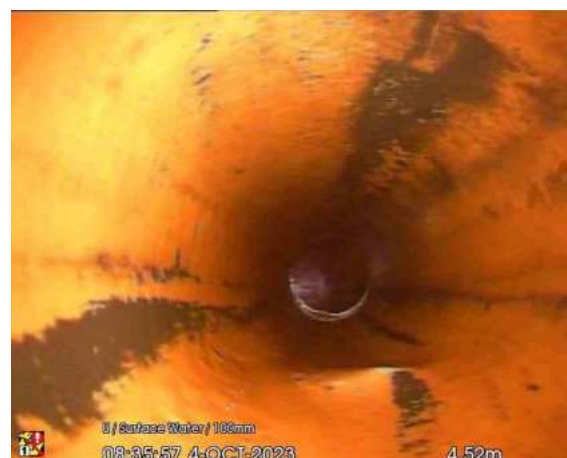
MH3 US RWP\_4-52m\_083557.jpg, 00:00:25, 4.52 m  
Deformed sewer or drain, 10%

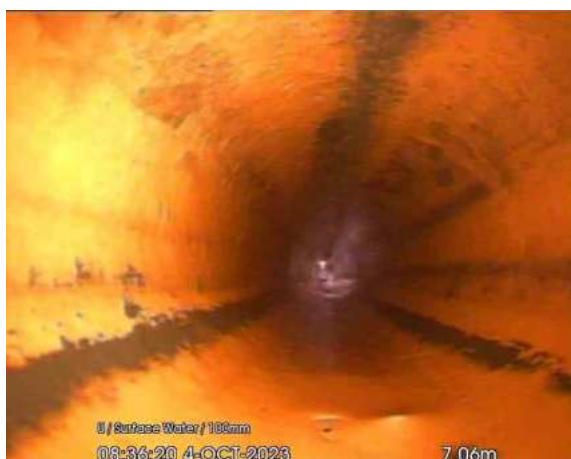
MH3 US RWP\_7-06m\_083620.jpg, 00:00:39, 7.06 m  
Deformed sewer or drain, 10%

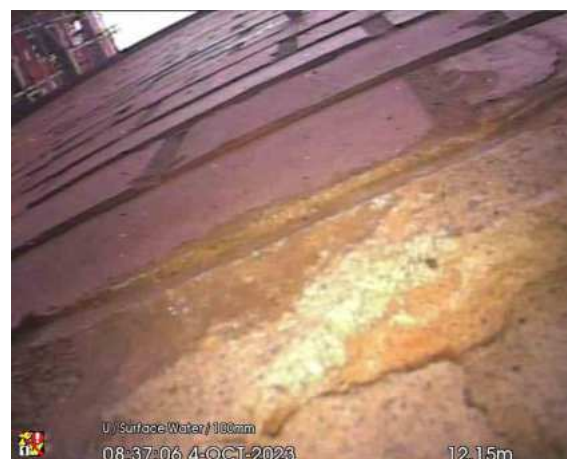
MH3 US RWP\_12-15m\_083706.jpg, 00:01:02, 12.15 m  
Survey abandoned, RWP MISSING OFF WALL

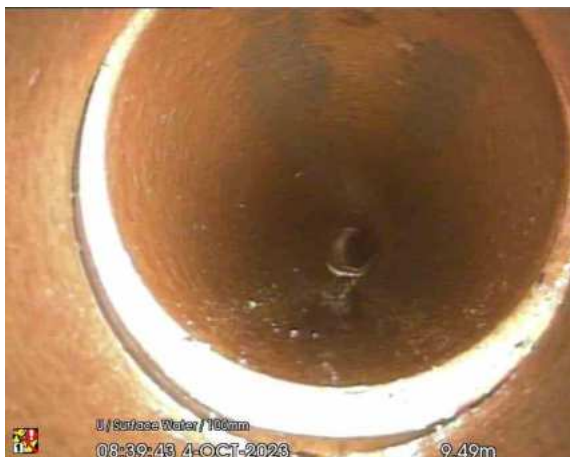
MH3 US ACO\_9-49m\_083943.jpg, 00:00:41, 9.49 m  
Joint displaced, medium

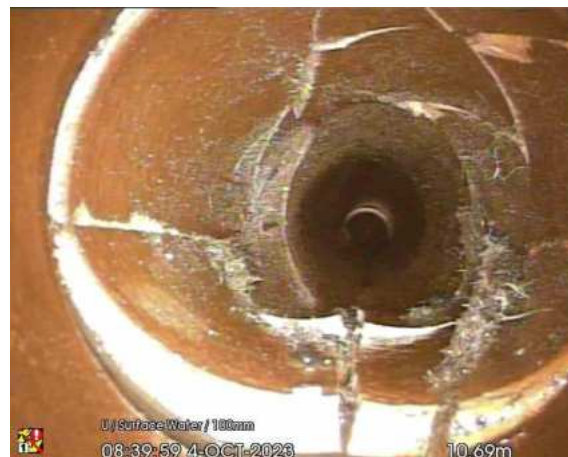
MH3 US ACO\_10-69m\_083959.jpg, 00:00:48, 10.69 m  
Fractures, multiple at 12 o'clock

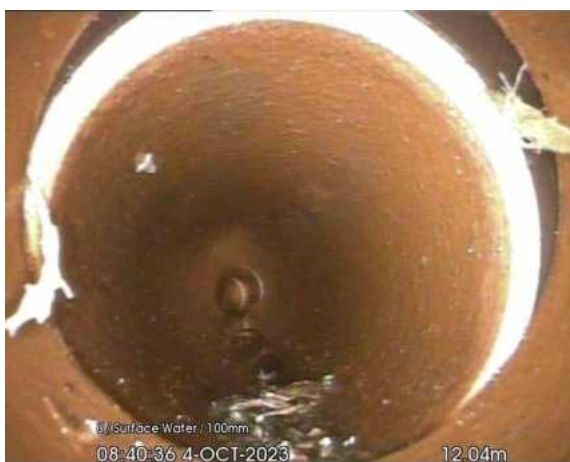
MH3 US ACO\_12-04m\_084036.jpg, 00:01:08, 12.04 m  
Joint displaced, large

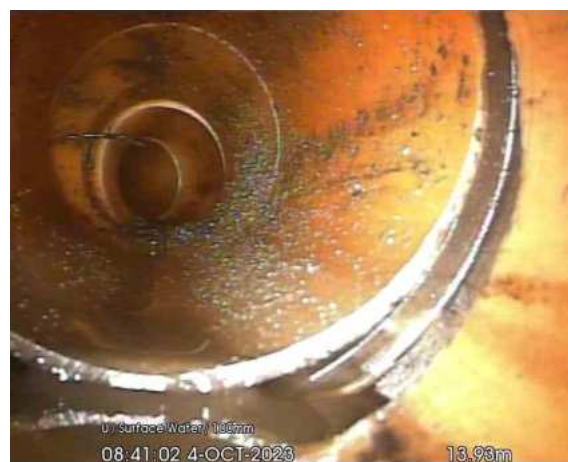
MH3 US ACO\_13-93m\_084102.jpg, 00:01:23, 13.93 m  
Joint displaced, large

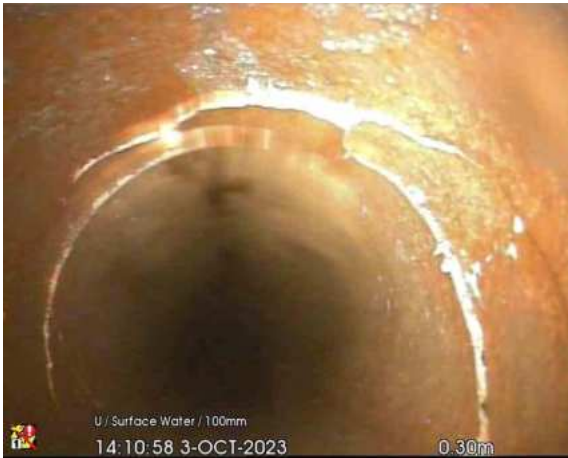
MH4 US GULLY\_0-30m\_141058.jpg, 00:00:04, 0.30 m  
Fractures, multiple at joint from 8 o'clock to 5 o'clock

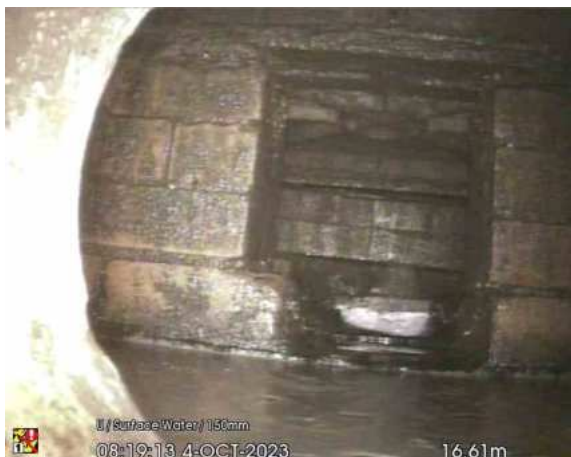
MH4A US INTERCEPTOR MH\_16-61m\_081913.jpg, 00:01:02,  
16.61 m

Finish node, other special chamber, reference:  
INTERCEPTOR MH, INT MH WASH DOWN AREA

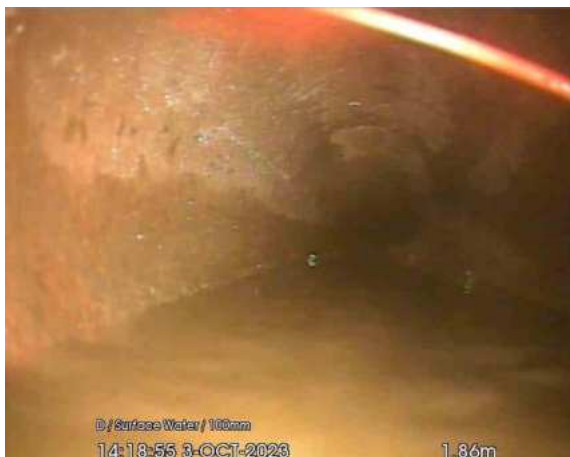
MH4A DS MH5\_1-88m\_141855.jpg, 00:00:11, 1.88 m  
Other obstacles at joint from 10 o'clock to 3 o'clock, 5% cross-sectional area loss, PLASTIC

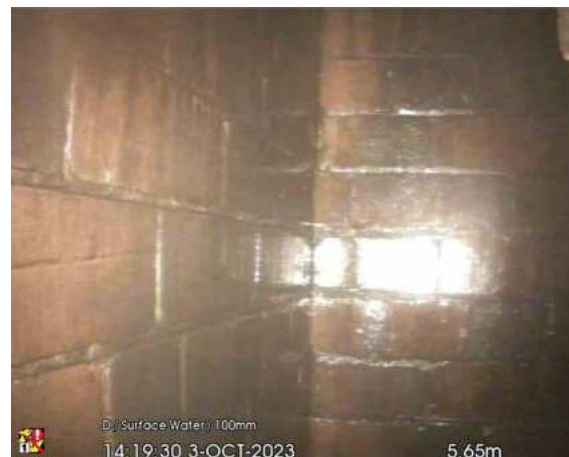
MH4A DS MH5\_5-65m\_141930.jpg, 00:00:33, 5.65 m  
Finish node, manhole, reference: MH5, CULVERT MH

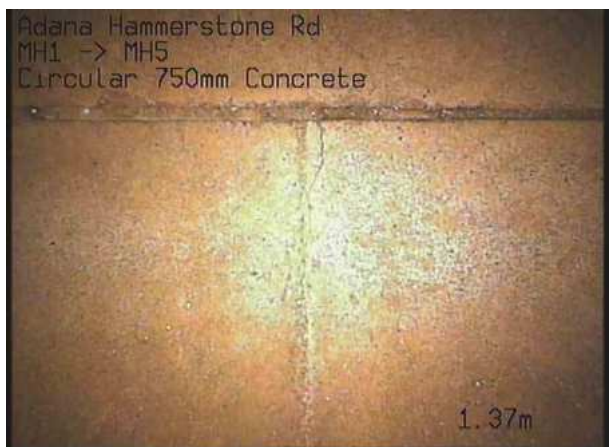
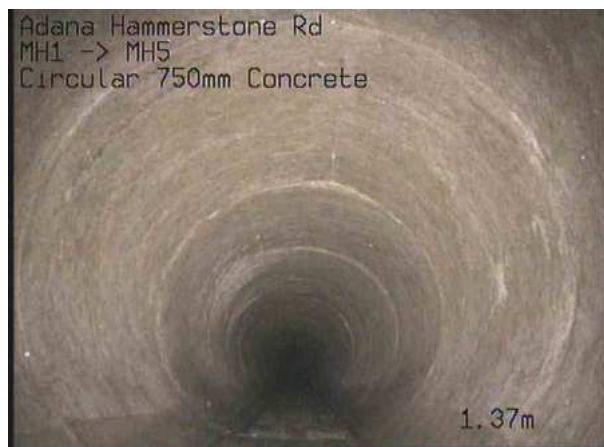
| Scale: | 1:219 | Position [m] | Code | Observation | MPEG | Photo | Grade | |
|---|---|---|---|---|---|---|---|---|
| | | 1.37 | S01 | FL | Fracture, longitudinal at 12 o'clock, start | 00:00:36 | MH1X_e8<br>ddb24d-3b<br>20-4023-af | |

MH1X\_e8ddb24d-3b20-4023-afa7-0dde4b1c943f\_20230929\_082331\_720.jpg, 00:00:36, 1.37 m  
Fracture, longitudinal at 12 o'clock, start

MH1X\_3c9c27db-fb99-4094-9bf2-97fcb271940e\_20230929\_082340\_048.jpg, 00:00:36, 1.37 m  
Fracture, longitudinal at 12 o'clock, start

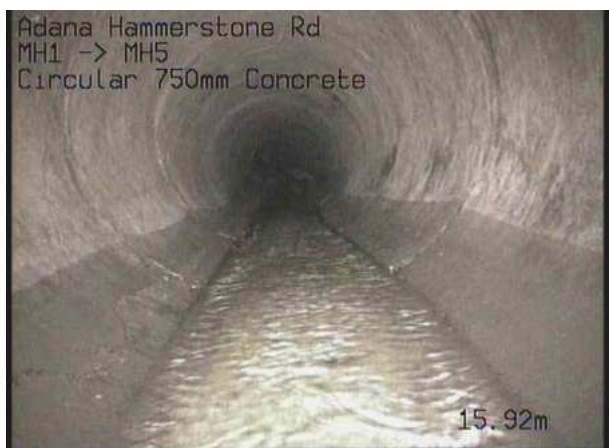
| Scale: | 1:219 | Position [m] | Code | Observation | MPEG | Photo | Grade | |
|---|---|---|---|---|---|---|---|---|
| | | 15.92 | FL | Fracture, longitudinal at 7 o'clock | 00:02:43 | MH1X_57c<br>3ec85-d13<br>d-4d4f-ba5 | 3 / 2 | |

MH1X\_57c3ec85-d13d-4d4f-ba57-254ecc38816c\_20230929\_082539\_013.jpg, 00:02:43, 15.92 m  
Fracture, longitudinal at 7 o'clock

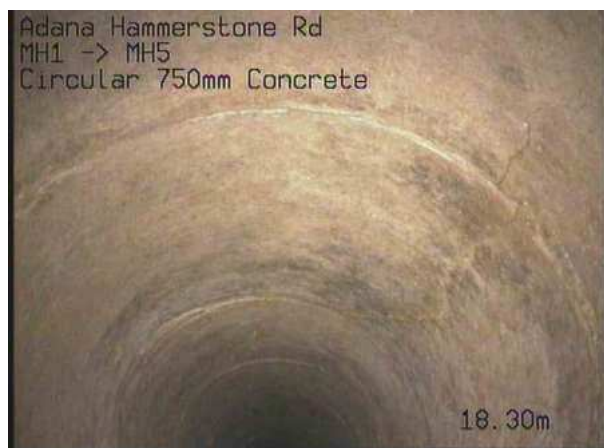
| Scale: | 1:219 | Position [m] | Code | Observation | MPEG | Photo | Grade | |
|---|---|---|---|---|---|---|---|---|
| | | 18.30 | S02 | FL | Fracture, longitudinal at 2 o'clock, start | 00:03:37 | MH1X_c25<br>94daa-fcaf<br>-402d-bd6 | |

MH1X\_c2594daa-fcaf-402d-bd67-0043181de174\_20230929\_082633\_141.jpg, 00:03:37, 18.30 m  
Fracture, longitudinal at 2 o'clock, start

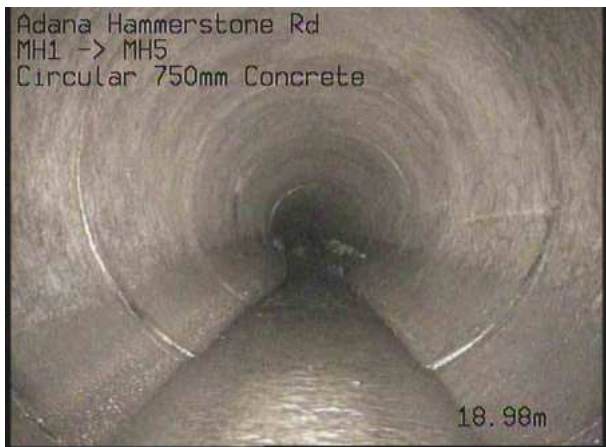
| Scale: | 1:219 | Position [m] | Code | Observation | MPEG | Photo | Grade | |
|---|---|---|---|---|---|---|---|---|
| | | 18.98 | FC | Fracture, circumferential from 3 o'clock to 9 o'clock | 00:04:16 | MH1X_b6f<br>ec33a-22d<br>3-4af2-983 | 3 / 2 | |

MH1X\_b6fec33a-22d3-4af2-9836-bf00c744b5a6\_20230929\_082711\_786.jpg, 00:04:16, 18.98 m  
Fracture, circumferential from 3 o'clock to 9 o'clock

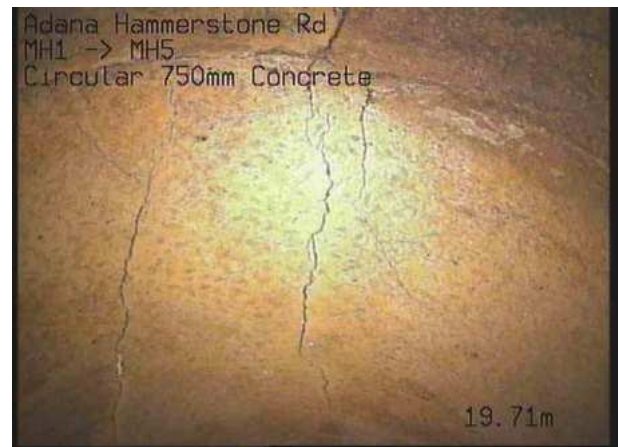
| Scale: | 1:219 | Position [m] | Code | Observation | MPEG | Photo | Grade | |
|---|---|---|---|---|---|---|---|---|
| | | 19.71 | FM | Fractures, multiple from 11 o'clock to 2 o'clock | 00:04:34 | MH1X_56c<br>66650-322<br>1-4101-b6 | 4 / 2 | |

MH1X\_56c66650-3221-4101-b6ba-7d3f042609b4\_20230929\_082729\_854.jpg, 00:04:34, 19.71 m  
Fractures, multiple from 11 o'clock to 2 o'clock

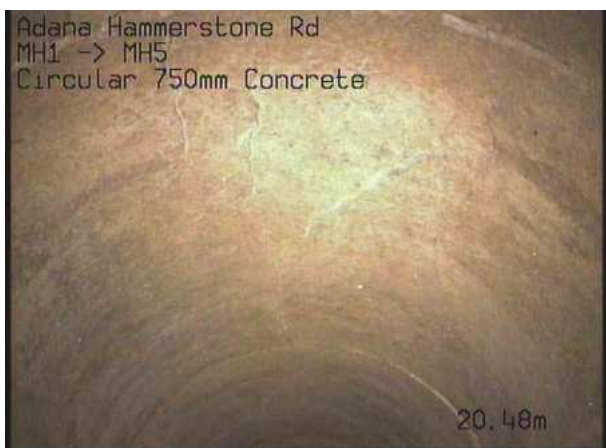
| Scale: | 1:219 | Position [m] | Code | Observation | MPEG | Photo | Grade | |
|---|---|---|---|---|---|---|---|---|
| | | 20.48 | S03 | FM | Fractures, multiple from 12 o'clock to 12 o'clock, start | 00:05:06 | MH1X_e0<br>97ea5e-e3<br>66-4a2c-9 | |

MH1X\_e097ea5e-e366-4a2c-9436-68de88a165e2\_20230929\_082822\_672.jpg, 00:05:06, 20.48 m  
Fractures, multiple from 12 o'clock to 12 o'clock, start

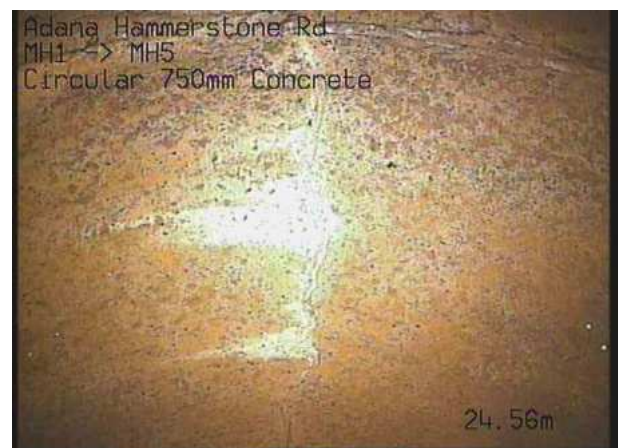
| Scale: | 1:219 | Position [m] | Code | Observation | MPEG | Photo | Grade | |
|---|---|---|---|---|---|---|---|---|
| | | 24.56 | S04 | FL | Fracture, longitudinal at 12 o'clock, start | 00:06:57 | MH1X_3d<br>9dbc05-6e<br>24-48b4-b | |

MH1X\_3d9dbc05-6e24-48b4-bd28-cb39d0947a73\_20230929\_082952\_988.jpg, 00:06:57, 24.56 m  
Fracture, longitudinal at 12 o'clock, start

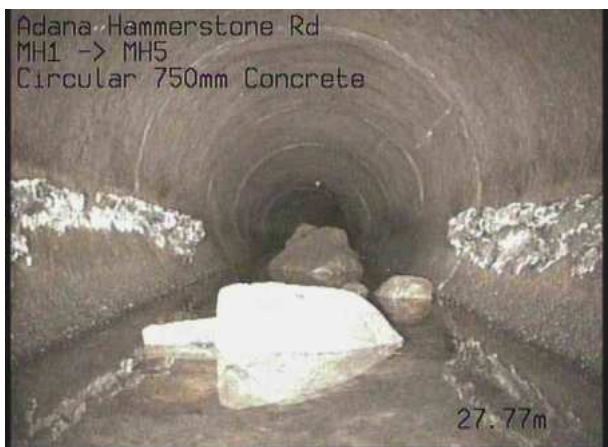
MH1X\_0bc624e5-c3b6-449d-b80d-909b61ccf2e0\_20230929\_083200\_349.jpg, 00:09:04, 27.77 m

Settled deposits, hard or compacted, 40% cross-sectional area loss, Bricks/rubble

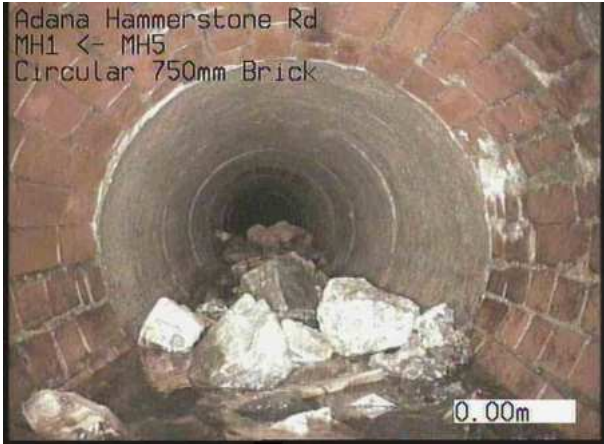
MH1X\_1e4fff8e-f462-4aec-b3d1-adf4e246590f\_20230928\_14  
4150\_540.jpg, 00:01:02, 0.00 m  
Settled deposits, hard or compacted, 40% cross-sectional area  
loss, Rocks & Bricks ahead

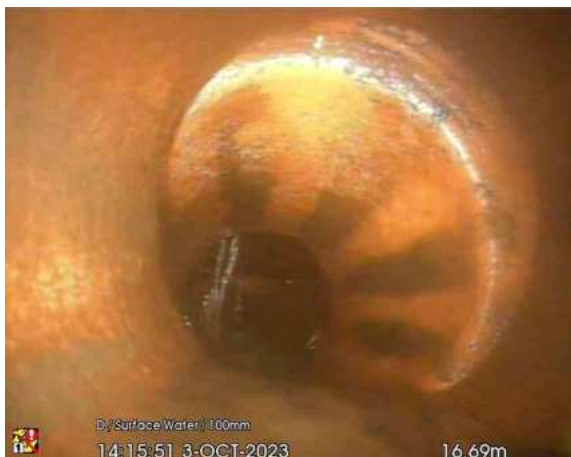
MH4 DS MH5\_16-69m\_141551.jpg, 00:01:10, 16.69 m  
Joint displaced, medium

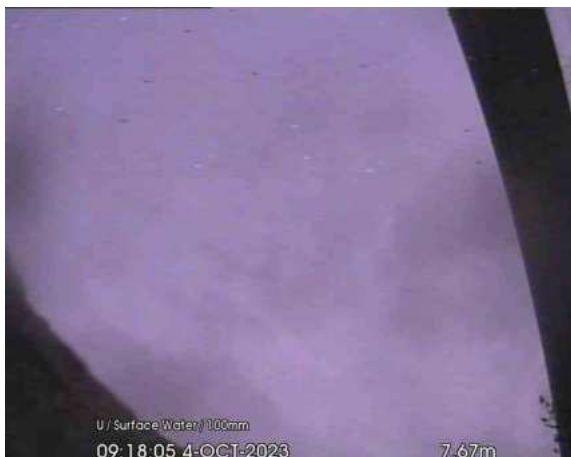
MH16 US ROD EYE\_7-67m\_091805.jpg, 00:00:34, 7.67 m  
Finish node, rodding eye, reference: ROD EYE, NO CAP ON  
RE

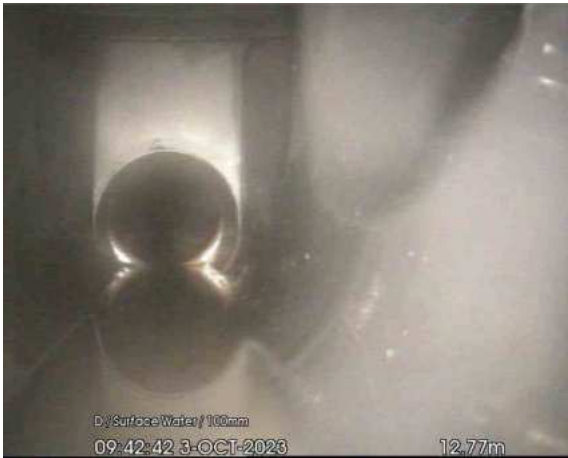
MH17 DS MH18\_12-77m\_094242.jpg, 00:00:47, 12.77 m  
Finish node, inspection chamber, reference: MH18, DIP IN  
CHAMBER

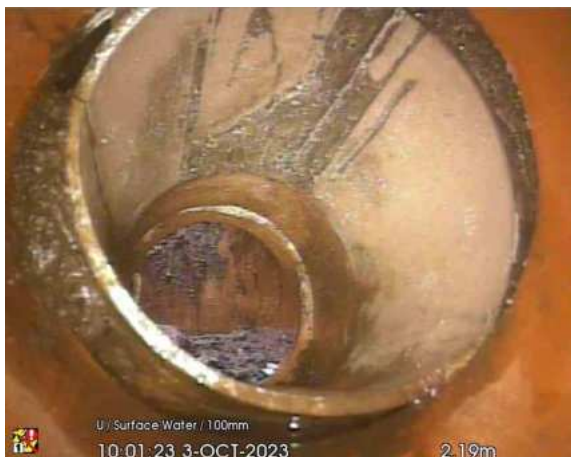
MH18 US GULLY\_2-19m\_100123.jpg, 00:00:14, 2.19 m  
Joint displaced, large

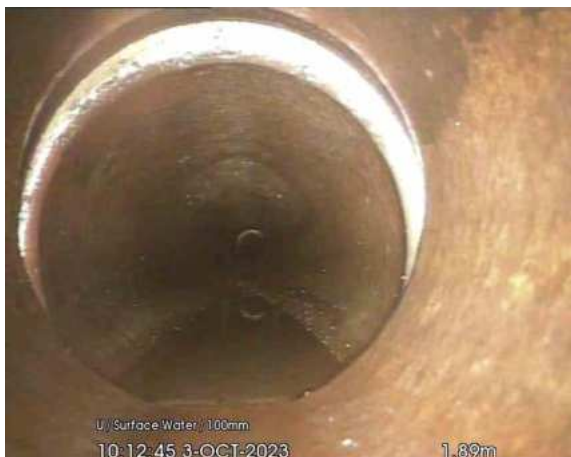
MH19 US GULLY\_1-89m\_101245.jpg, 00:00:16, 1.89 m  
Joint displaced, medium

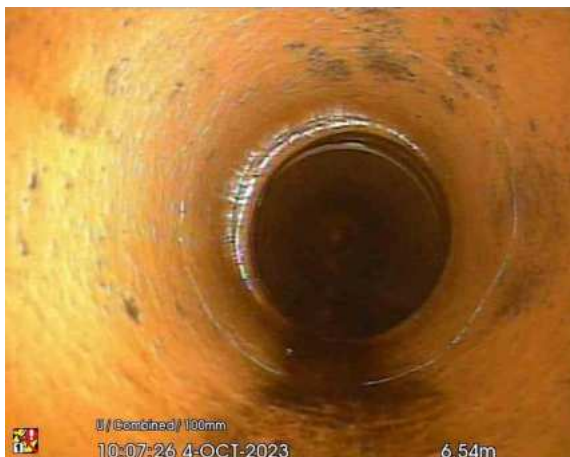
| Scale: | 1:91 | Position [m] | Code | Observation | MPEG | Photo | Grade |
|---|---|---|---|---|---|---|---|
| | | 6.54 | FCJ | Fracture, circumferential at joint at 12 o'clock | 00:00:35 | MH24<br>US_6-54m<br>_100726.j | |

MH24 US\_6-54m\_100726.jpg, 00:00:35, 6.54 m  
Fracture, circumferential at joint at 12 o'clock

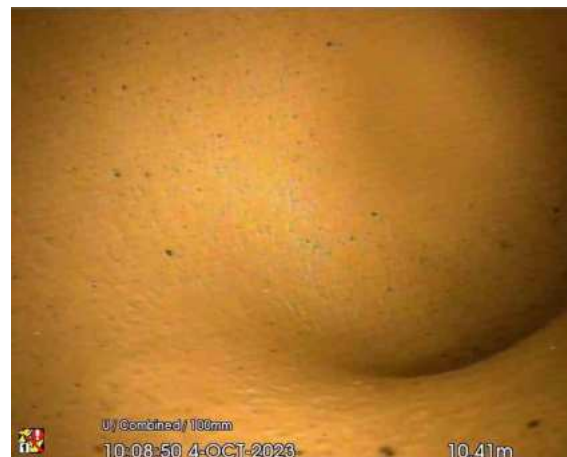
MH24 US\_10-41m\_100850.jpg, 00:01:26, 10.41 m  
Survey abandoned, UNABLE TO PASS BENDS

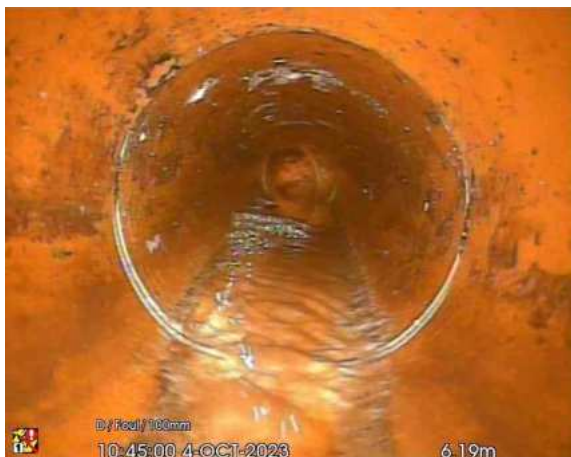
FWIC1 DS MH25\_6-19m\_104500.jpg, 00:00:27, 6.19 m  
Water level, 20% of the vertical dimension, DIP

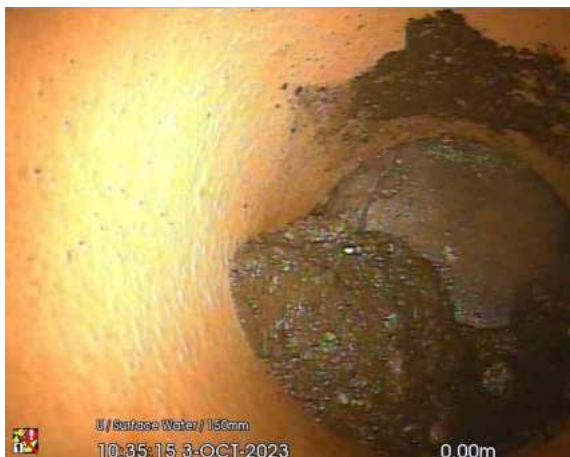
MH26 US\_0-00m\_103515.jpg, 00:00:02, 0.00 m  
General remark, CAPPED

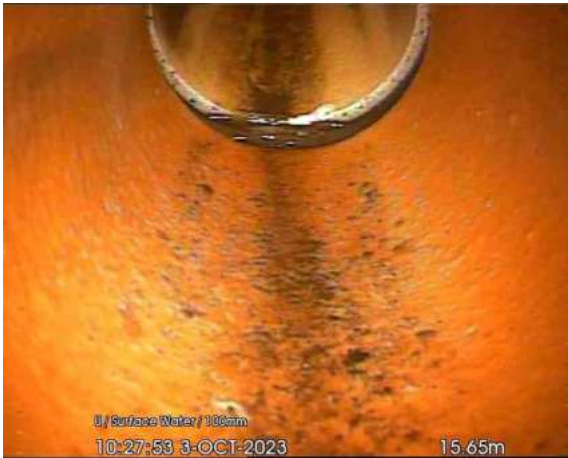
MH28 US RWP B\_15-65m\_102753.jpg, 00:01:41, 15.65 m  
Survey abandoned, RWP B

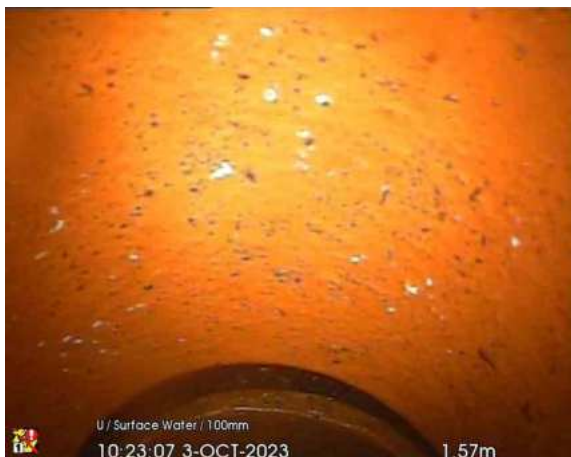
MH28 US RWP A\_1-57m\_102307.jpg, 00:00:32, 1.57 m  
Open joint, medium

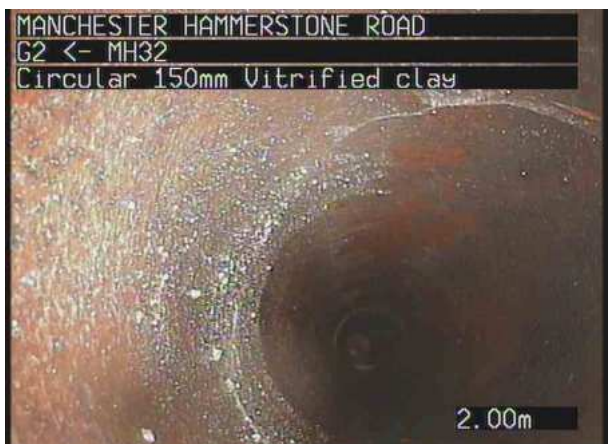
G2X\_d3ff5865-e93a-4ec7-a84c-383277f4871d\_20230822\_14  
4547\_320.jpg, 00:00:26, 2.00 m  
Fracture, circumferential at joint from 12 o'clock to 12 o'clock,  
FROM HOLE

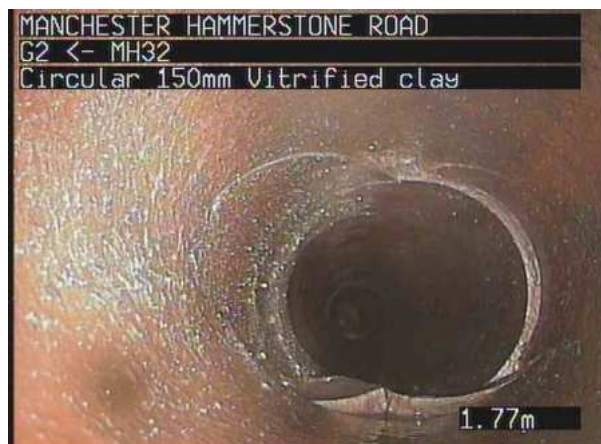
G2X\_2be08d98-3f9c-4bdc-8a9a-d6455144f56f\_20230822\_14  
4653\_113.jpg, 00:01:03, 2.30 m  
Broken pipe from 4 o'clock to 8 o'clock

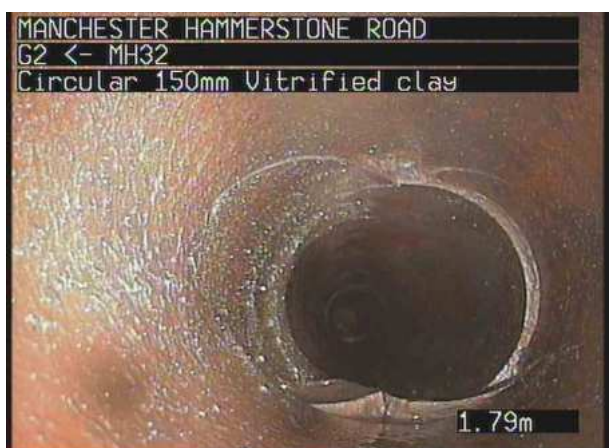
G2X\_747da227-0512-4bbe-84f2-efa2331e3276\_20230822\_14  
4655\_798.jpg, 00:01:08, 2.30 m  
Deformed sewer or drain, 10%

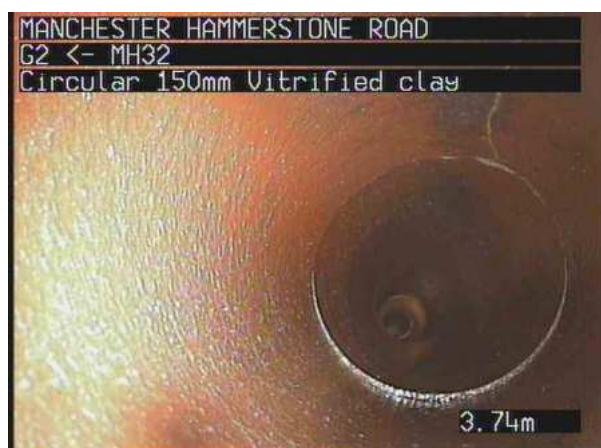
G2X\_ab06da00-461d-487a-9062-864238af2135\_20230822\_1  
44730\_122.jpg, 00:01:49, 3.74 m  
Fracture, longitudinal at joint at 1 o'clock

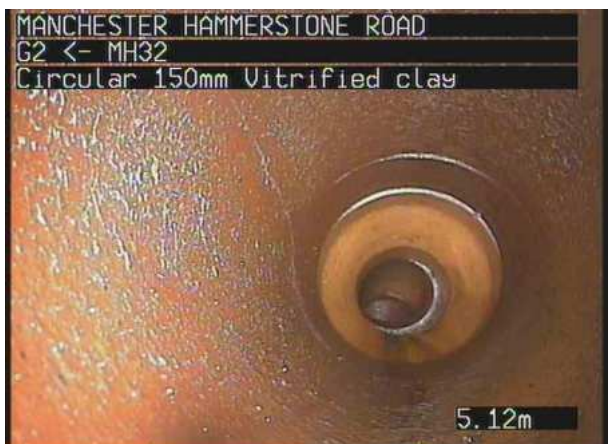
G2X\_7d0afabf-d9d6-4a7d-873b-f683bedce10f\_20230822\_144  
819\_634.jpg, 00:02:07, 5.12 m

Fracture, circumferential from 12 o'clock to 12 o'clock

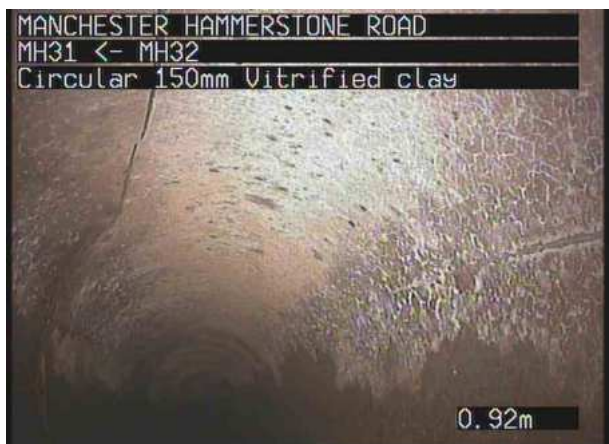
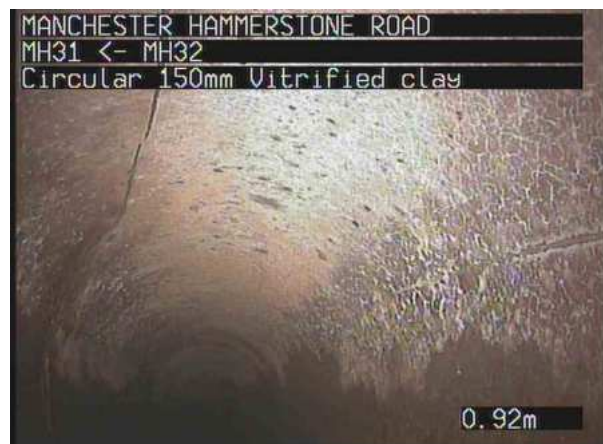
MH31X\_56cae0d2-2bc6-4c28-862c-216765a5cfea\_20230822\_142250\_192.jpg, 00:00:24, 0.90 m  
Fracture, longitudinal at joint at 11 o'clock

MH31X\_a7e1bd3b-4274-4a7a-8eac-753dbce24893\_20230822\_142250\_429.jpg, 00:00:24, 0.90 m  
Fracture, longitudinal at joint at 11 o'clock

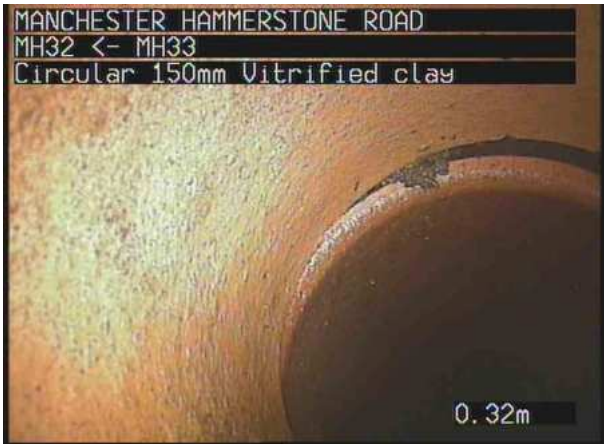
MH32X\_24bb07b8-93c2-4e3b-8492-e88e5f53e045\_20230822  
\_123855\_790.jpg, 00:00:15, 0.30 m  
Joint displaced, large

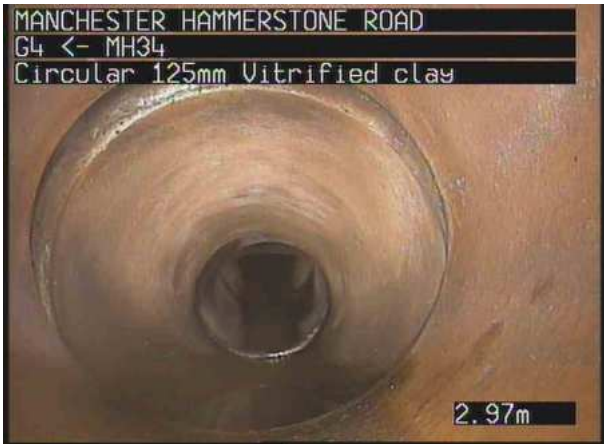
G4X\_9f5969be-001d-4340-b98b-1ba644824653\_20230822\_1  
50615\_700.jpg, 00:00:49, 2.95 m  
Joint displaced, large

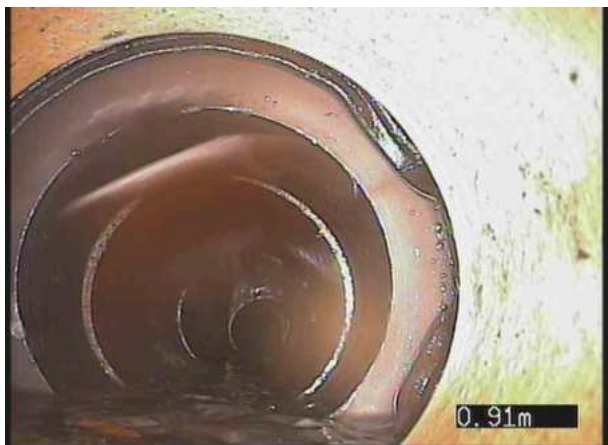
MH37X\_2a16aa07-31ea-4574-9c90-f29b9d278d83\_20230822\_115907\_537.jpg, 00:00:24, 0.91 m

Joint displaced, large, SEALING RING VISIBLE

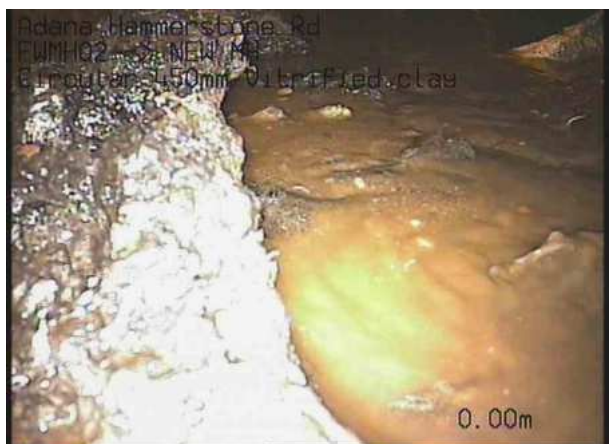
FWMH02X\_db9322b8-9ab3-4d4a-8258-9b1e2f5a8361\_20230929\_124453\_432.jpg, 00:00:00, 0.00 m  
Start node, manhole, reference: FWMH02, Hard standing in MH

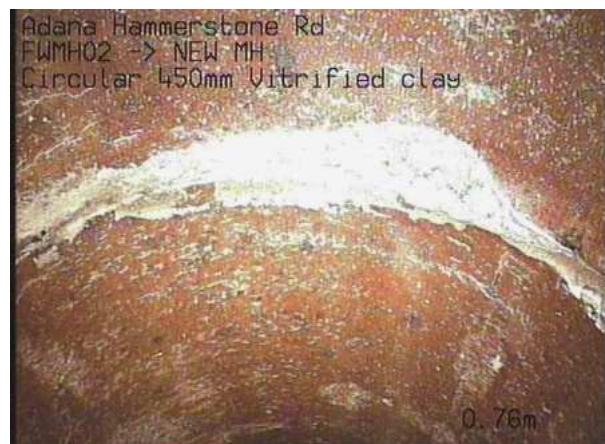
FWMH02X\_d2215c8f-f3bb-4127-9b8e-fde0659868d8\_20230929\_124600\_242.jpg, 00:01:26, 0.76 m  
Attached deposits, encrustation from 7 o'clock to 5 o'clock, 5% cross-sectional area loss, start

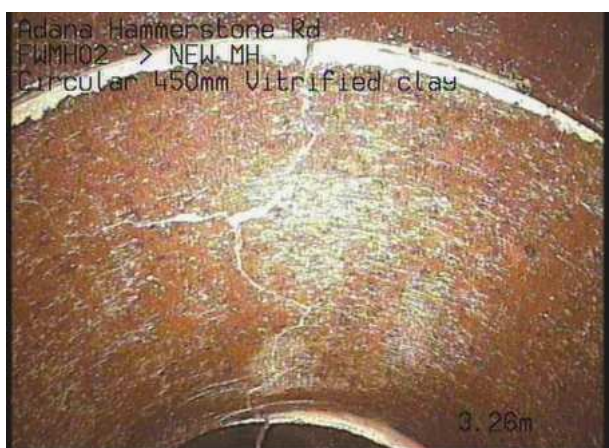
| Scale: 1:147 | Position [m] | Code | Observation | MPEG | Photo | Grade |
|---|---|---|---|---|---|---|
| | 3.26 | S02 | FL Fracture, longitudinal at 12 o'clock, start | 00:02:12 | FWMH02X_d67fa18a-261f-42cc | |

FWMH02X\_d67fa18a-261f-42cc-b472-823572ada9df\_20230929\_124648\_735.jpg, 00:02:12, 3.26 m  
Fracture, longitudinal at 12 o'clock, start

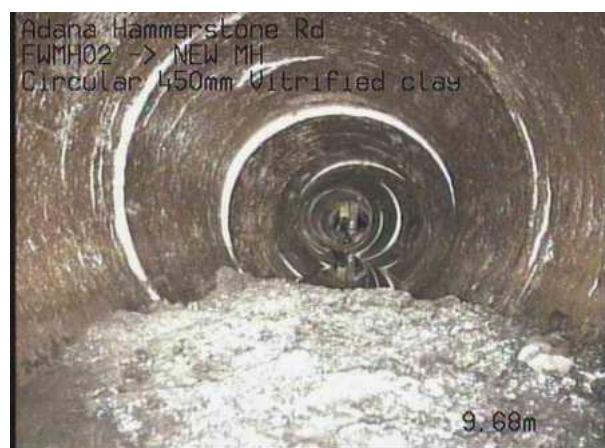
FWMH02X\_22d30264-c456-4ae7-aeda-8c7f10495bb9\_20230929\_124915\_902.jpg, 00:04:32, 9.68 m  
Settled deposits, hard or compacted, 30% cross-sectional area loss, Concrete

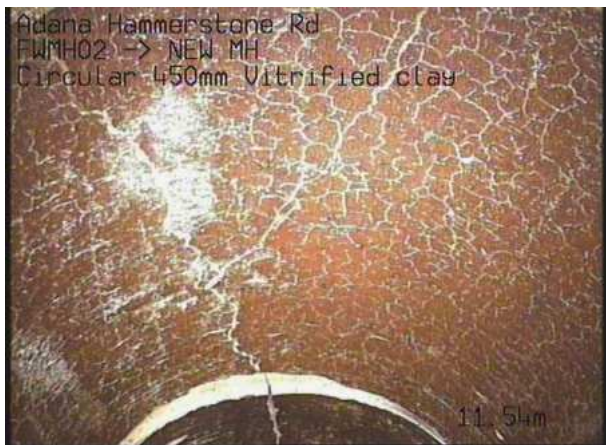
| Scale: 1:147 | Position [m] | Code | Observation | MPEG | Photo | Grade |
|---|---|---|---|---|---|---|
| | 11.54 | S03 | FL Fracture, longitudinal at 12 o'clock, start | 00:05:27 | FWMH02X_633f7784-7216-437 | |

FWMH02X\_633f7784-7216-4371-80bf-317db178d39e\_20230929\_125002\_555.jpg, 00:05:27, 11.54 m  
Fracture, longitudinal at 12 o'clock, start

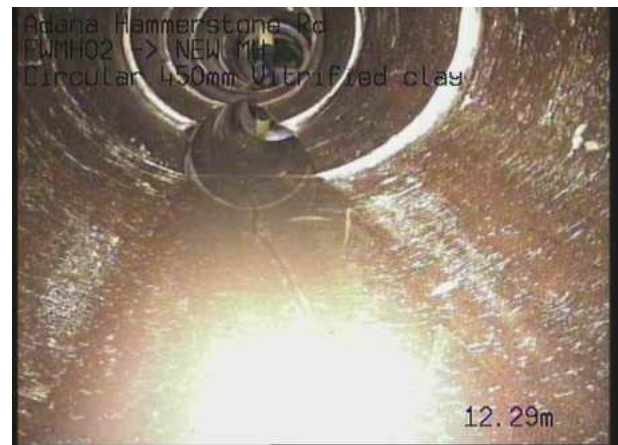
| Scale: 1:147 | Position [m] | Code | Observation | MPEG | Photo | Grade |
|---|---|---|---|---|---|---|
| | 12.29 | FL | Fracture, longitudinal at 6 o'clock | 00:06:02 | FWMH02X_f3b58675-fd07-4717 | 3 / 2 |

FWMH02X\_f3b58675-fd07-4717-8b15-d7f2aa510cb6\_20230929\_125036\_729.jpg, 00:06:02, 12.29 m  
Fracture, longitudinal at 6 o'clock

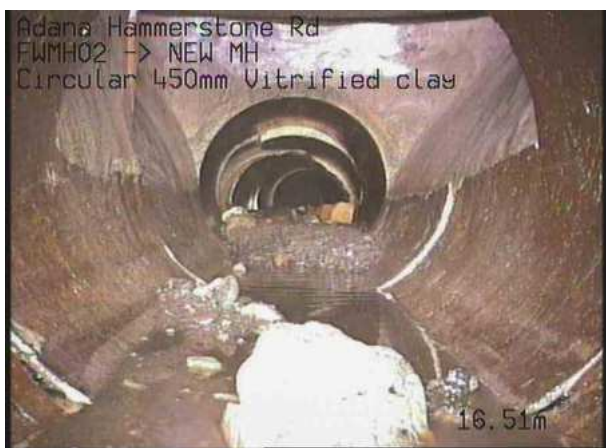
FWMH02X\_88bea82c-ac8f-4bd6-ad0a-3f201e129369\_20230929\_125210\_984.jpg, 00:07:37, 16.51 m  
Other obstacles, brick or masonry in invert at joint from 5 o'clock to 6 o'clock, 10% cross-sectional area loss

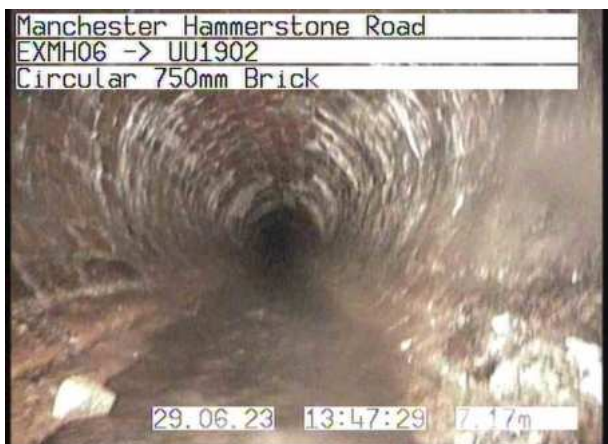
EXMH06X\_eed5b47b-ed46-48a0-857e-6e44c42f80e7\_20230704\_092341\_194.jpg, 00:00:36, 7.27 m  
Settled deposits, coarse, 5% cross-sectional area loss

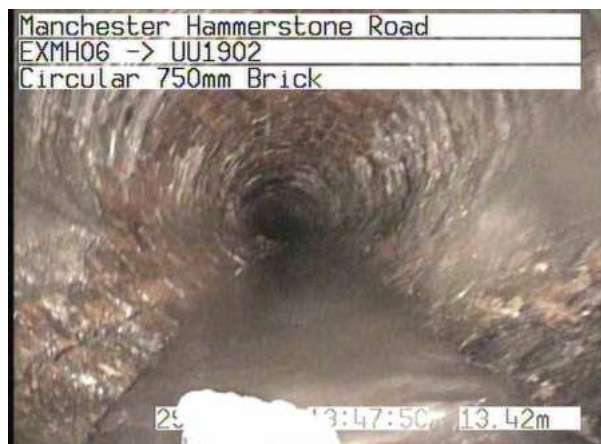
EXMH06X\_a55d7d83-2f42-41d3-88d7-abd184265b1f\_20230704\_092346\_033.jpg, 00:00:56, 13.44 m  
Settled deposits, coarse, 5% cross-sectional area loss

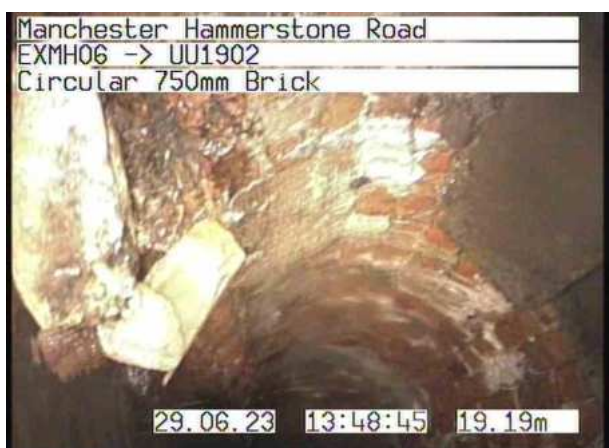
EXMH06X\_1122bd28-ce2d-4a72-aa66-86907662bf99\_20230704\_092352\_690.jpg, 00:01:51, 19.18 m  
Other obstacles, brick or masonry in invert from 7 o'clock to 8 o'clock, 15% cross-sectional area loss, Unable to jet due to bricks catching encrustation

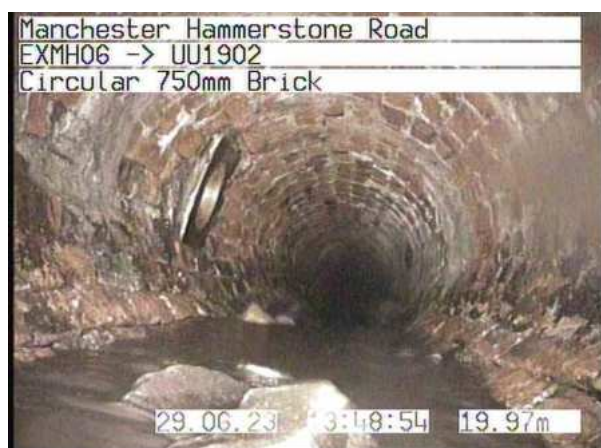
EXMH06X\_061fc6ce-03c3-4108-b9bc-a6451c6e9e0e\_20230704\_092358\_690.jpg, 00:02:00, 20.02 m  
Other obstacles, brick or masonry in invert at 6 o'clock, 10% cross-sectional area loss

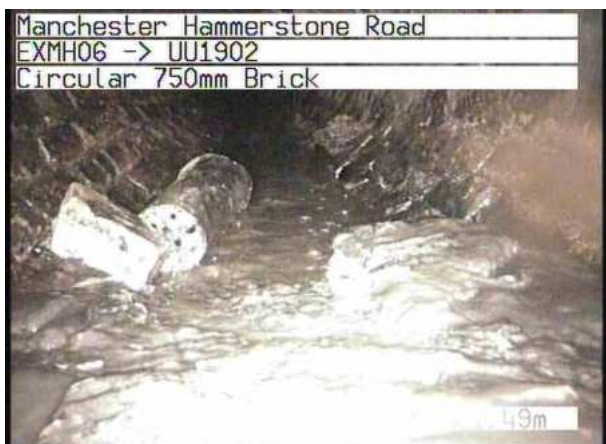
EXMH06X\_705dcd75-53f9-4874-8eb6-03ca64d7bcdd\_20230704\_092405\_783.jpg, 00:02:25, 21.52 m  
Attached deposits, encrustation from 5 o'clock to 7 o'clock, 15% cross-sectional area loss, Bricks are catching on this whilst jetting, unable to remove

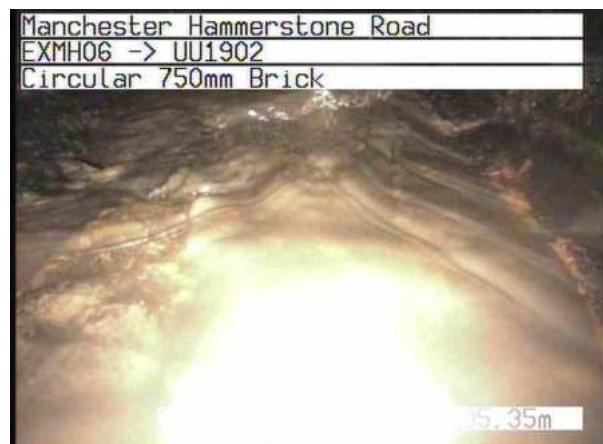
| Scale: 1:527 | Position [m] | Code | Observation | MPEG | Photo | Grade |
|---|---|---|---|---|---|---|
| | 35.12 | DH | Deformed horizontally, 5%: Bricks moved causing an improper flow | 00:04:43 | EXMH06X<br>_db1f7b05<br>-343a-492 | 2 / 2 |

EXMH06X\_db1f7b05-343a-4923-9bc0-7baf1208481a\_20230704\_092412\_620.jpg, 00:04:43, 35.12 m  
Deformed horizontally, 5%, Bricks moved causing an improper flow

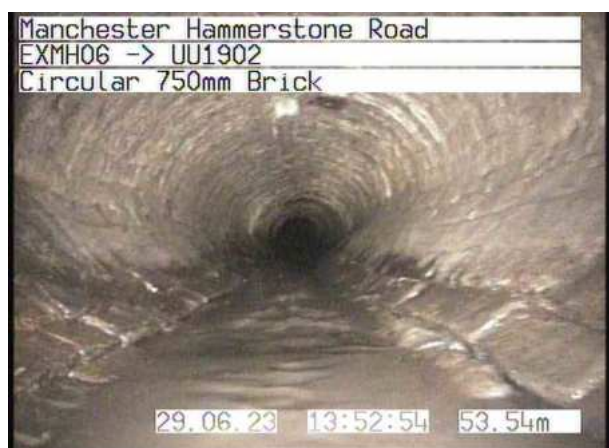
EXMH06X\_b2d37cc8-baa6-4236-ae01-568821f6fe03\_20230704\_092421\_558.jpg, 00:06:00, 53.59 m  
Attached deposits, encrustation from 8 o'clock to 4 o'clock, 5% cross-sectional area loss, start
