## Hammerstone Road Depot, Manchester

# Discharge of Planning Condition 11

**Curtins Ref: HRD-CUR-00-XX-T-RE-006**

**Project****Project Name:** Adana Hammerstone Rd Goreton Manchester projects**Project Description:** WinCan Import in Miraculix Standard**Project Date:** 17/10/2023**Inspection Standard:** MSCC5 Sewers & Drainage GB (SRM5 Scoring)

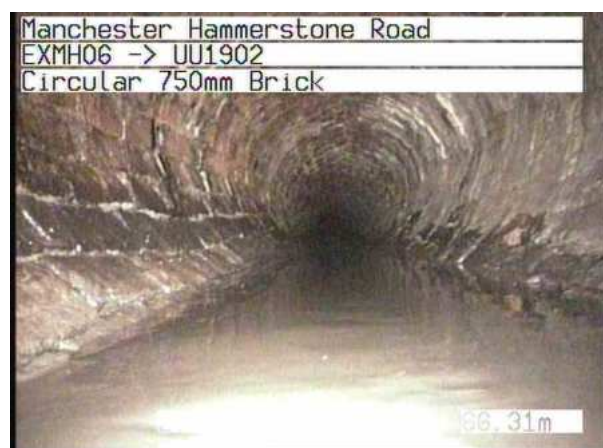
EXMH06X\_6b01fa59-4330-4891-a585-e5ad4d59d3d0\_20230704\_092429\_813.jpg, 00:07:32, 66.41 m  
Attached deposits, encrustation from 8 o'clock to 4 o'clock, 5% cross-sectional area loss, finish

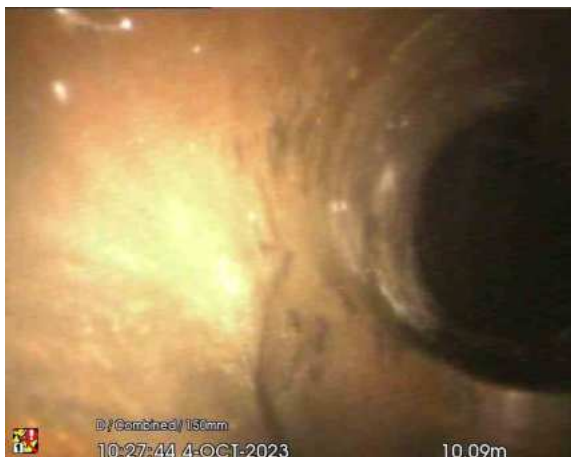
MH25 DS UU2801\_10-09m\_102744.jpg, 00:01:27, 10.09 m  
Junction at 6 o'clock, 150mm dia, DROP SHAFT

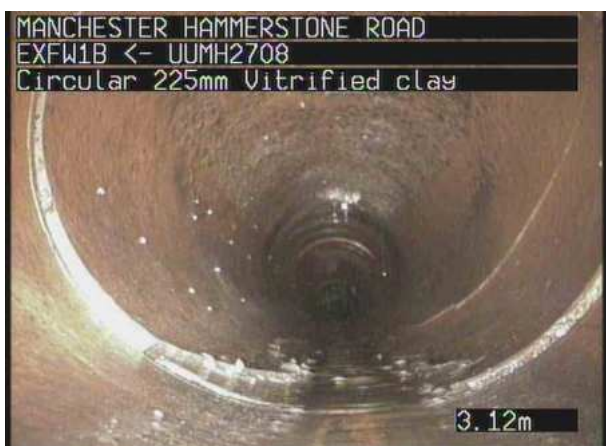
| Scale: | 1:62 | Position [m] | Code | Observation | MPEG | Photo | Grade |
|---|---|---|---|---|---|---|---|
| | | 3.09 | FCJ | Fracture, circumferential at joint from 1 o'clock to 10 o'clock | 00:00:46 | EXFW1BX_4dbb72b<br>1-1295-45 | 3 / 2 |

EXFW1BX\_4dbb72b1-1295-4541-a76e-22125fdc992b\_20230822\_110208\_059.jpg, 00:00:46, 3.09 m  
Fracture, circumferential at joint from 1 o'clock to 10 o'clock

**Recommendations:** PATCH / FULL LINER

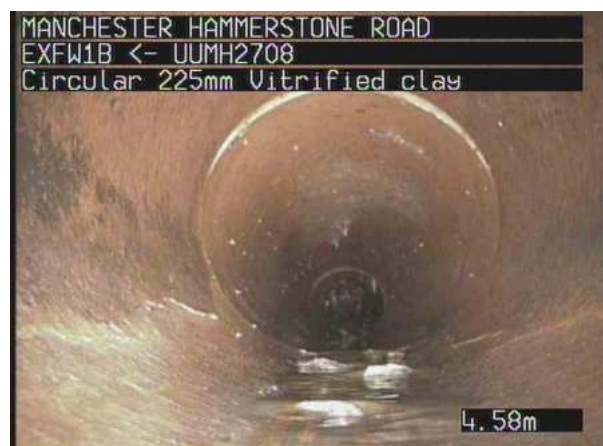
| Scale: | 1:62 | Position [m] | Code | Observation | MPEG | Photo | Grade |
|---|---|---|---|---|---|---|---|
| | | 4.58 | FL | Fracture, longitudinal at 4 o'clock | 00:01:32 | EXFW1BX_db974e7<br>2-2cce-4a | 3 / 2 |

EXFW1BX\_db974e72-2cce-4a01-80a6-9243de8bc956\_20230822\_110300\_543.jpg, 00:01:32, 4.58 m  
Fracture, longitudinal at 4 o'clock

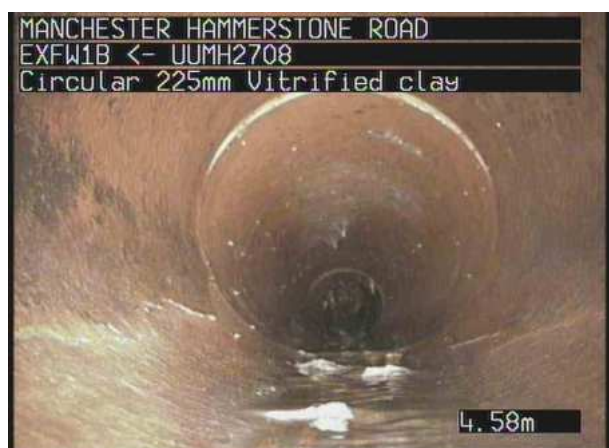
| Scale: | 1:62 | Position [m] | Code | Observation | MPEG | Photo | Grade |
|---|---|---|---|---|---|---|---|
| | | 4.58 | FL | Fracture, longitudinal at 8 o'clock | 00:01:38 | EXFW1BX_5939447<br>d-403e-4a | 3 / 2 |

EXFW1BX\_5939447d-403e-4a0f-ae56-577e9bebf2b4\_20230822\_110312\_377.jpg, 00:01:38, 4.58 m  
Fracture, longitudinal at 8 o'clock

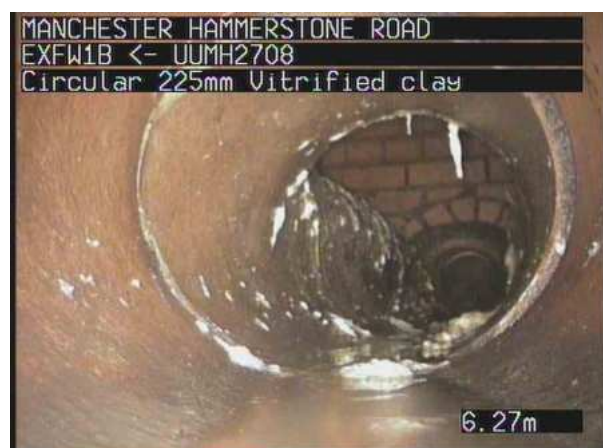
| Scale: | 1:62 | Position [m] | Code | Observation | MPEG | Photo | Grade |
|---|---|---|---|---|---|---|---|
| | | 6.29 | FCJ | Fracture, circumferential at joint from 10 o'clock to 1 o'clock | 00:02:03 | EXFW1BX_1f52a089<br>-6d68-439 | 3 / 2 |

EXFW1BX\_1f52a089-6d68-439b-b6e4-a2acf425ded2\_20230822\_110353\_274.jpg, 00:02:03, 6.29 m  
Fracture, circumferential at joint from 10 o'clock to 1 o'clock

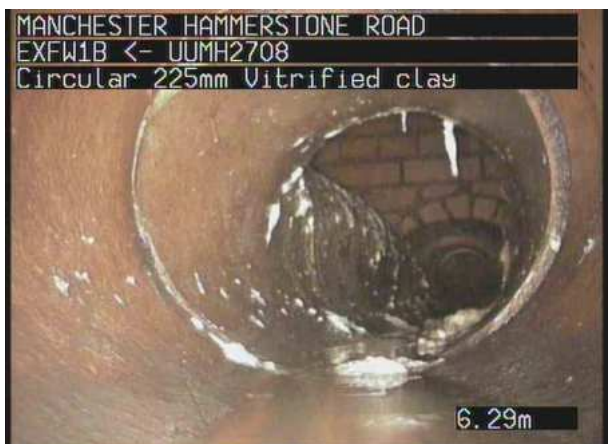
EXFW1BX\_9b32c581-e6a0-4426-97a8-5dfa9d785a36\_20230  
822\_110456\_184.jpg, 00:02:03, 6.29 m

Fracture, circumferential at joint from 10 o'clock to 1 o'clock

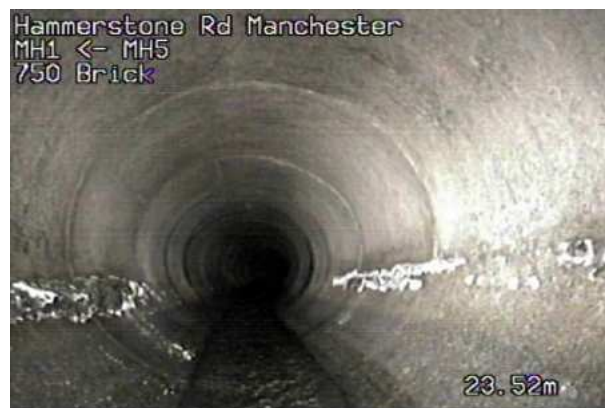
MH1X\_012cdac9-bc28-4f1c-bf1c-46af3d245a1e\_20240201\_1  
01857\_282.jpg, 00:03:13, 23.52 m  
Attached deposits, grease at 08 o'clock, 5% cross-sectional  
area loss, grease

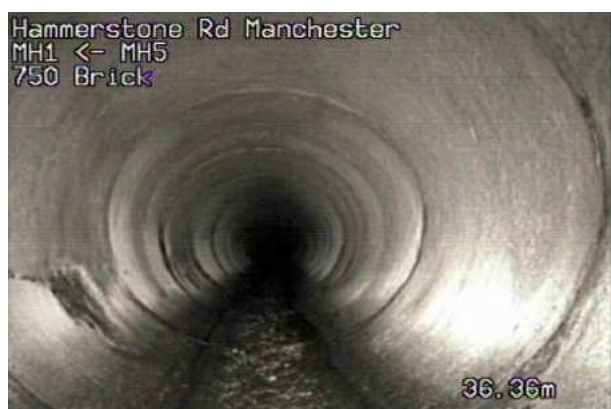
MH1X\_d86746ce-af0b-49ac-bf60-ade12876c7f0\_20240201\_1  
02241\_993.jpg, 00:04:23, 37.00 m  
Fracture, longitudinal at joint at 8 o'clock

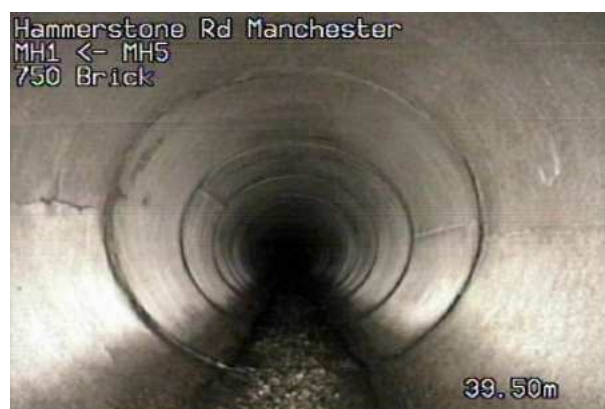
MH1X\_cd383f44-f452-42c0-b12e-c7d4cdfae8e6\_20240201\_1  
02311\_947.jpg, 00:04:38, 40.00 m  
Fracture, longitudinal at joint at 9 o'clock

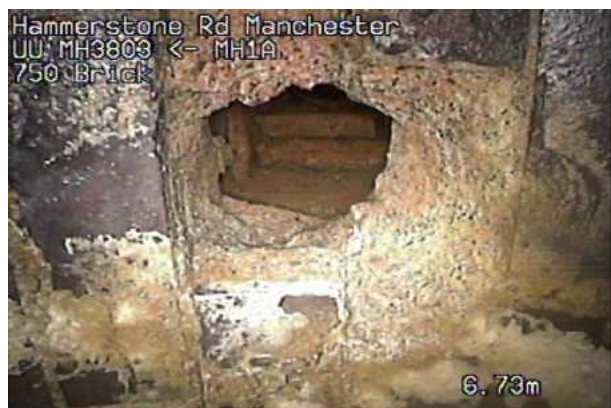
| Scale: | 1:93 | Position [m] | Code | Observation | MPEG | Photo | Grade |
|---|---|---|---|---|---|---|---|
| | | 6.73 | H | Hole in drain or sewer at 12 o'clock: MISSING BRICK | 00:01:37 | UU MH3803X _7de389c | |

MH3803X\_7de389c4-e6ec-4690-9aac-c2fc7a252f20\_20240201\_170816\_726.jpg, 00:01:37, 6.73 m

Hole in drain or sewer at 12 o'clock, MISSING BRICK
