# Phase I Geoenvironmental Site Assessment

Site: Riverpark Road, Manchester, M40 2XP

Reference: 17-246-R1-5

Date: March 25

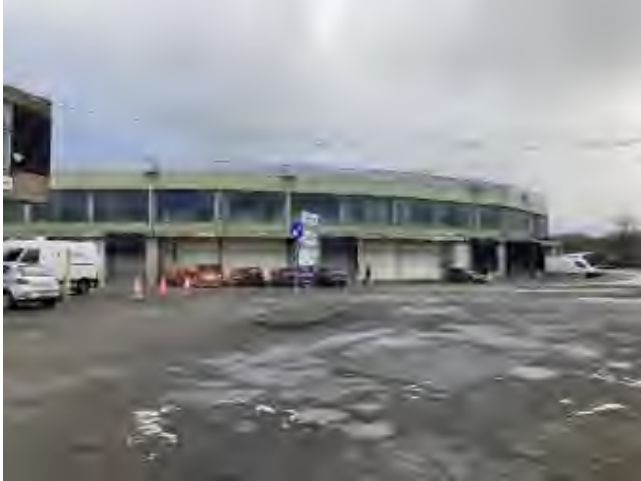
| <p><b>Structures</b></p> | <p>There are six structures present, including an office block in the west, former livestock building and warehouses in the east. Western structures and the MODA furniture building in the east, are comprised of brick and concrete. The central self-store warehouse and eastern warehouse are steel clad, portal frame structures.</p> <p>A communication tower is present atop a concrete pillar located immediately adjacent east of the centre of the self-store building.</p> <p>A small office building is present along the southern boundary.</p> <p>As off 2025 demolition of onsite structures is ongoing.</p> | |

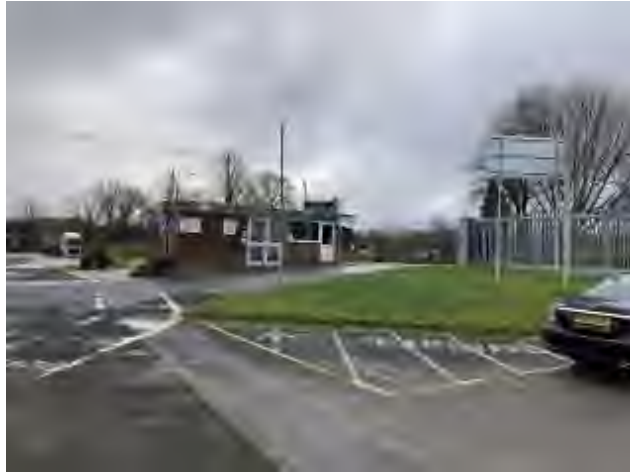
| <b>Access</b> | <p>Vehicle and pedestrian access can be granted to site via gates on Riverpark Road located along the southern boundary, with the main entrance adjacent to the security hut.</p> <p>Both access routes have vehicle control barriers and gates.</p> | |
