# Validation Report

Site: Bennett Street, Manchester

Reference: 15-974-R6-4

Date: February 2025

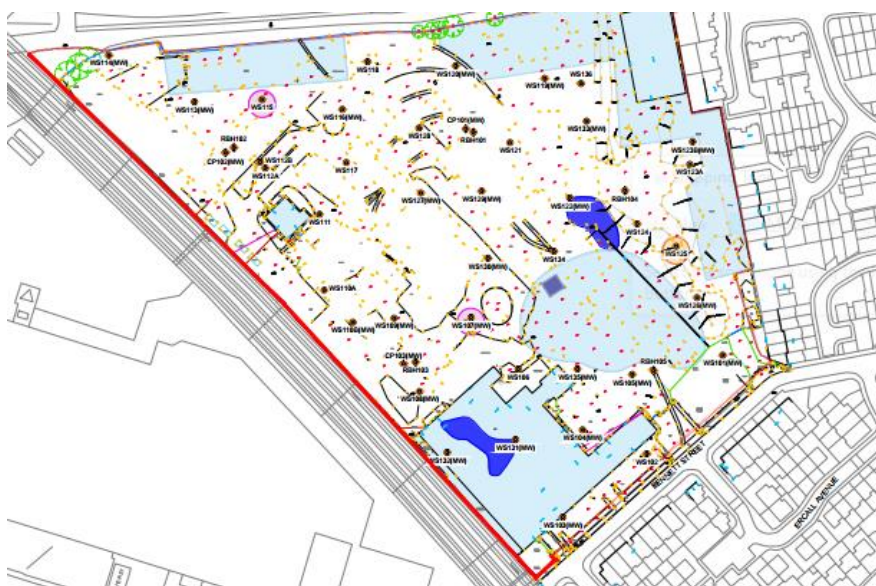
**FIGURE 4.4 – HISTORICAL FEATURES PLAN (HISTORICAL PONDS SHOWN IN DARK BLUE)**

Two historic infilled ponds were identified on site during the previous phases of investigation. All known former infilled ponds were to be delineated and investigated to assess the nature of materials and the extent of any deleterious elements. The location of historic ponds is shown as areas of dark blue in Figure 4.4.

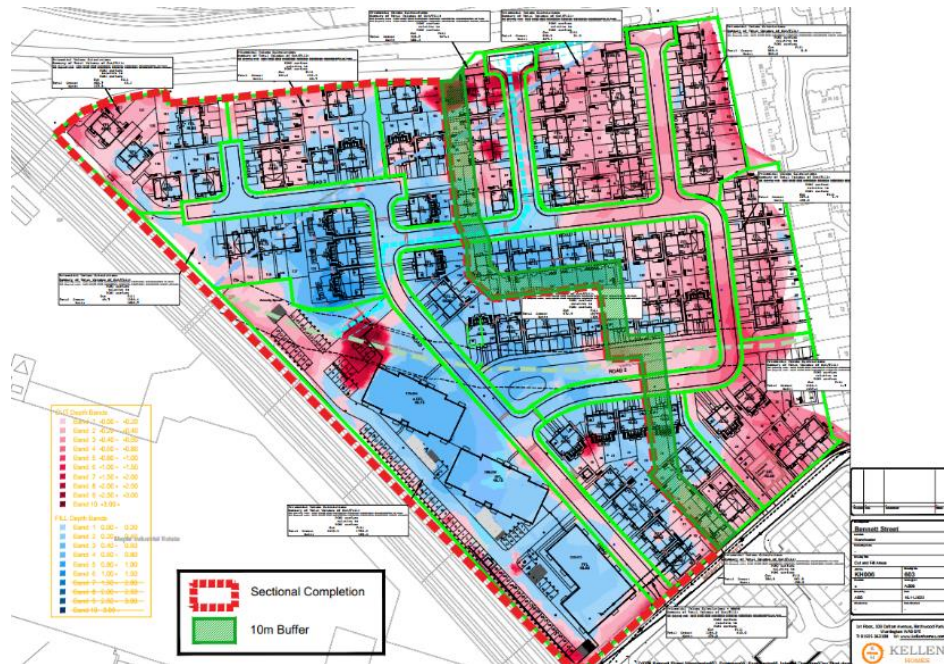
**FIGURE 4.5 KELLEN HOMES CUT AND FILL SITE MODEL**

The ground levels for the subject site were subject to cut (blue) and fill (red) as shown on Figure 4.5 (Kellen Drawing: KH006-003 in Appendix III).
