Gas Membrane Installation  
Validation Report  
Casey Group  
The Enterprise Centre  
Benchill Road  
Wythenshawe  
M22 8LF

## Appendix 1 – Site Survey Sheets

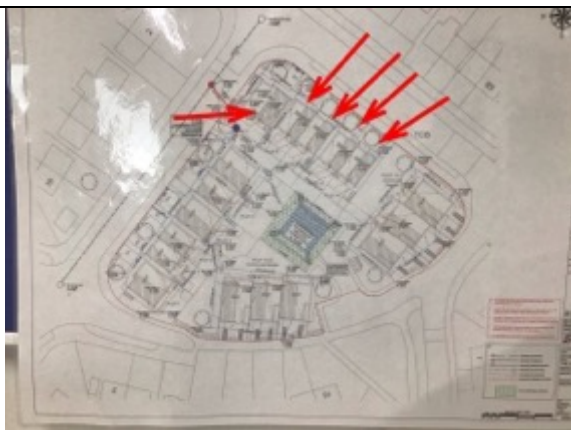
Location of plots

| 7-8-9-10-11 | No Defects recorded at the time of our inspection. As the works were complete prior to our inspection, MEC were unable to provide evidence of the materials used. | N/A |

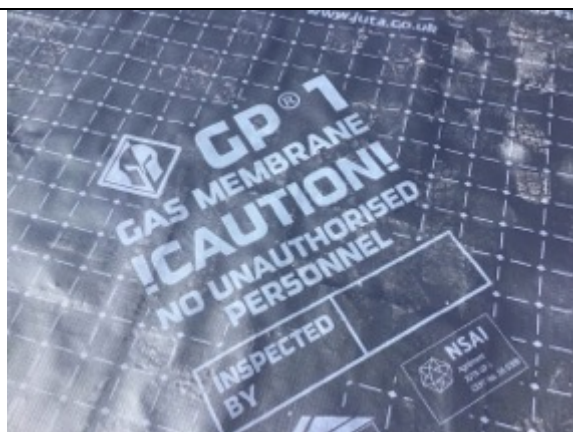
Juta GP1 membrane
