**Project Name:** British Legion Site  
**Project Description:** CCTV Survey  
**Project Number:** 21678  
**Project Status:** Processing  
**Project Date:** 26/06/2024  
**Inspection Standard:** MSCC5 Sewers & Drainage GB (SRM5 Scoring)

**Company:** Rowlinson Construction Ltd  
**Description:** Construction  
**Contact:** Mark Frain  
**Street:** 118b Gatley Road  
**Town or City:** Cheadle  
**Post Code:** SK8 4AU

**Company:** British Legion Site  
**Street:** Woodhouse Lane  
**Town or City:** Wythenshawe  
**County:** Manchester  
**Post Code:** M22 9TF

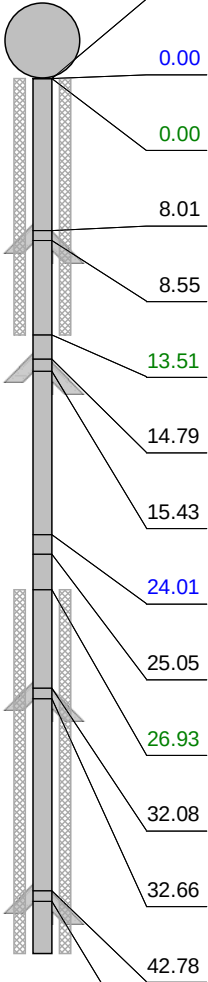
| Scale: | 1:398 | Position [m] | Code | Observation | MPEG | Photo | Grade |
|---|---|---|---|---|---|---|---|
| | 0.00 | S01 | DES | Settled deposits, fine, 10% cross-sectional area loss, start | 00:00:15 | MH<br>8301X_03<br>66b74d-69 | |
| | 13.51 | F01 | DES | Settled deposits, fine, 10% cross-sectional area loss, finish | 00:01:16 | MH<br>8301X_d7<br>274702-45 | 3 |
| | 26.93 | S02 | DES | Settled deposits, fine, 10% cross-sectional area loss, start | 00:02:12 | MH<br>8301X_57<br>444b3b-2d | |

Comments:  
Recommendations: None
