# Asbestos Refurbishment Survey Report

Job Ref No: **581081**, Account Ref No: **1550**, Contract Ref No: **98086**

## Victoria Baths, Hathersage Road, Manchester, M13 0FE

| Contract Title | (CL/45355) Victoria Baths, Hathersage Road, Manchester, M13 0FE - Fire Alarm System - Pre refurbishment Survey |

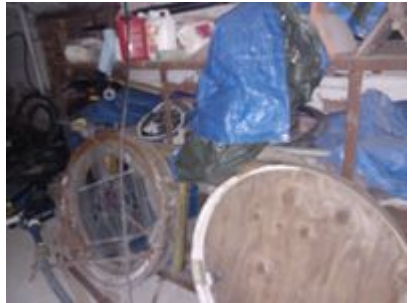
| Building | Level | Location | Item / Product Examined | Accessibility | Access Comments | Photograph |
|---|---|---|---|---|---|---|
| Victoria Baths, Hathersage Road, Manchester, M13 0FE | -1 | B01/B1-006 | <b>Entire Location</b> | Limited Access | stored items | |

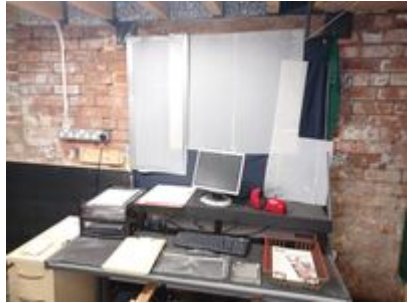
| Building | Level | Location | Item / Product Examined | Accessibility | Access Comments | Photograph |
|---|---|---|---|---|---|---|
| Victoria Baths, Hathersage Road, Manchester, M13 0FE | -1 | B01/B1-008 | <b>Entire Location</b> | No Access | area is sealed shut | |

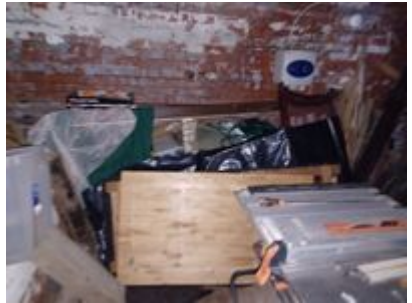
| Building | Level | Location | Item / Product Examined | Accessibility | Access Comments | Photograph |
|---|---|---|---|---|---|---|
| Victoria Baths, Hathersage Road, Manchester, M13 0FE | -1 | B01/B1-014 | <b>Entire Location</b> | Limited Access | stored items | |

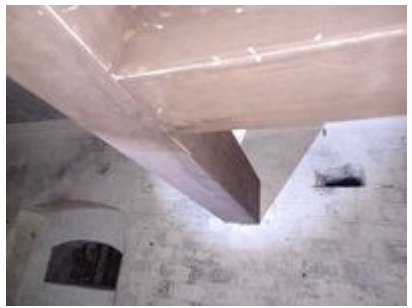
| Building | Level | Location | Item / Product Examined | Accessibility | Access Comments | Photograph |
|---|---|---|---|---|---|---|
| Victoria Baths, Hathersage Road, Manchester, M13 0FE | -1 | B01/B1-018 | Boxing | No Access | Outside scope of proposed works | |

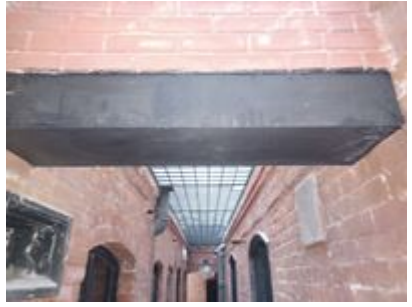
| Building | Level | Location | Item / Product Examined | Accessibility | Access Comments | Photograph |
|---|---|---|---|---|---|---|
| Victoria Baths, Hathersage Road, Manchester, M13 0FE | -1 | B01/B1-022 | Boxing | No Access | Outside scope of proposed works | |

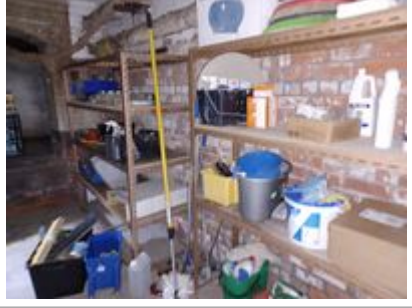
| Building | Level | Location | Item / Product Examined | Accessibility | Access Comments | Photograph |
|---|---|---|---|---|---|---|
| Victoria Baths, Hathersage Road, Manchester, M13 0FE | -1 | B01/B1-030 | <b>Entire Location</b> | Limited Access | stored items | |

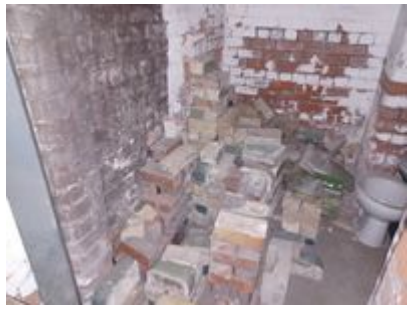
| Building | Level | Location | Item / Product Examined | Accessibility | Access Comments | Photograph |
|---|---|---|---|---|---|---|
| Victoria Baths, Hathersage Road, Manchester, M13 0FE | -1 | B01/B1-031 | <b>Entire Location</b> | Limited Access | stored items | |

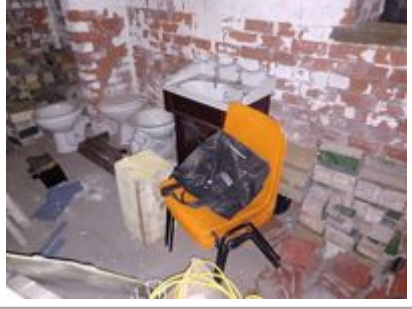
| Building | Level | Location | Item / Product Examined | Accessibility | Access Comments | Photograph |
|---|---|---|---|---|---|---|
| Victoria Baths, Hathersage Road, Manchester, M13 0FE | -1 | B01/B1-032 | <b>Entire Location</b> | Limited Access | stored items | |

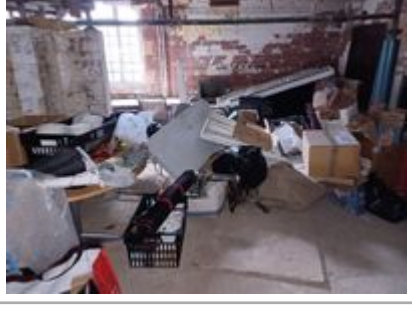
| Building | Level | Location | Item / Product Examined | Accessibility | Access Comments | Photograph |
|---|---|---|---|---|---|---|
| Victoria Baths, Hathersage Road, Manchester, M13 0FE | -1 | B01/B1-034 | <b>Entire Location</b> | Limited Access | stored items | |

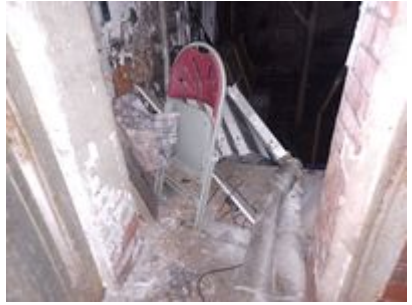
| Building | Level | Location | Item / Product Examined | Accessibility | Access Comments | Photograph |
|---|---|---|---|---|---|---|
| Victoria Baths, Hathersage Road, Manchester, M13 0FE | 0 | B02/GF-002 | <b>Entire Location</b> | No Access | stored items on stairs | |

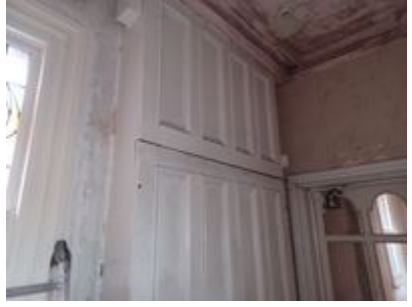
| Building | Level | Location | Item / Product Examined | Accessibility | Access Comments | Photograph |
|---|---|---|---|---|---|---|
| Victoria Baths, Hathersage Road, Manchester, M13 0FE | 1 | B01/01-005 | Boxing | No Access | Outside scope of proposed works | |

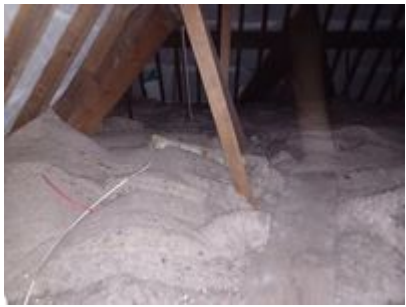
| Building | Level | Location | Item / Product Examined | Accessibility | Access Comments | Photograph |
|---|---|---|---|---|---|---|
| Victoria Baths, Hathersage Road, Manchester, M13 0FE | 2 | B01/02-001-Roof void | <b>Entire Location</b> | Limited Access | reasons of health and safety | |
