## 38 to 42 Mosley Street Paint Analysis

### Report on Findings Report No HPM88MS01

ISSUE 01– 22/12/2024

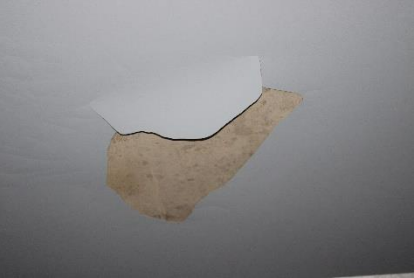
| Sample Ref: 01 | Location: 38 to 42 Mosley Street |
|---|---|
| <p>Paint sample removed from:</p> <p>Location: 01 – Banking Hall, Central Ceiling area.</p> <p>A total of 22 separate paint layers were found.</p> | |

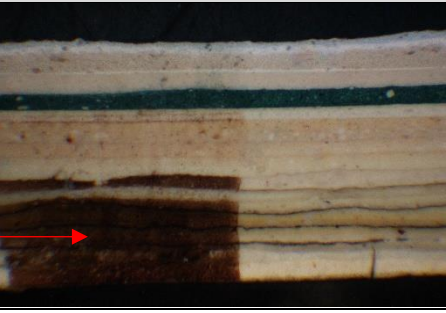
| Sample Ref: 01 | Location: 38 to 42 Mosley Street |
|---|---|
| <p>Early schemes tested for lead</p> <p>Yes – evidence early lead based paints present.</p> <p>(Lead bearing paint layers noted in black).</p> <p>The first 11 paint layers are based on lead carbonate.</p> | |

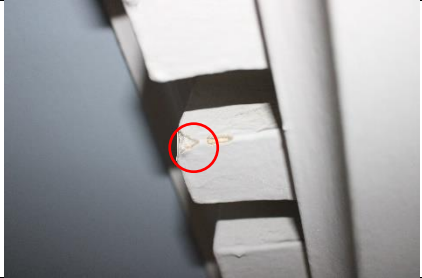
| Sample Ref: 02 | Location: 38 to 42 Mosley Street |
|---|---|
| <p>Paint sample removed from:</p> <p>Location: 02 – Banking Hall, Central Dentil Moulding.</p> <p>A total of 25 separate paint layers were found.</p> | |

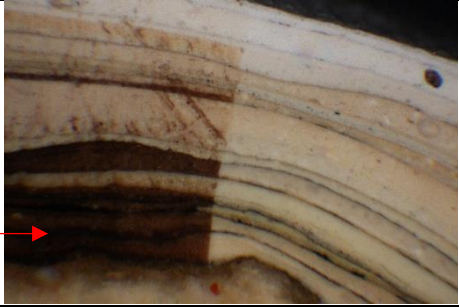
| Sample Ref: 02 | Location: 38 to 42 Mosley Street |
|---|---|
| <p>Early schemes tested for lead</p> <p>Yes – evidence early lead based paints present.</p> <p>(Lead bearing paint layers noted in black).</p> <p>The first 10 paint layers are based on Lead Carbonate.</p> | |

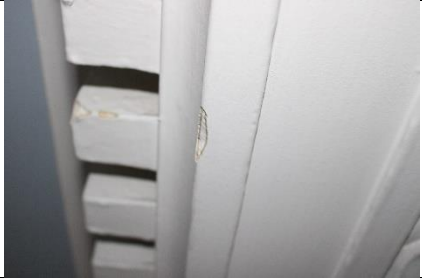
| Sample Ref: 03 | Location: 38 to 42 Mosley Street |
|---|---|
| <p>Paint sample removed from:</p> <p>Location: 03 – Banking Hall, Inner Ceiling Moulding.</p> <p>A total of 22 separate paint layers were found.</p> | |

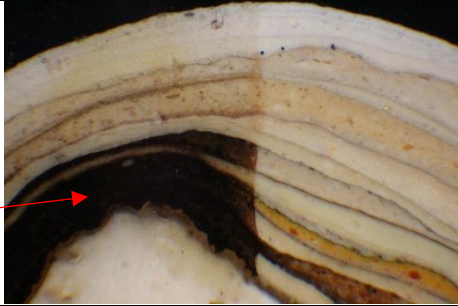
| Sample Ref: 03 | Location: 38 to 42 Mosley Street |
|---|---|
| <p>Early schemes tested for lead</p> <p>Yes – evidence early lead based paints present.</p> <p>(Lead bearing paint layers noted in black).</p> <p>8 out of 10 of the first paint layers are based on lead carbonate.</p> | |

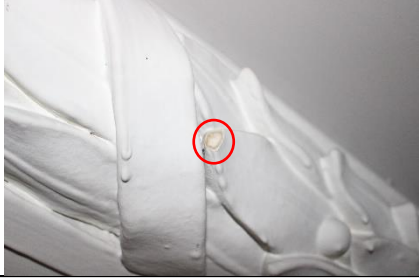
| Sample Ref: 04 | Location: 38 to 42 Mosley Street |
|---|---|
| <p>Paint sample removed from:</p> <p>Location: 04 – Banking Hall, Ceiling Leaf Moulding.</p> <p>A total of 12 separate paint layers were found.</p> | |

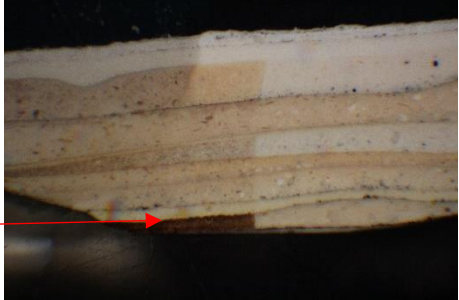
| Sample Ref: 04 | Location: 38 to 42 Mosley Street |
|---|---|
| <p>Early schemes tested for lead</p> <p>Yes – evidence early lead based paints present.</p> <p>(Lead bearing paint layers noted in black).</p> <p>Only the two earliest layers are based on lead carbonate – possible a repaired feature.</p> | |

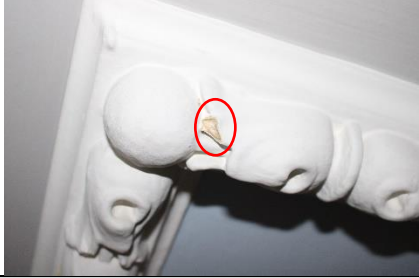
| Sample Ref: 05 | Location: 38 to 42 Mosley Street |
|---|---|
| <p>Paint sample removed from:</p> <p>Location: 05 – Banking Hall, Ceiling Outer Running Moulding.</p> <p>A total of 22 separate paint layers were found.</p> | |

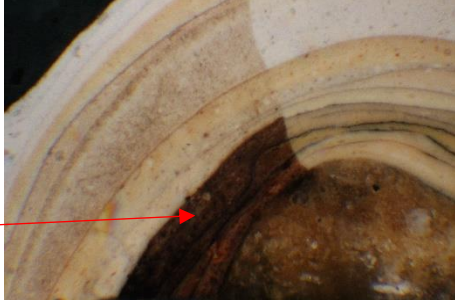
| Sample Ref: 05 | Location: 38 to 42 Mosley Street |
|---|---|
| <p>Early schemes tested for lead</p> <p>Yes – evidence early lead based paints present.</p> <p>(Lead bearing paint layers noted in black).</p> <p>The first 10 paint layers are based on lead carbonate.</p> | |

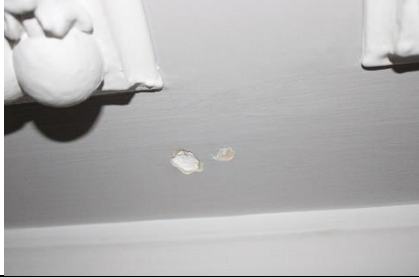
| Sample Ref: 06 | Location: 38 to 42 Mosley Street |
|---|---|
| <p>Paint sample removed from:</p> <p>Location: 06 – Banking Hall, Perimeter area of ceiling (panted grey).</p> <p>A total of 31 separate paint layers were found.</p> | |

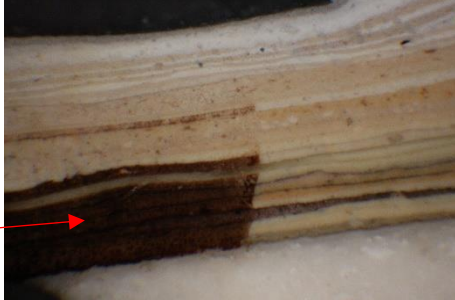
| Sample Ref: 06 | Location: 38 to 42 Mosley Street |
|---|---|
| <p>Early schemes tested for lead</p> <p>Yes – evidence early lead based paints present.</p> <p>(Lead bearing paint layers noted in black).</p> <p>The first 12 layers are based on lead carbonate.</p> | |

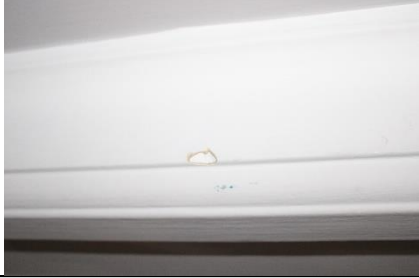
| Sample Ref: 07 | Location: 38 to 42 Mosley Street |
|---|---|
| <p>Paint sample removed from:</p> <p>Location: 07 – Banking Hall, Upper Ceiling Cornice.</p> <p>A total of 25 separate paint layers were found.</p> | |

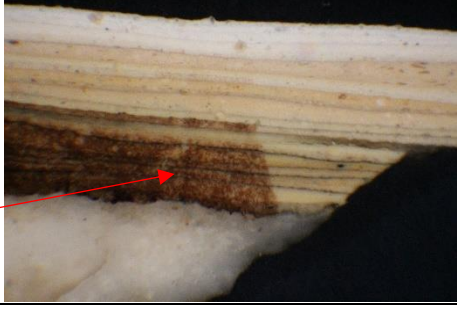
| Sample Ref: 07 | Location: 38 to 42 Mosley Street |
|---|---|
| <p>Early schemes tested for lead</p> <p>Yes – evidence early lead based paints present.</p> <p>(Lead bearing paint layers noted in black).</p> <p>The earliest 10 layers are based on lead carbonate.</p> | |

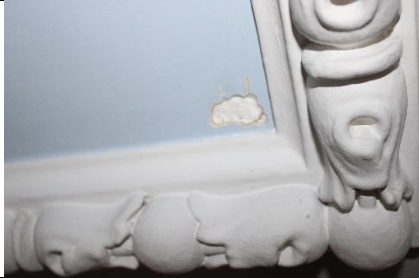
| Sample Ref: 08 | Location: 38 to 42 Mosley Street |
|---|---|
| <p>Paint sample removed from:</p> <p>Location: 08 – Banking Hall, perimeter area of ceiling (currently painted blue).</p> <p>A total of 25 separate paint layers were found.</p> | |

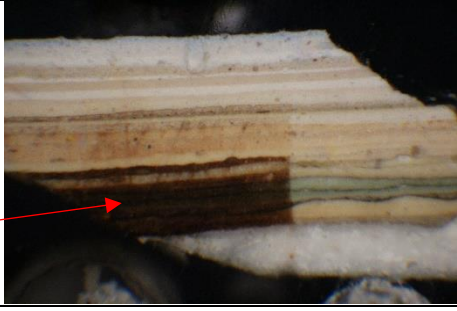
| Sample Ref: 08 | Location: 38 to 42 Mosley Street |
|---|---|
| <p>Early schemes tested for lead</p> <p>Yes – evidence early lead based paints present.</p> <p>(Lead bearing paint layers noted in black).</p> <p>The earliest 9 layers are based on lead carbonate.</p> | |

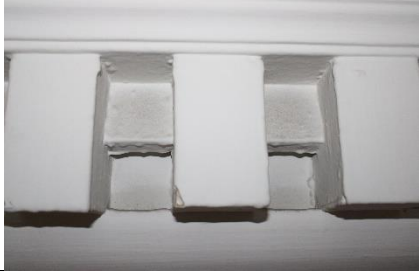
| Sample Ref: 09 | Location: 38 to 42 Mosley Street |
|---|---|
| <p>Paint sample removed from:</p> <p>Location: 09 – Banking Hall, Cornice Dentil Moulding.</p> <p>A total of 21 separate paint layers were found.</p> | |

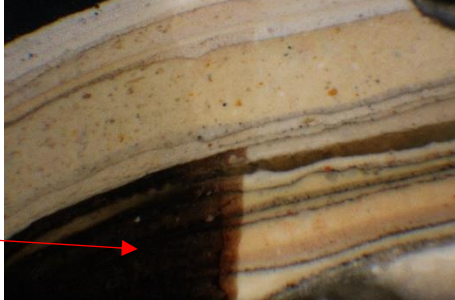
| Sample Ref: 09 | Location: 38 to 42 Mosley Street |
|---|---|
| <p>Early schemes tested for lead</p> <p>Yes – evidence early lead based paints present.</p> <p>(Lead bearing paint layers noted in black).</p> <p>The first 9 paint layers are based on lead carbonate.</p> | |

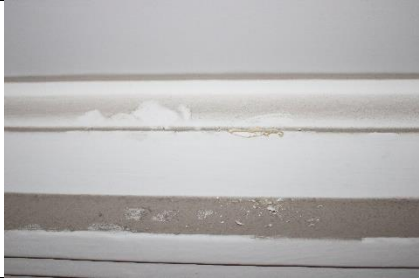
Ceiling beam lower border (sample 10) - This element was retained in a white / off-white appearance throughout its life. This detail also had an applied layer of clear varnish similar to that noted on the dentil moulding.

| Sample Ref: 10 | Location: 38 to 42 Mosley Street |
|---|---|
| <p>Paint sample removed from:</p> <p>Location: 10 – Banking Hall, Ceiling Beam lower border.</p> <p>A total of 22 separate paint layers were found.</p> | |

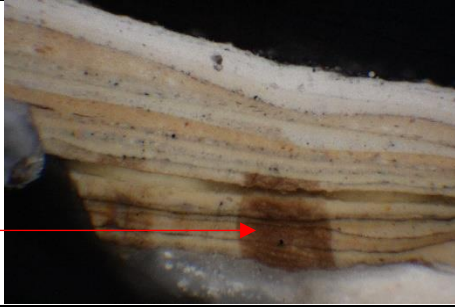
| Sample Ref: 10 | Location: 38 to 42 Mosley Street |
|---|---|
| <p>Early schemes tested for lead</p> <p>Yes – evidence early lead based paints present.</p> <p>(Lead bearing paint layers noted in black).</p> <p>The first 10 paint layers are based on lead carbonate.</p> | |

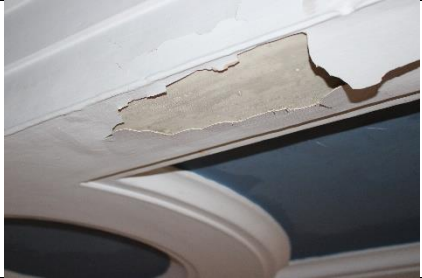
Ceiling beam border, underside, (sample 11) - This element was retained in a white / off-white appearance throughout its life. This detail also had an applied layer of clear varnish similar to that noted on the dentil moulding.

| Sample Ref: 11 | Location: 38 to 42 Mosley Street |
|---|---|
| <p>Paint sample removed from:</p> <p>Location: 11 – Banking Hall, Ceiling Beam Border (underside).</p> <p>A total of 23 separate paint layers were found.</p> | |

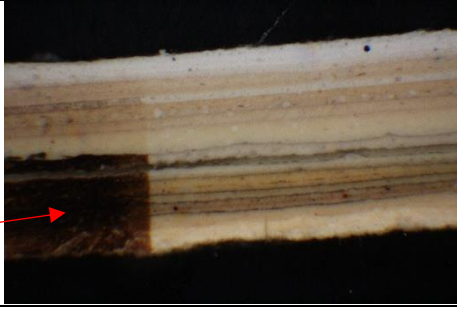
| Sample Ref: 11 | Location: 38 to 42 Mosley Street |
|---|---|
| <p>Early schemes tested for lead</p> <p>Yes – evidence early lead based paints present.</p> <p>(Lead bearing paint layers noted in black).</p> <p>The first 10 paint layers are based on lead carbonate.</p> | |

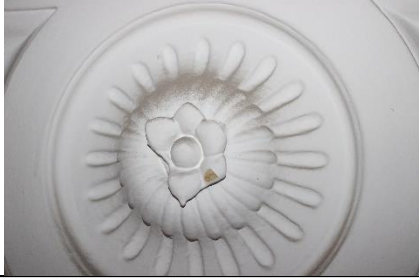
| Sample Ref: 12 | Location: 38 to 42 Mosley Street |
|---|---|
| <p>Paint sample removed from:</p> <p>Location: 12 – Banking Hall, Moulded flower roundel to centre of ceiling beam</p> <p>A total of 22 separate paint layers were found.</p> | |

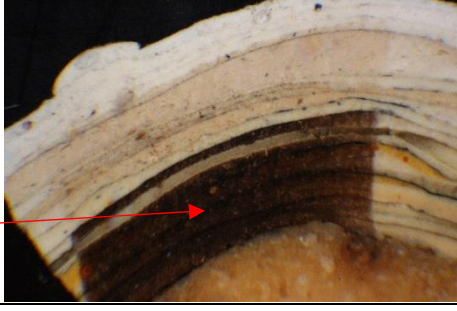
| Sample Ref: 12 | Location: 38 to 42 Mosley Street |
|---|---|
| <p>Early schemes tested for lead</p> <p>Yes – evidence early lead based paints present.</p> <p>(Lead bearing paint layers noted in black).</p> <p>The first 11 paint layers are based on lead carbonate.</p> | |

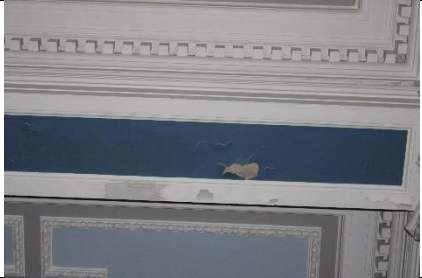
| Sample Ref: 13 | Location: 38 to 42 Mosley Street |
|---|---|
| <p>Paint sample removed from:</p> <p>Location: 13 – Banking Hall, Ceiling Beam - Underside</p> <p>A total of 21 separate paint layers were found.</p> | |

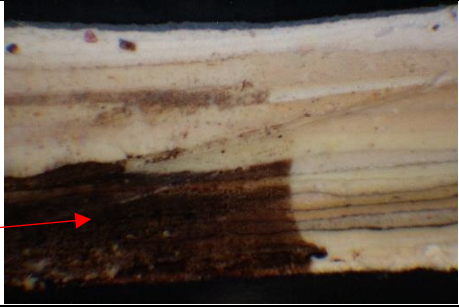
| Sample Ref: 13 | Location: 38 to 42 Mosley Street |
|---|---|
| <p>Early schemes tested for lead</p> <p>Yes – evidence early lead based paints present.</p> <p>(Lead bearing paint layers noted in black).</p> <p>The first 10 paint layers are based on lead carbonate.</p> | |

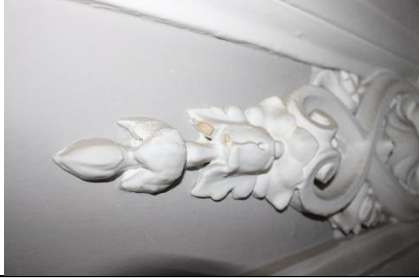
| Sample Ref: 14 | Location: 38 to 42 Mosley Street |
|---|---|
| <p>Paint sample removed from:</p> <p>Location: 14 – Banking Hall, Beam Corner Moulding.</p> <p>A total of 22 separate paint layers were found.</p> | |

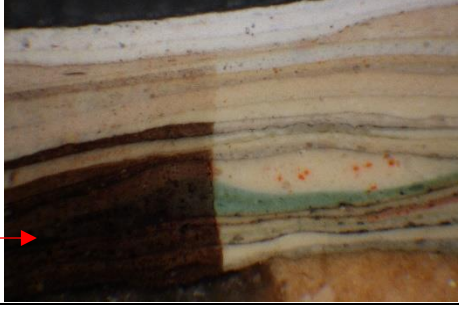
| Sample Ref: 14 | Location: 38 to 42 Mosley Street |
|---|---|
| <p>Early schemes tested for lead</p> <p>Yes – evidence early lead based paints present.</p> <p>(Lead bearing paint layers noted in black).</p> <p>The first 10 layers are based on lead carbonate.</p> | |

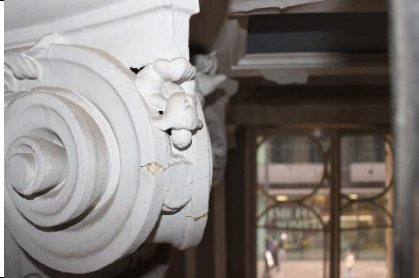
| Sample Ref: 15 | Location: 38 to 42 Mosley Street |
|---|---|
| <p>Paint sample removed from:</p> <p>Location: 15 – Banking Hall, Column Capital.</p> <p>A total of 25 separate paint layers were found.</p> | |

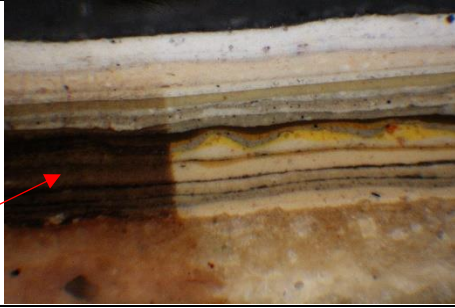
| Sample Ref: 15 | Location: 38 to 42 Mosley Street |
|---|---|
| <p>Early schemes tested for lead</p> <p>Yes – evidence early lead based paints present.</p> <p>(Lead bearing paint layers noted in black).</p> <p>The earliest 14 paint layers are based on lead carbonate.</p> | |

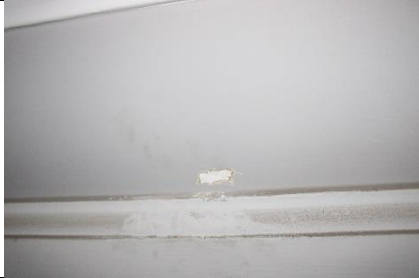
| Sample Ref: 16 | Location: 38 to 42 Mosley Street |
|---|---|
| <p>Paint sample removed from:</p> <p>Location: 16 – Banking Hall, Beam Infill Panel.</p> <p>A total of 24 separate paint layers were found.</p> | |

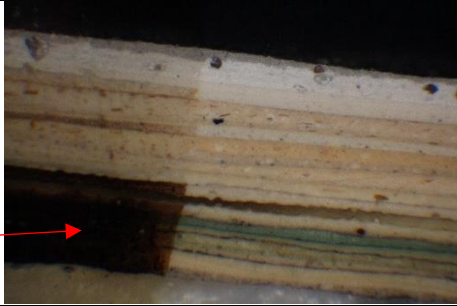
| Sample Ref: 16 | Location: 38 to 42 Mosley Street |
|---|---|
| <p>Early schemes tested for lead</p> <p>Yes – evidence early lead based paints present.</p> <p>(Lead bearing paint layers noted in black).</p> <p>The first 11 paint layers are based on lead carbonate.</p> | |

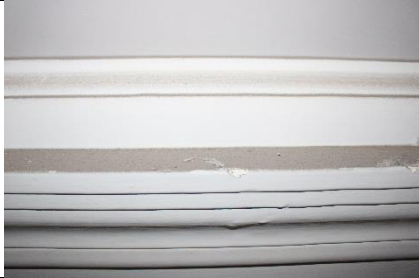
| Sample Ref: 17 | Location: 38 to 42 Mosley Street |
|---|---|
| <p>Paint sample removed from:</p> <p>Location: 17 – Banking Hall, Picture Rail Moulding</p> <p>A total of 22 separate paint layers were found.</p> | |

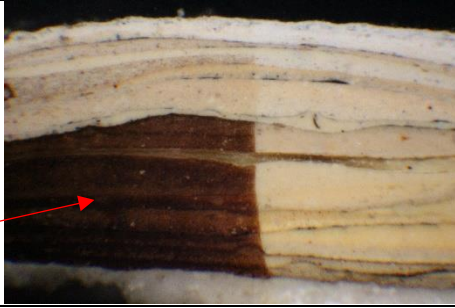
| Sample Ref: 17 | Location: 38 to 42 Mosley Street |
|---|---|
| <p>Early schemes tested for lead</p> <p>Yes – evidence early lead based paints present.</p> <p>(Lead bearing paint layers noted in black).</p> <p>The earliest 9 paint layers are based on lead carbonate.</p> | |

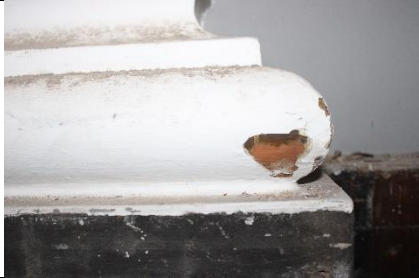
| Sample Ref: 18 | Location: 38 to 42 Mosley Street |
|---|---|
| <p>Paint sample removed from:</p> <p>Location: 18 – Banking Hall, Base of Pilaster</p> <p>A total of 20 separate paint layers were found.</p> | |

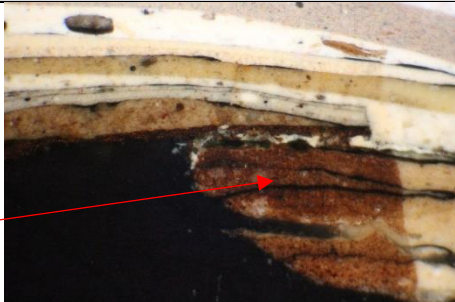
| Sample Ref: 18 | Location: 38 to 42 Mosley Street |
|---|---|
| <p>Early schemes tested for lead</p> <p>Yes – evidence early lead based paints present.</p> <p>(Lead bearing paint layers noted in black).</p> <p>The first 8 paint layers are based on lead carbonate.</p> | |

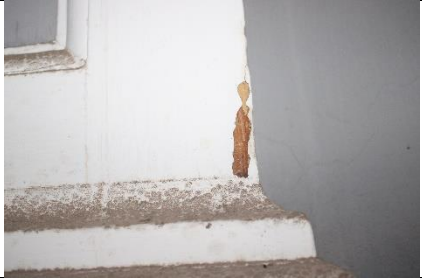
| Sample Ref: 19 | Location: 38 to 42 Mosley Street |
|---|---|
| <p>Paint sample removed from:</p> <p>Location: 19 – Banking Hall, Border of Pilaster</p> <p>A total of 22 separate paint layers were found.</p> | |

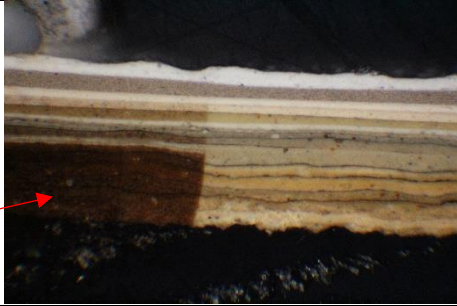
| Sample Ref: 19 | Location: 38 to 42 Mosley Street |
|---|---|
| <p>Early schemes tested for lead</p> <p>Yes – evidence early lead based paints present.</p> <p>(Lead bearing paint layers noted in black).</p> <p>The first 12 paint layers are based on lead carbonate.</p> | |

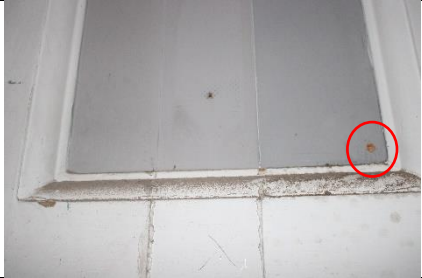
| Sample Ref: 20 | Location: 38 to 42 Mosley Street |
|---|---|
| <p>Paint sample removed from:</p> <p>Location: 20 – Banking Hall, Infill Panel of Pilaster</p> <p>A total of 2 separate paint layers were found.</p> | |

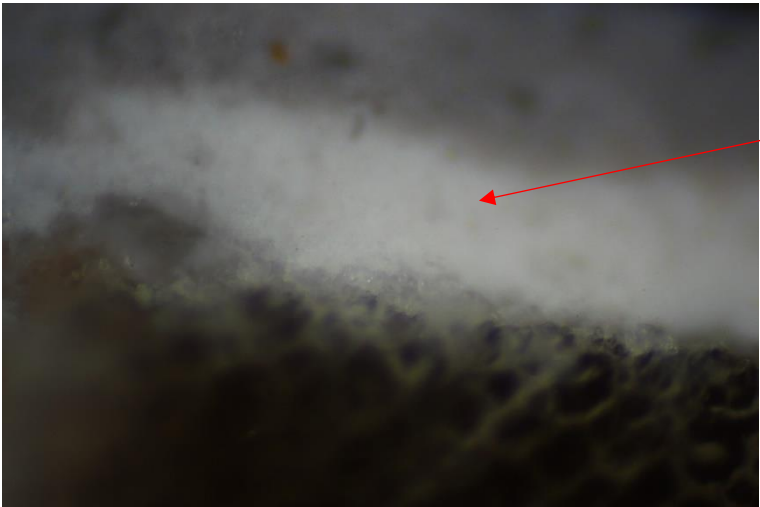
| Sample Ref: 20 | Location: 38 to 42 Mosley Street |
|---|---|
| | <p><b>X400 Magnification -</b></p> <p>Earliest paint layers.</p> <p>Earliest paint scheme – white paint based on Titanium white.</p> <p>Note: The white may be a primer layer with the grey being the only decorative colour applied. It is likely that the plywood covers the original panelling.</p> |

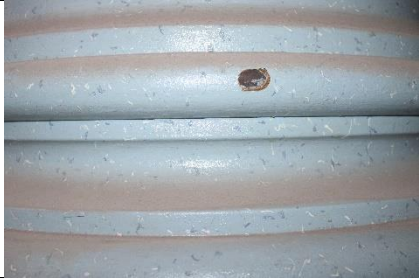
| Sample Ref: 21 | Location: 38 to 42 Mosley Street |
|---|---|
| <p>Paint sample removed from:</p> <p>Location: 21 – Banking Hall, Column Lower Band</p> <p>A total of 24 separate paint layers were found.</p> | |

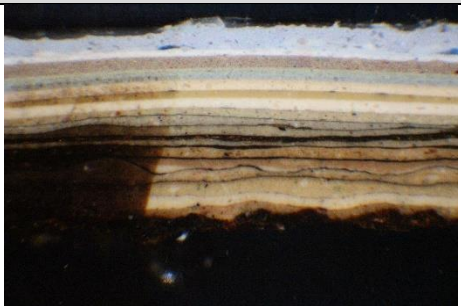
| <p><b>Lead Test</b></p> <p>Early schemes tested for lead</p> <p>Yes – evidence early lead based paints present.</p> <p>(Lead bearing paint layers noted in black).</p> <p>9 out of 12 of the earliest paint layers are based on lead carbonate.</p> | |

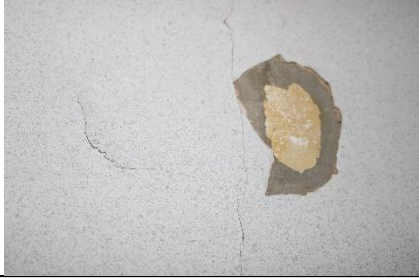
| Sample Ref: 22 | Location: 38 to 42 Mosley Street |
|---|---|
| <p>Paint sample removed from:</p> <p>Location: 22 – Banking Hall, Wall Inner Panel area.</p> <p>A total of 10 separate paint layers were found.</p> | |

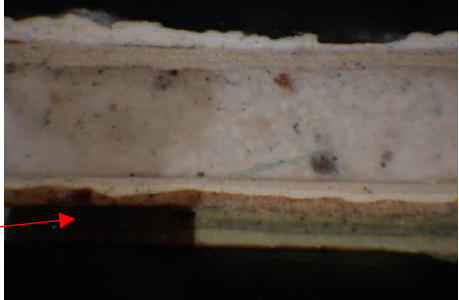
| Sample Ref: 22 | Location: 38 to 42 Mosley Street |
|---|---|
| <p>Early schemes tested for lead</p> <p>Yes – evidence early lead based paints present.</p> <p>(Lead bearing paint layers noted in black).</p> <p>The earliest 3 paint layers are based on lead carbonate.</p> | |

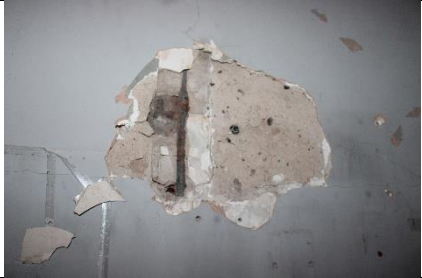
Outer panel areas (sample 23) – This sample also indicated that the wall area had been disturbed as modern pink gypsum was present in the sample. All paint samples found were modern based on Titanium white.

| Sample Ref: 23 | Location: 38 to 42 Mosley Street |
|---|---|
| <p>Paint sample removed from:</p> <p>Location: 23 – Banking Hall, Wall Outer Panel</p> <p>A total of 6 separate paint layers were found.</p> | |

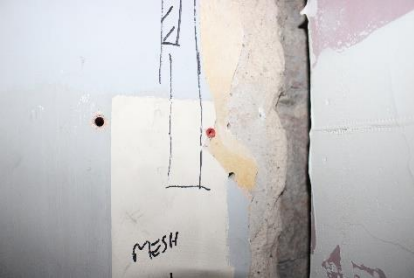
| Sample Ref: 24 | Location: 38 to 42 Mosley Street |
|---|---|
| <p>Paint sample removed from:</p> <p>Location: 24 – Banking Hall, Wall to side of door opening.</p> <p>A total of 22 separate paint layers were found.</p> | |

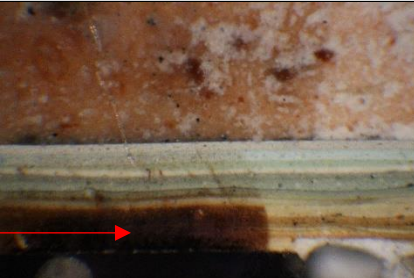
| Sample Ref: 24 | Location: 38 to 42 Mosley Street |
|---|---|
| <p>Early schemes tested for lead</p> <p>Yes – evidence early lead based paints present.</p> <p>(Lead bearing paint layers noted in black).</p> <p>The earliest 10 paint layers are based on lead carbonate.</p> | |

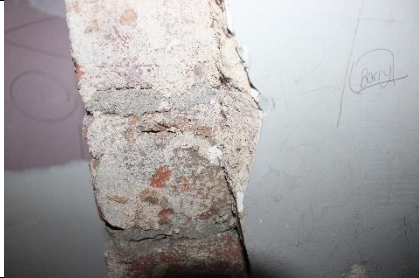
| Sample Ref: 25 | Location: 38 to 42 Mosley Street |
|---|---|
| <p>Paint sample removed from:</p> <p>Location: 25 – Banking Hall, Wall to side of door opening.</p> <p>A total of 21 separate paint layers were found.</p> | |

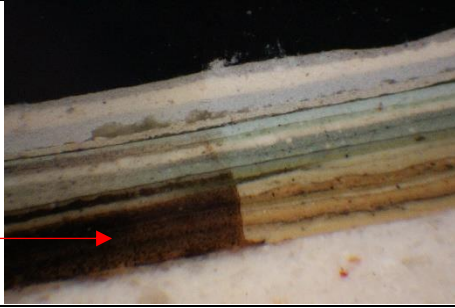
| Sample Ref: 25 | Location: 38 to 42 Mosley Street |
|---|---|
| <p>Early schemes tested for lead</p> <p>Yes – evidence early lead based paints present.</p> <p>(Lead bearing paint layers noted in black).</p> <p>The earliest 10 paint layers are based on lead carbonate.</p> | |

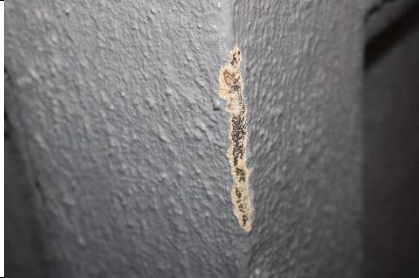
| Sample Ref: 26 | Location: 38 to 42 Mosley Street |
|---|---|
| <p>Paint sample removed from:</p> <p>Location: 26 – Banking Hall, Stone Base to Column.</p> <p>A total of 7 separate paint / coating layers were found.</p> | |

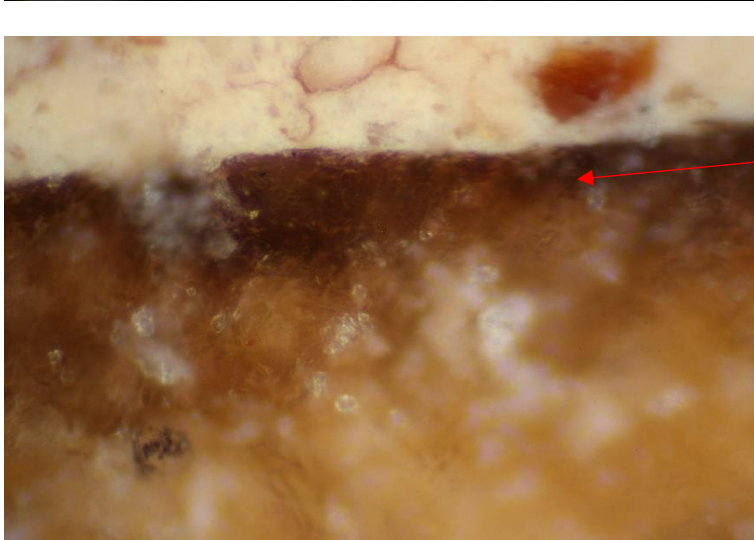
| Sample Ref: 26 | Location: 38 to 42 Mosley Street |
|---|---|
| | <p><b>X400 Magnification -</b></p> <p>Earliest paint layers.</p> <p>Earliest paint scheme – resin / varnish over stonework to base of column.</p> <p>Note: The shelter coating and subsequent paint layers are modern. The roughness of the shelter coating provided a textured look to the column base.</p> |

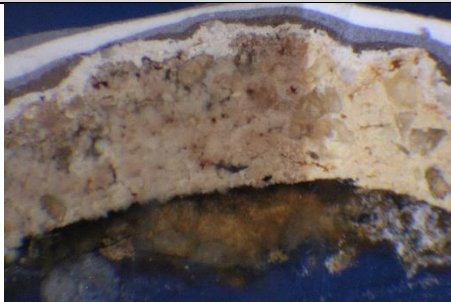
| Sample Ref: 26 | Location: 38 to 42 Mosley Street |
|---|---|
| <p>Early schemes tested for lead</p> <p>Yes – no evidence early lead based paints present.</p> | |

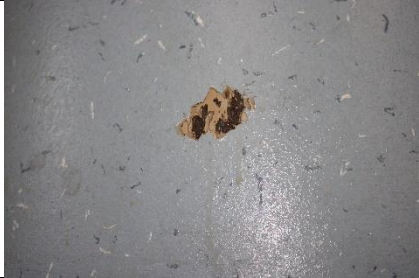
| Sample Ref: 27 | Location: 38 to 42 Mosley Street |
|---|---|
| <p>Paint sample removed from:</p> <p>Location: 27 – Banking Hall, Iron Column.</p> <p>A total of 22 separate paint layers were found.</p> | |

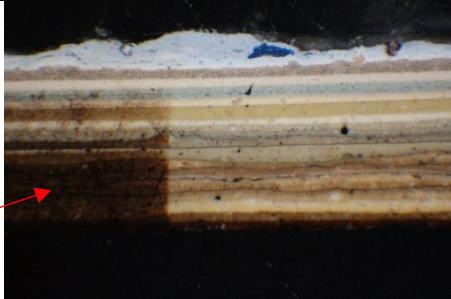
| Sample Ref: 27 | Location: 38 to 42 Mosley Street |
|---|---|
| <p>Early schemes tested for lead</p> <p>Yes – evidence early lead based paints present.</p> <p>(Lead bearing paint layers noted in black).</p> <p>The earliest 12 paint layers are based on lead carbonate.</p> | |

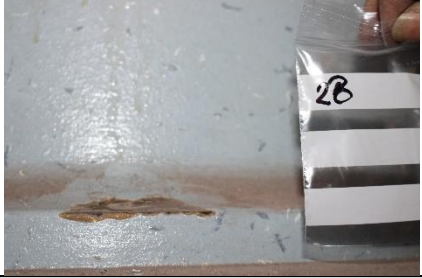
| Sample Ref: 28 | Location: 38 to 42 Mosley Street |
|---|---|
| <p>Paint sample removed from:</p> <p>Location: 28 – Banking Hall, Bottom of Column / Band.</p> <p>A total of 24 separate paint layers were found.</p> | |

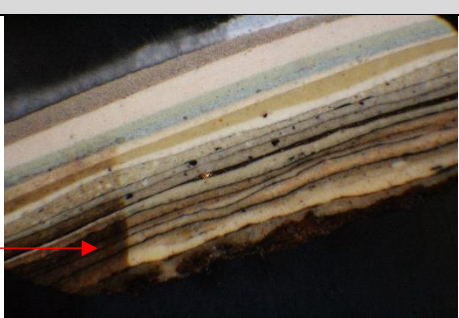
| Sample Ref: 28 | Location: 38 to 42 Mosley Street |
|---|---|
| <p>Early schemes tested for lead</p> <p>Yes – evidence early lead based paints present.</p> <p>(Lead bearing paint layers noted in black).</p> <p>12 of the 13 earliest paints are based on lead carbonate.</p> | |

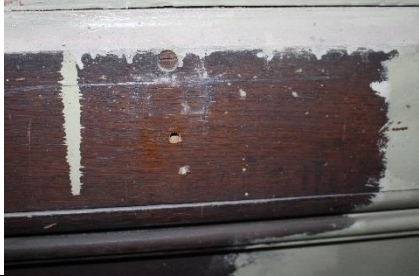
| Sample Ref: 29 | Location: 38 to 42 Mosley Street |
|---|---|
| <p>Paint sample removed from:</p> <p>Location: 29 – Banking Hall, Timber Panels (where painted).</p> <p>A total of 3 separate paint layers were found.</p> | |

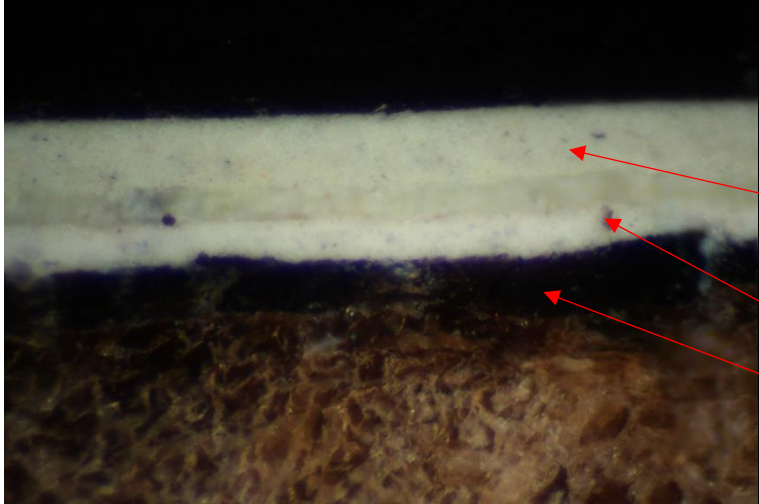
| Sample Ref: 29 | Location: 38 to 42 Mosley Street |
|---|---|
| | <p><b>X400 Magnification -</b><br/>Earliest paint layers.</p> <p>2No Modern light green paint layers based on Titanium white.</p> <p>White primer.</p> <p>Tinted varnish over timberwork.</p> |

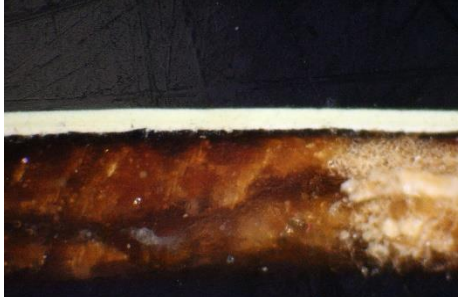
| Sample Ref: 29 | Location: 38 to 42 Mosley Street |
|---|---|
| <p>Sample tested – no evidence of lead based paints.</p> | |

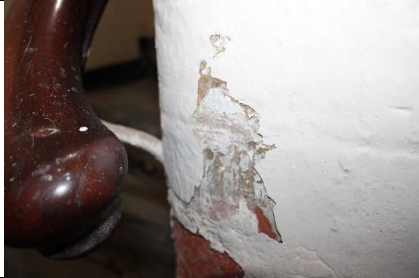
| Sample Ref: 30 | Location: 38 to 42 Mosley Street |
|---|---|
| <p>Paint sample removed from:</p> <p>Location: 30 – Stairs (Brickwork wall).</p> <p>A total of 16 separate paint layers were found.</p> | |

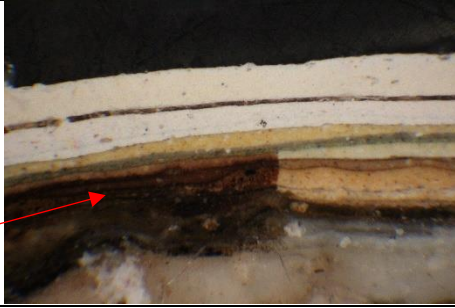
| Sample Ref: 30 | Location: 38 to 42 Mosley Street |
|---|---|
| <p>Early schemes tested for lead</p> <p>Yes – evidence early lead based paints present.</p> <p>(Lead bearing paint layers noted in black).</p> <p>5 layers of paint were identified as being lead carbonate based. These were all applied over the lime washes.</p> | |

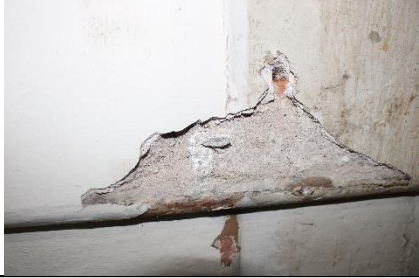
| Sample Ref: 31 | Location: 38 to 42 Mosley Street |
|---|---|
| <p>Paint sample removed from:</p> <p>Location: 31 – Stairs (Plastered wall).</p> <p>A total of 12 separate paint layers were found.</p> | |

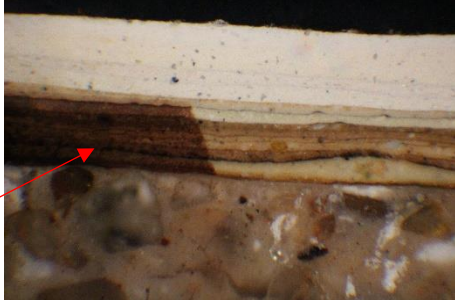
| Sample Ref: 31 | Location: 38 to 42 Mosley Street |
|---|---|
| <p>Early schemes tested for lead</p> <p>Yes – evidence early lead based paints present.</p> <p>(Lead bearing paint layers noted in black).</p> <p>The earliest 7 paint layers are based on lead carbonate.</p> | |

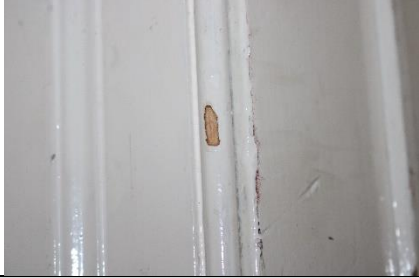
| Sample Ref: 32 | Location: 38 to 42 Mosley Street |
|---|---|
| <p>Paint sample removed from:</p> <p>Location: 32 – Stairs (Architrave to door).</p> <p>A total of 5 separate paint layers were found.</p> | |

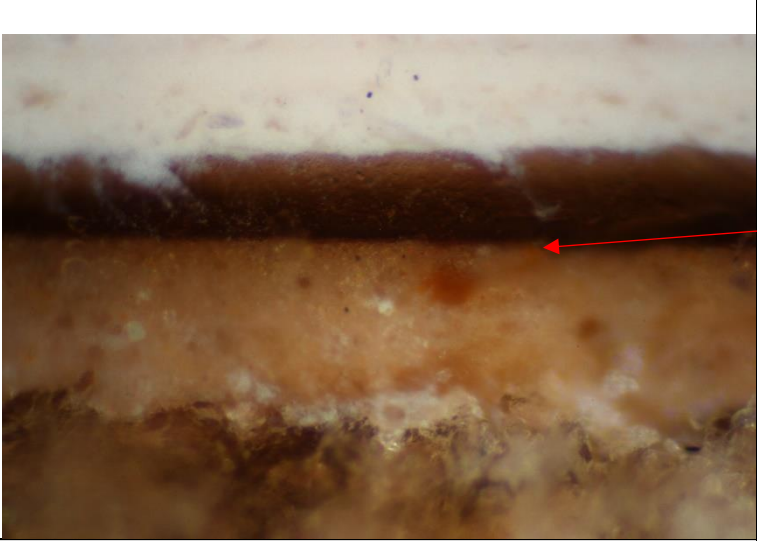
| Sample Ref: 32 | Location: 38 to 42 Mosley Street |
|---|---|
| | <p><b>X400 Magnification -</b><br/>Earliest paint layers.</p> <p>Earliest paint scheme – tinted varnish over stone coloured paint based on lead carbonate.</p> <p>Note: The original appearance of the timberwork would have been of a slightly grained hardwood.</p> |

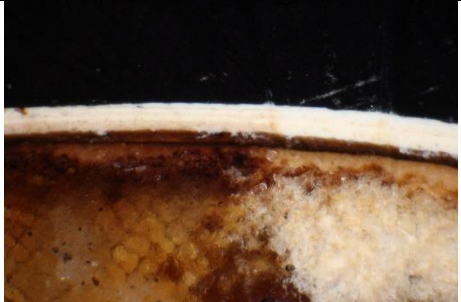
| Sample Ref: 32 | Location: 38 to 42 Mosley Street |
|---|---|
| <p>Early schemes tested for lead</p> <p>Yes – no evidence early lead based paints present.</p> | |

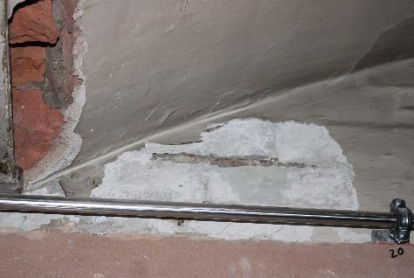
| Sample Ref: 33 | Location: 38 to 42 Mosley Street |
|---|---|
| <p>Paint sample removed from:</p> <p>Location: 33 – Basement, External Wall.</p> <p>A total of 20+ separate paint layers were found.</p> | |

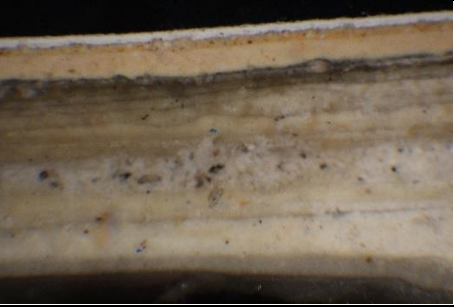
| Sample Ref: 33 | Location: 38 to 42 Mosley Street |
|---|---|
| <p>Early schemes tested for lead</p> <p>Yes – no evidence early lead-based paints present.</p> | |

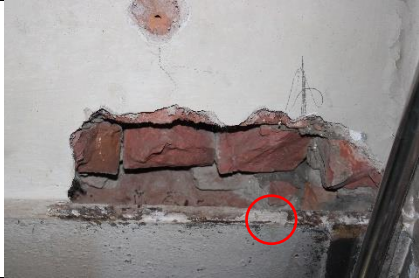
| Sample Ref: 34 | Location: 38 to 42 Mosley Street |
|---|---|
| <p>Paint sample removed from:</p> <p>Location: 34 – Basement, Iron Beam.</p> <p>A total of 20+ separate paint layers were found.</p> | |

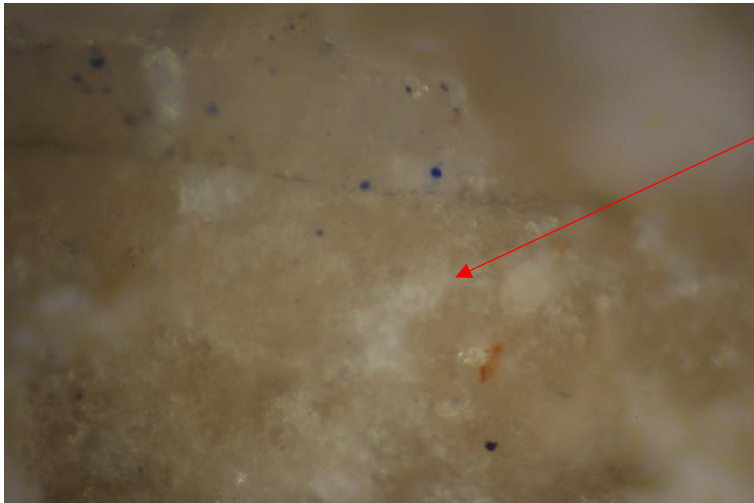
| Sample Ref: 34 | Location: 38 to 42 Mosley Street |
|---|---|
| | <p><b>X400 Magnification -</b><br/>Earliest paint layers.</p> <p>Earliest paint scheme – white lime wash.</p> |

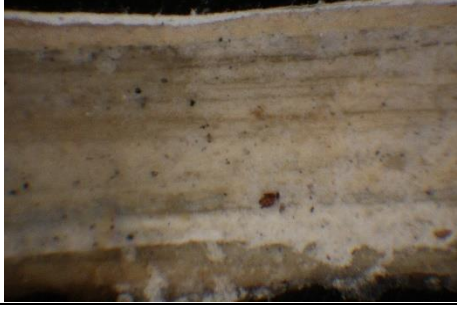
| Sample Ref: 34 | Location: 38 to 42 Mosley Street |
|---|---|
| <p>Early schemes tested for lead</p> <p>Yes – no evidence early lead-based paints present.</p> | |

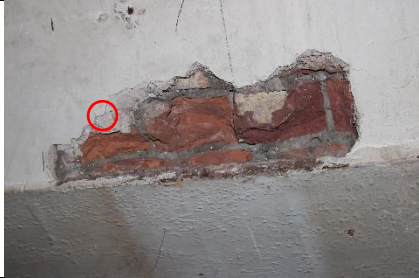
| Sample Ref: 35 | Location: 38 to 42 Mosley Street |

| Sample Ref: 35 | Location: 38 to 42 Mosley Street |
|---|---|
| <p>Paint sample removed from:</p> <p>Location: 35 – Basement, Vaulted Ceiling.</p> <p>A total of 2 separate paint layers were found.</p> | |

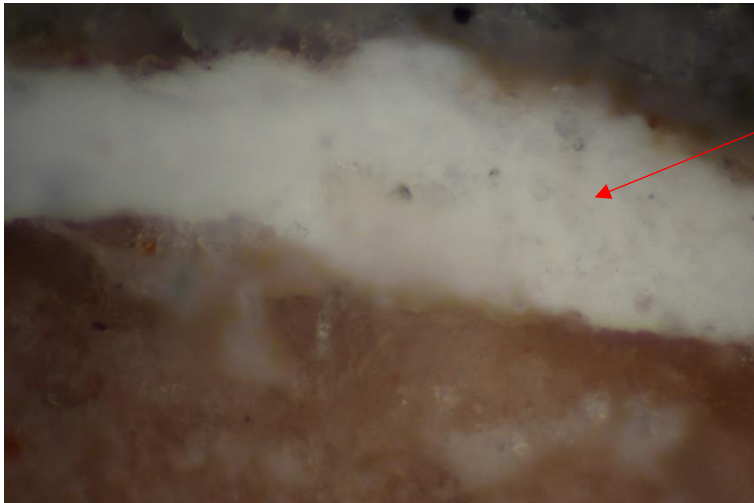
| Sample Ref: 35 | Location: 38 to 42 Mosley Street |
|---|---|
| | <p><b>X400 Magnification -</b><br/>Earliest paint layers.</p> <p>Earliest paint scheme – modern white paint based on Titanium white.</p> |

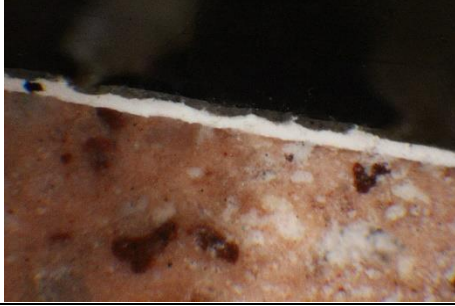
| Sample Ref: 35 | Location: 38 to 42 Mosley Street |
|---|---|
| <p>Tested for lead based paints.</p> <p>Yes – no lead paints present.</p> | |

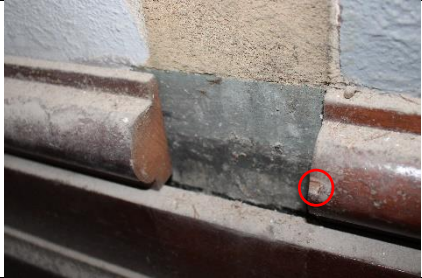
| Sample Ref: 36 | Location: 38 to 42 Mosley Street |
|---|---|
| <p>Paint sample removed from:</p> <p>Location: 36 – Banking Hall - Skirting.</p> <p>A total of 1 separate paint layer was found.</p> | |

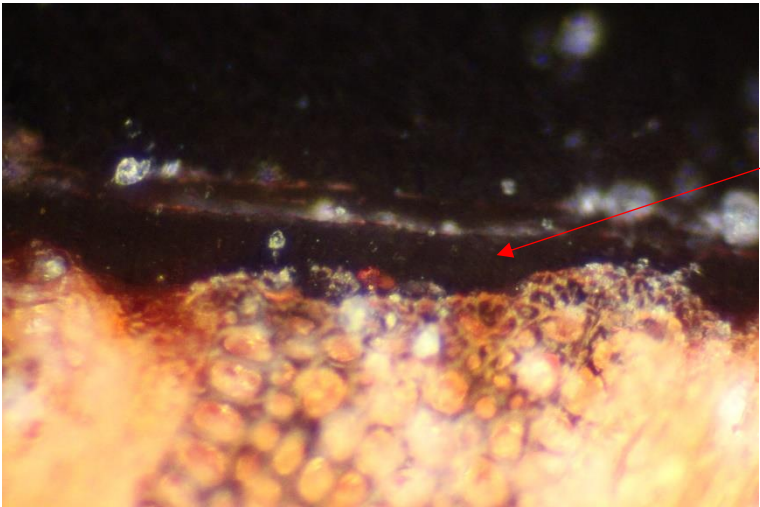
| Sample Ref: 36 | Location: 38 to 42 Mosley Street |
|---|---|
| | <p><b>X400 Magnification -</b><br/>Earliest paint layers.</p> <p>Earliest decorative scheme – tinted varnish over hardwood timber.</p> |
