**Project: 680 Rylands Building, Manchester**  
**Non-Intrusive Condition Survey**

**Metalwork Surveyor and Conservator – Sam Jacklin & Andrew Chant**  
**Survey Carried Out – Tuesday 19<sup>th</sup> November 2024**

**Calibre Metalwork Limited**

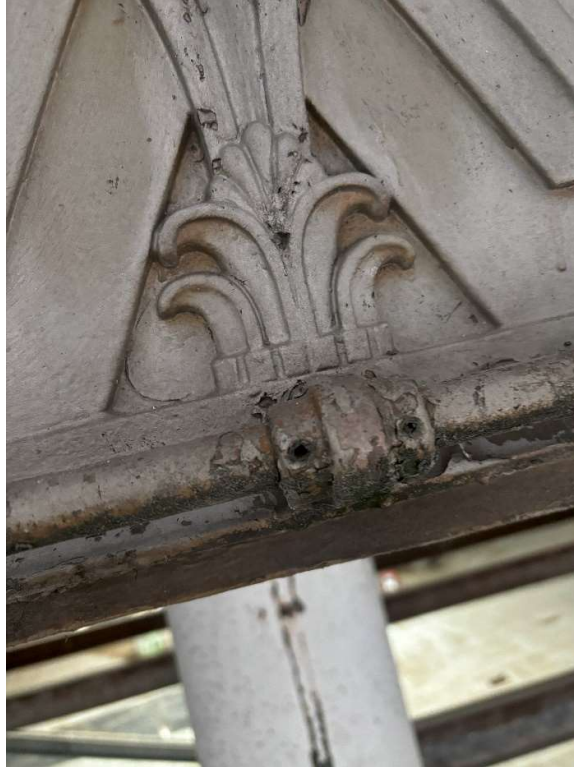
The frieze panels have been overpainted many times over the years. The existing paintwork is flaking and failing throughout, making the current condition of the frieze difficult to survey in-situ. However, the frieze appears to be in complete condition throughout.

The frieze sections are in ~1800mm panels with a metal rail fixed with decorative rail holders at approximately 500mm centres. The rail appeared to be installed in approximately 3000mm lengths and is joined via a wider rail holder and fixed via 2 no grub screws.

It is our proposal to tag, record and remove each panel / rail and decorative fixings. Sensitively clean, as not to damage the finish of the soft castings, to reveal the true condition of the frieze beneath.

We will then undertake a condition survey to reveal any unforeseen repairs and issue a quotation for your approval.

Following your approval, we will carry out any required repairs and we propose to apply our heritage approved wax to preserve the original material finish and install into original locations.

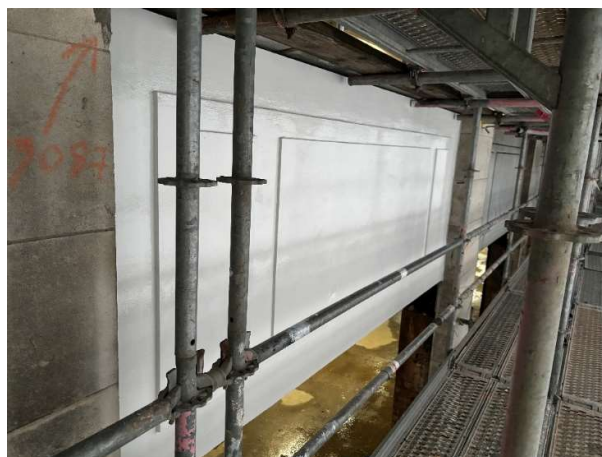
There is localised corrosion apparent on a number of the panels and in many cases, there are casting defects (pits) within the panel. Where the paint has been damaged or lifted, localised corrosion has become apparent.

As per the sample we have already undertaken, we propose to retain as much of the sound paint as possible, treating only corroded areas with the complete removal of paint. Rust would then be abraded to bright metal and converted using our acidic solution and primer applied locally. All other areas would be sanded to provide a key feathering in any edges to existing paint throughout to achieve a smooth finish.

We will apply our own heritage approved paint system by roller / brush.

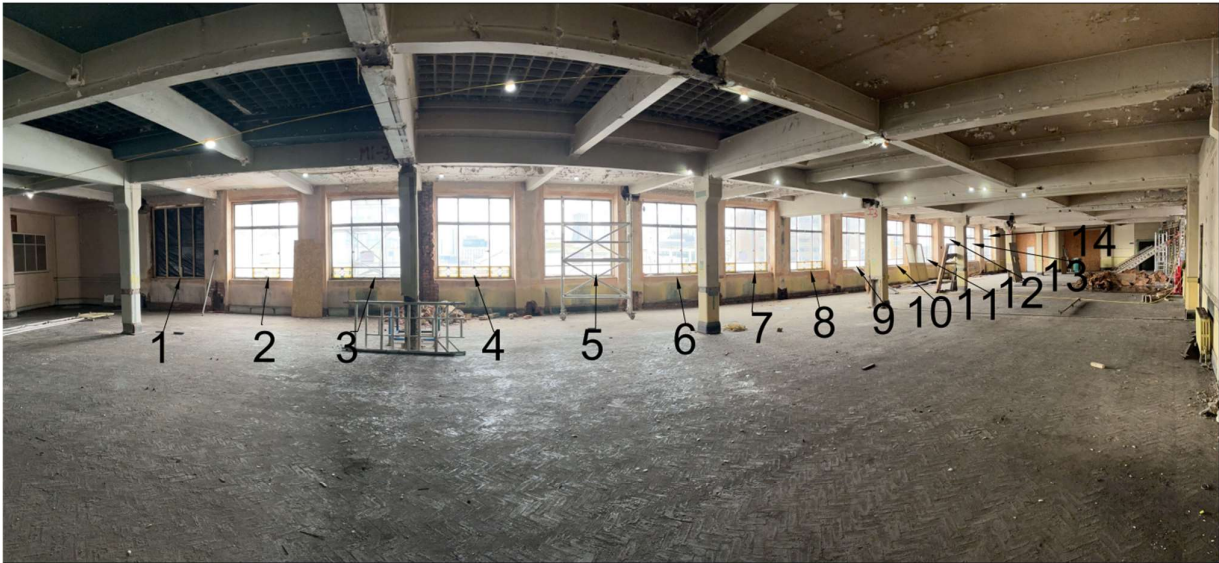
Level 7 Windows (14no)

For the ease of the report, I have numbered each window as per the annotated photo below-

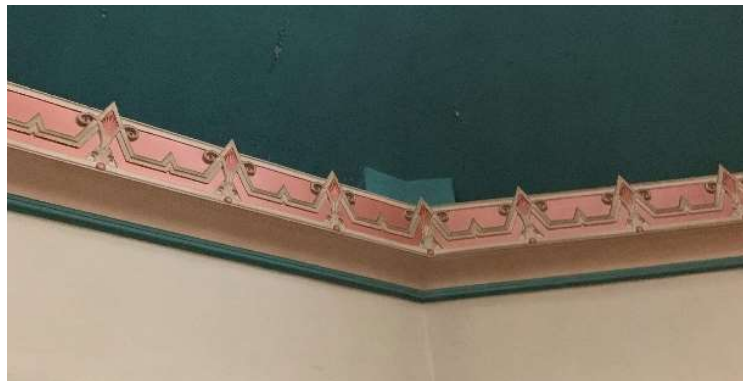
Access to the frieze below the cupola's was not available so a detailed survey of this was not achieved. Without suitable access it is unclear what material the frieze is constructed of but from floor level it is believed to be decorative plaster. The reasoning behind this is due to there being no visible joins / fixings similar to those visible on the exterior of the building.

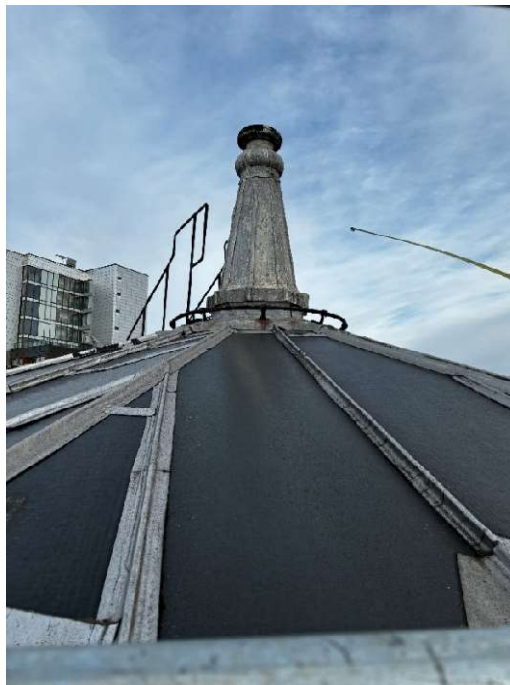
The flagpole location was not accessible during our survey. It was apparent from the scaffold deck at rooflight level that the flagpole is no longer in-situ.
