# Cornbrook Culvert Condition Survey

JANUARY 2025

Ref. 222-176

# Bennet Street Culvert Survey- Comprehensive Report and Recommendations

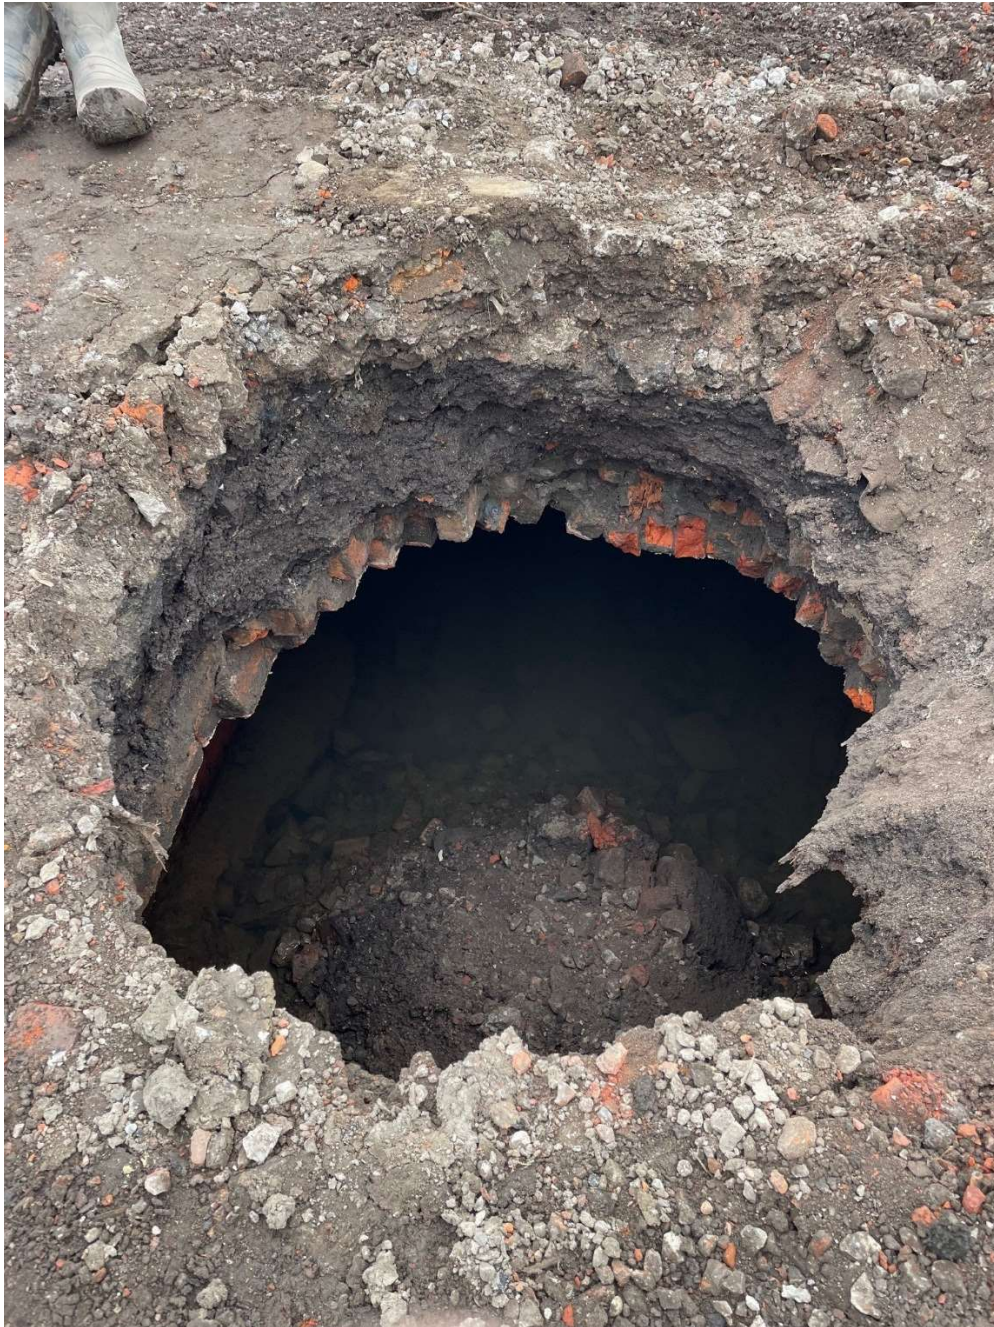
- A partial collapse of the culvert's brick archway was noted, resulting in a 1.5m diameter opening.
- The reduced ground cover above the culvert was identified as a contributing factor to the structural failure, as it limited the arch's capacity to distribute the applied loads.
- Debris and loose bricks were observed within the culvert, but it was confirmed that water flow remained largely unobstructed at the time of inspection.
- Ground investigations revealed a layer of site fill material, approximately 500mm thick, above a stiff clay layer encountered at a depth of approximately 1m. The clay stratum provided sufficient bearing capacity for the proposed remedial measures.

- The damaged brickwork of the culvert will be carefully removed back to the spring line of the arch to ensure the stability of the remaining structure.

- New trench fill foundations, approximately 900mm wide, will be constructed on either side of the culvert to support the reinforced concrete slab.

- A secondary 300mm thick reinforced concrete slab will be installed over the trench fill foundations to span the culvert and form a bridging structure capable of supporting vehicular and pedestrian loads.
