An inspection of timber at

CLAYTON HALL, M11 4RU

## INTRODUCTION

Following instructions from Michael Clarkson of Rosslee Construction, I visited the above building on 01.05.24.

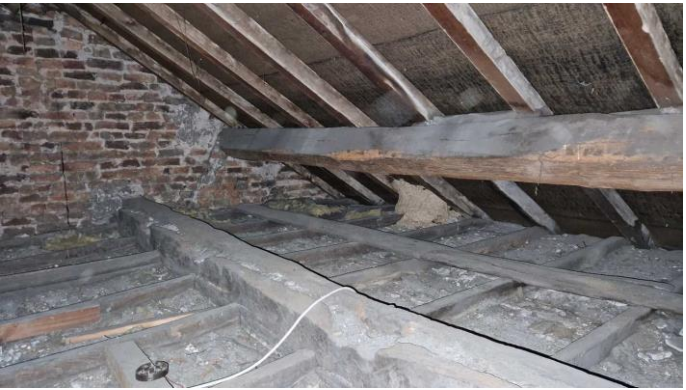
| <p>1</p> <p>Modern felt. Principal timbers with export marks indicating some replacement timber is imported <i>Pinus sylvestris</i>.</p> <p>Some replaced common rafters.</p> | | <p>2</p> <p>General arrangement – no comment.</p> | |

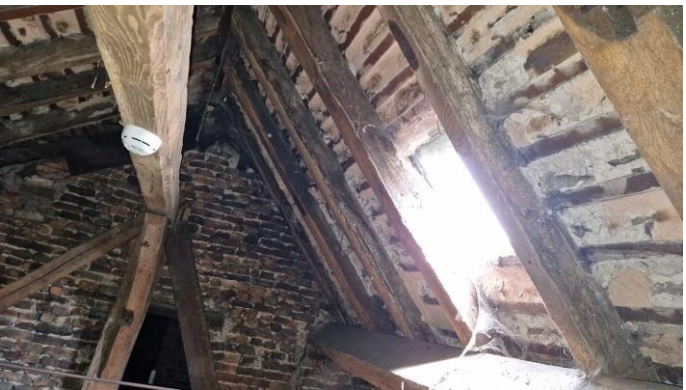
| <p>3</p> <p>Goal post arrangement picking up purlin with reduced section in wall – all historic.</p> | | <p>4</p> <p>General arrangement. See previous photos</p> | |

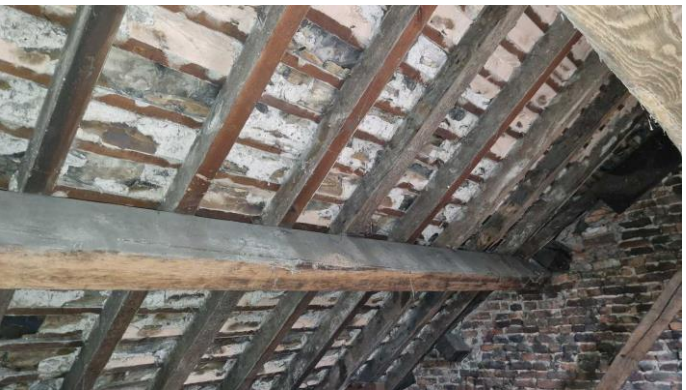
| <p>5</p> <p>General arrangement.</p> | | <p>6</p> <p>Bell turret foundation beams all sound. See previous photos.</p> | |
