## ASBESTOS REFURBISHMENT SURVEY REPORT

| <b>Site</b> | Brunswick (B Lounge), 97 Piccadilly, Manchester, M1 2DB |
| <b>Date report issued</b> | 6th January 2025 |
| <b>Survey reference</b> | J1104079 |

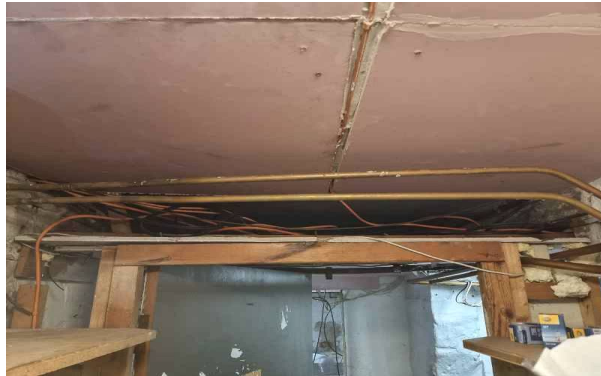
| Item / Inspection Ref: | #10 | Material Assessment | Product type: | 2 | |

| Comments: | Continues to ceiling in lobby between offices | | | | | |

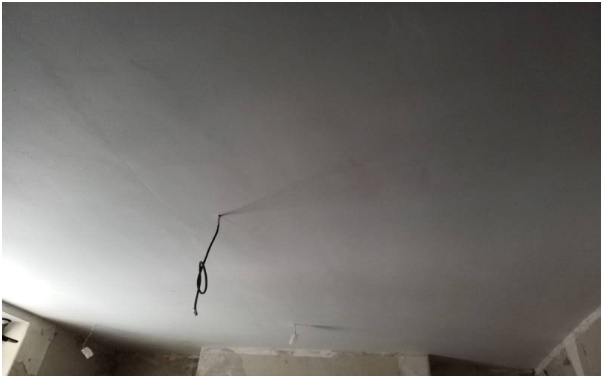
| Item / Inspection Ref: | #12 | Material Assessment | Product type: | 1 | |

| Comments: | Stipple effect | | | | |

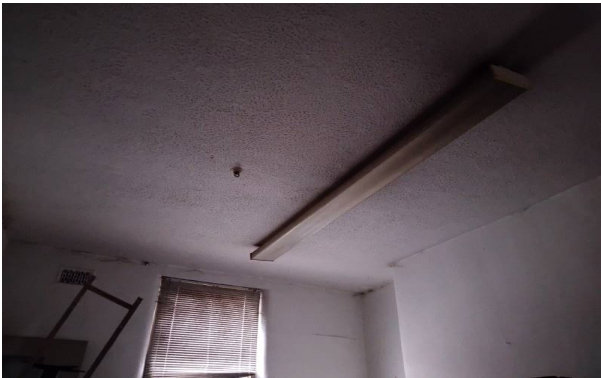
| Item / Inspection Ref: | #13 | Material Assessment | Product type: | 1 | |

| Comments: | Stipple effect | | | | |

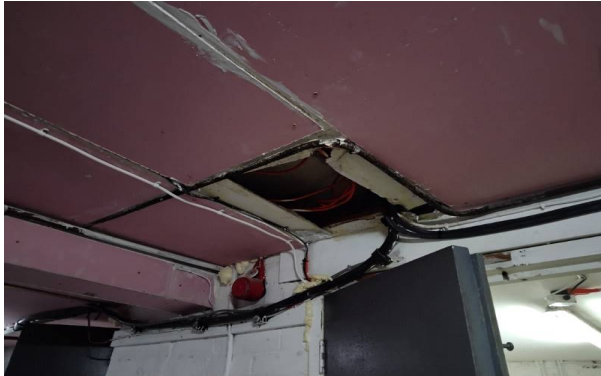
| Item / Inspection Ref: | #25 | Material Assessment | Product type: | 2 | |

| Comments: | During the asbestos re-inspection undertaken on 28/07/2023 it was identified that this material has been removed, which is understood to have been completed by iES in July 2022. | | | | |

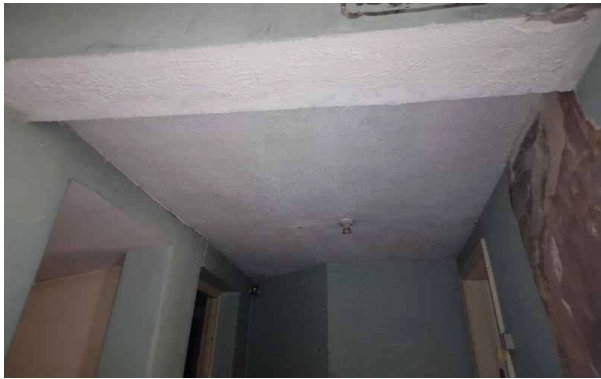
| Item / Inspection Ref: | #33 | Material Assessment | Product type: | 2 | |

| Comments: | During the asbestos re-inspection undertaken on 28/07/2023 it was identified that this material has been removed, which is understood to have been completed by iES in July 2022. | | | | |

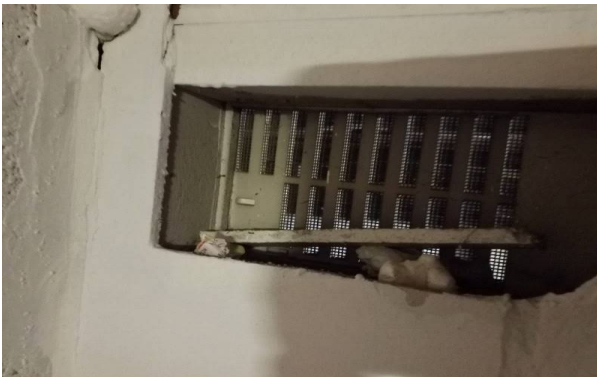
| Item / Inspection Ref: | #34 | Material Assessment | Product type: | 2 | |

| Comments: | During the asbestos re-inspection undertaken on 28/07/2023 it was identified that this material has been removed, which is understood to have been completed by iES in July 2022. | | | | |

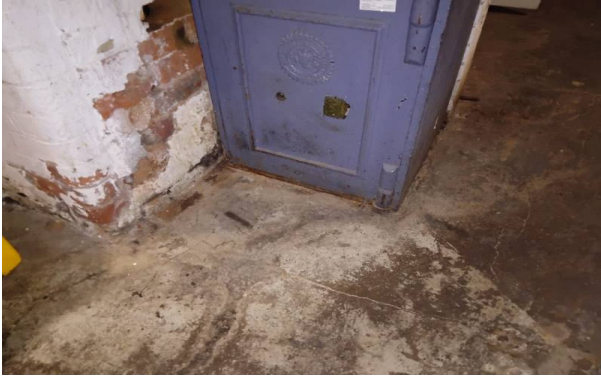
| <b>Item / Inspection Ref:</b> | #35 | <b>Material Assessment</b> | Product type: | | |

| <b>Comments:</b> | During the asbestos re-inspection undertaken on 28/07/2023 it was identified that this material has been removed, which is understood to have been completed by iES in July 2022. | | | | |

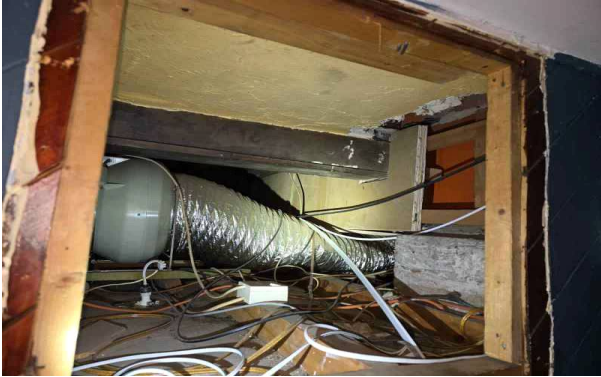
| <b>Item / Inspection Ref:</b> | #44 | <b>Material Assessment</b> | Product type: | | |

| Comments: | Stipple effect. Visible within hatch and adjacent light fittings | | | | | |

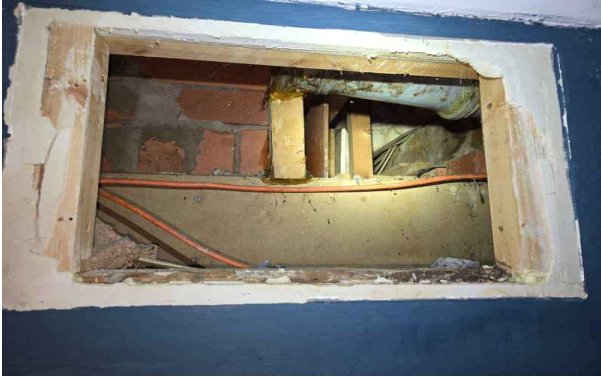
| <b>Item / Inspection Ref:</b> | #53 | <b>Material Assessment</b> | Product type: | | |

| Comments: | Visible above extract vent | | | | |

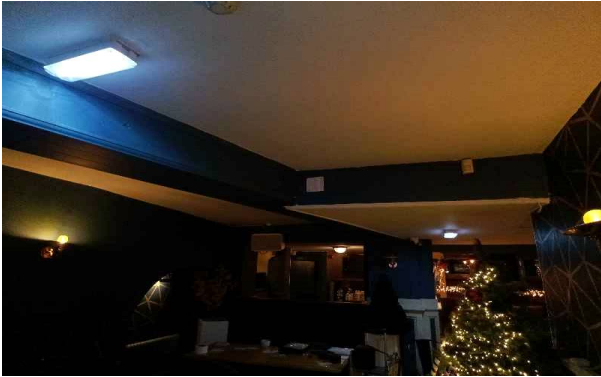
| <b>Item / Inspection Ref:</b> | #58 | <b>Material Assessment</b> | Product type: | | | |

| Comments: | Stipple effect. Visible above lowered ceiling and adjacent light fittings continues to ceiling above bulkhead towards bar servery. | | | | |

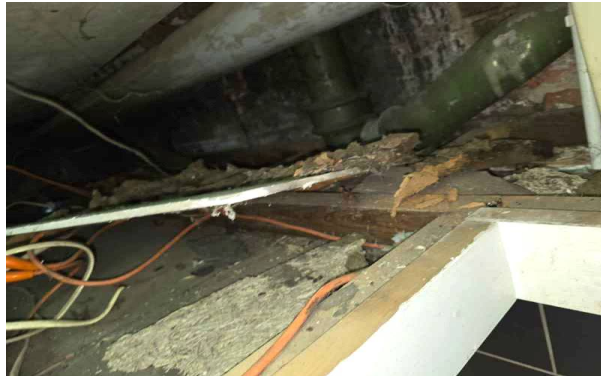
| Item / Inspection Ref: | #64 | Material Assessment | Product type: | 2 | |

| Comments: | Some areas have superlux overboarding. Presumed to remain behind timber to soffit of stairs. | | | | |

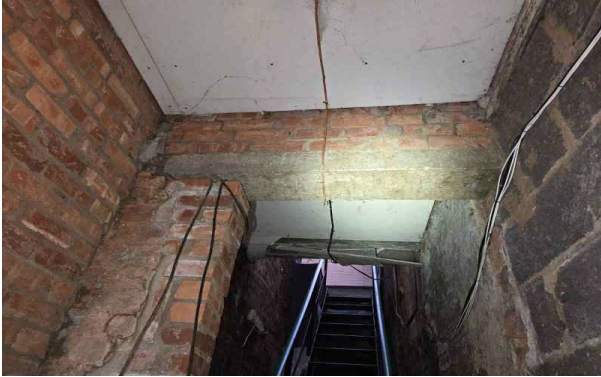
| <b>Item / Inspection Ref:</b> | #68 | <b>Material Assessment</b> | Product type: | 2 | |

| <b>Sample Ref:</b> | DJ003622 | | Condition / Damage: | 3 | |

| <b>Comments:</b> | Replace damaged boards and encapsulate | | | | |

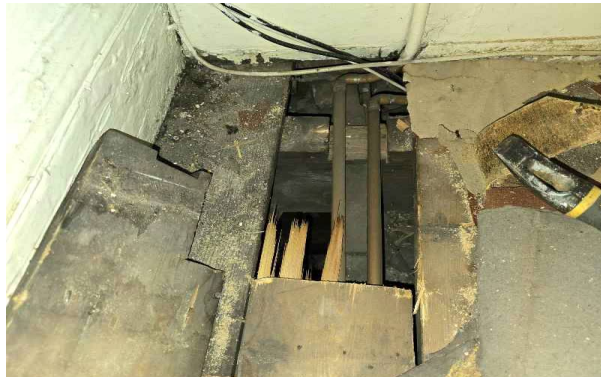
| Comments: | Limited inspection below floorboards due to amount of stored items and furniture in room | | | | |

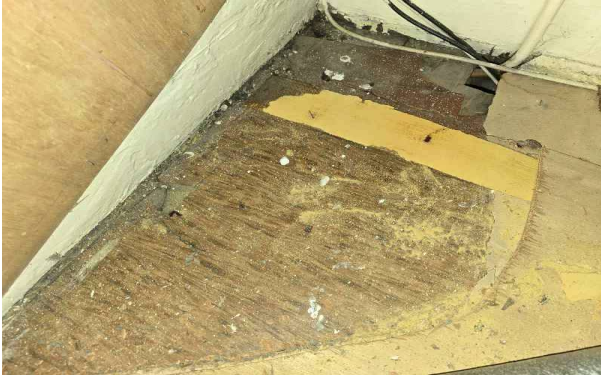
| <b>Item / Inspection Ref:</b> | #71 | <b>Material Assessment</b> | <b>Product type:</b> | | |

| <b>Comments:</b> | Unable to access below floor coverings due to amount of stored items and furniture in room | | | | |

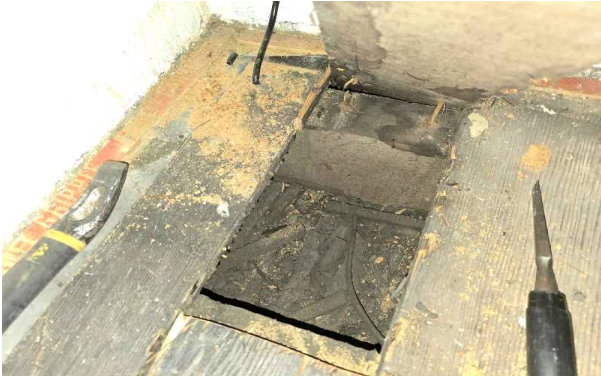
| <b>Item / Inspection Ref:</b> | #74 | <b>Material Assessment</b> | Product type: | | |

| <b>Comments:</b> | Limited inspection below floorboards due to amount of stored items and furniture in room | | | | |

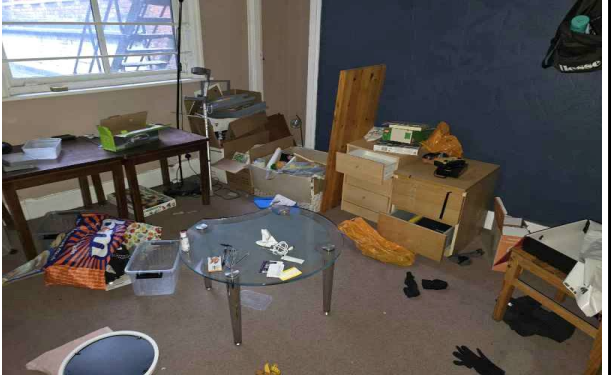
| <b>Item / Inspection Ref:</b> | #75 | <b>Material Assessment</b> | Product type: | | |

| <b>Comments:</b> | Unable to access below floor coverings due to amount of stored items and furniture in room | | | | |

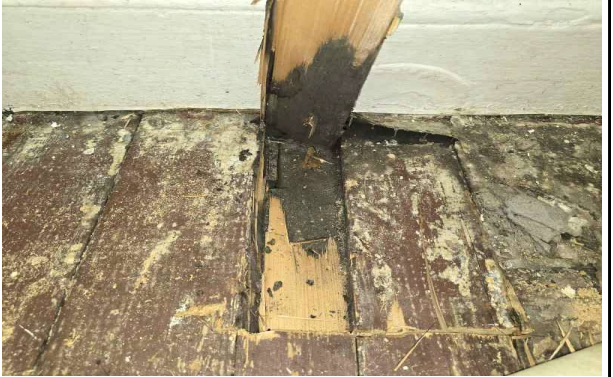
| <b>Item / Inspection Ref:</b> | #76 | <b>Material Assessment</b> | Product type: | | |

| <b>Comments:</b> | Limited inspection below floorboards due to fixed floor coverings in room | | | | |

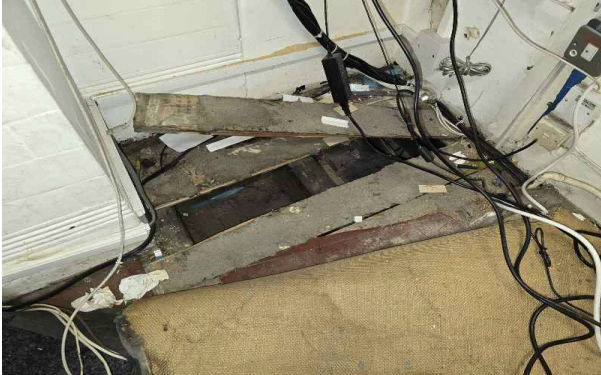
| <b>Item / Inspection Ref:</b> | #77 | <b>Material Assessment</b> | <b>Product type:</b> | | |

| <b>Comments:</b> | Limited inspection below floorboards due to amount of stored items and furniture in room | | | | |
