# Brunswick Mill

Manchester

## Inventory of significant fixtures and fittings

30<sup>th</sup> January  
2025

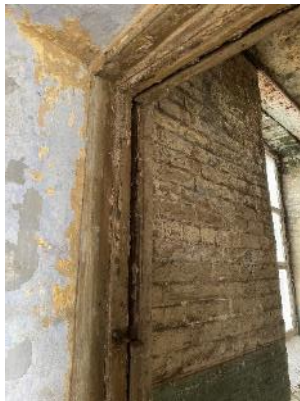
| 3 | Top half of original timber door frame between room A and C | 1 | Top half of original timber door frame between room A and C, shortened to form an internal window in the early 20 <sup>th</sup> century | | To be removed<br><br>will not achieve fire ratings and in way of new doorway | |

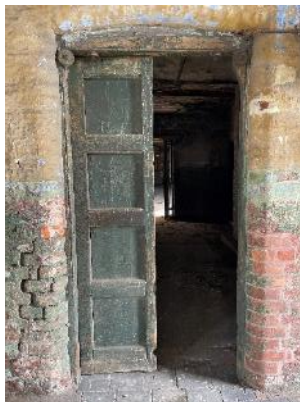
| 4 | Original timber door frame between room A and B | 1 | Original timber door frame between room A and B with c1930s panelled doors/closers | | KEEP in situ board / block around so not visible.<br><br>No restoration required as will be hidden | |

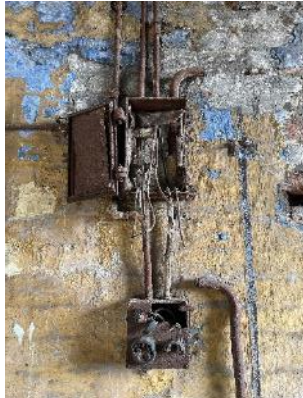
| 5 | Early 20 <sup>th</sup> century (likely 1909) metal fuse box and bank of four dolly light switches. | / | Early 20 <sup>th</sup> century (likely 1909) metal fuse box and bank of four dolly light switches. | | <p>REMOVE</p> <p>H&amp;S RISK</p> <p>In very poor condition and sharp broken edges</p> <p>Will struggle to restore due to corrosion.</p> | |

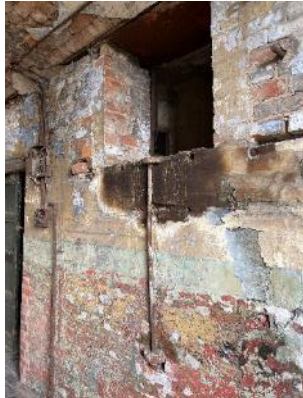
| 6 | Large opening between room A and 1930s toilets off room B. | 1 | Large opening between room A and 1930s toilets off room B with heavy iron supports originally supporting line shafting for looms (before toilets were installed). | | <p>Will require blocking up.</p> <p>needs to be 120 minutes blocked up</p> | |

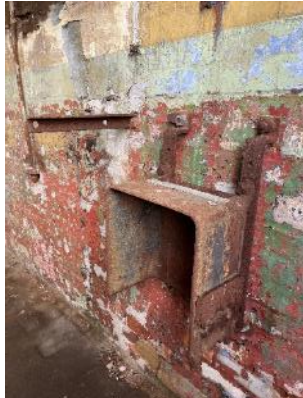
| 7 | Remains of c1909 electrical motor switch gear equipment to looms | 1 | Remains of c1909 electrical motor switch gear equipment to looms | | | <p>Remove and relocate item to a secure container for assessment.</p> <p>Review and design a heritage display for selected items in the concierge area.</p> <p>Offer any remaining heritage pieces to incoming commercial tenants.</p> <p>If item is used within the scheme it will be restored by specialist</p> |

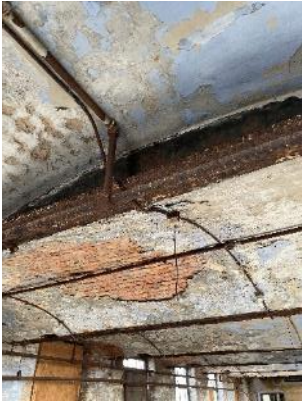
| 10 | C1909 water sprinkler pipes and electric lighting conduits. | / | <p>C1909 water sprinkler pipes and electric lighting conduits (majority with white ceramic pendant roses).</p> <p>Positioned across entire ceiling of room</p> | | <p>REMOVE</p> <p>KEEP sprinkler system in communal areas and restore / paint where possible as indicated by drawings provided</p> | |

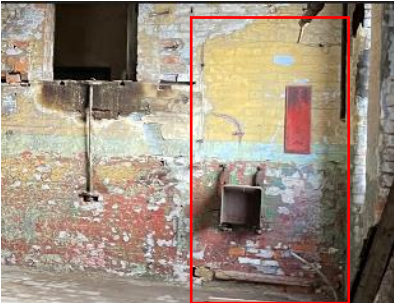
| 11 | Blocked entrance into original 1840 mill worker's latrine. | 1 | Blocked entrance into original 1840 mill worker's latrine. The original narrow room is now inaccessible and marked by the surviving segmental, brick-arched door head and sandstone step. | | Retain projecting stone step and outline of original door opening. | |

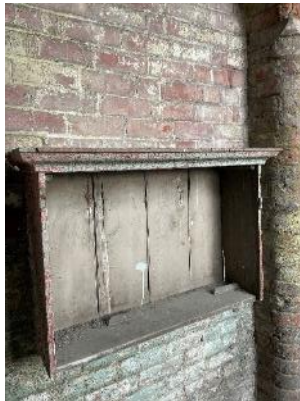
| Room C | | | | | | |
|---|---|---|---|---|---|---|
| 1 | Early 20 <sup>th</sup> century possibly timber fire extinguisher/hose wall mounted cabinet | 1 | Early 20 <sup>th</sup> century possibly timber fire extinguisher/hose wall mounted cabinet, with markings for two removed hooks inside. | | | <p>Remove and relocate item to a secure container for assessment.</p> <p>Review and design a heritage display for selected items in the concierge area.</p> <p>Offer any remaining heritage pieces to incoming commercial tenants.</p> <p>if item is used within the scheme it will be restored by specialist</p> |

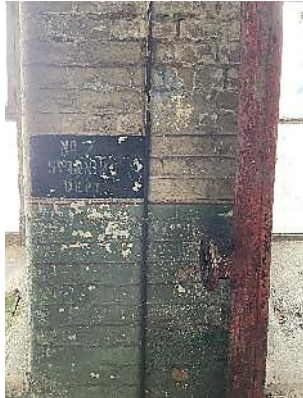
| 2 | Early 20th century painted floor level sign for “No 7 Spinning Dept” | 1 | Early 20th century painted floor level sign for “No 7 Spinning Dept” | | paint scheme to pier to be retained and sealed as a feature. | / |

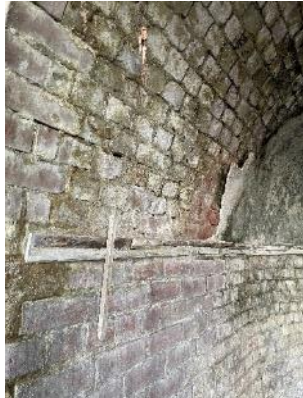
| 2 | Early 20th century painted floor level sign for “No 7 Spinning Dept” | 1 | Early 20th century painted floor level sign for “No 7 Spinning Dept” | | paint scheme to pier to be retained and sealed as a feature. | / |
|---|---|---|---|---|---|---|
| 3 | Original c1840 timber moulding separating the plastered ceiling of the staircase dome with the exposed/painted brickwork below. | / | Original c1840 timber moulding separating the plastered ceiling of the staircase dome with the exposed/painted brickwork below. | | Repair timber moulding/replace any missing or damaged areas.<br>Repair lime plaster ceiling/redecorate.<br><br>decoration finish | / |

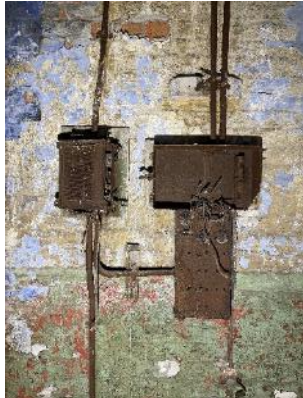
| 1 | Early 20 <sup>th</sup> century fuse/electric wall mounted boxes/conduits. | 1/3 | Early 20 <sup>th</sup> century fuse/electric boxes that are likely to date to the introduction of electricity into the mill in 1909 when the cotton looms/lighting were transferred to electric power. | | <p>Sits in stud partition line – remove.</p> <p>In very poor condition and sharp broken edges</p> <p>Will struggle to restore due to corrosion.</p> <p>Heigh also issue.</p> | |

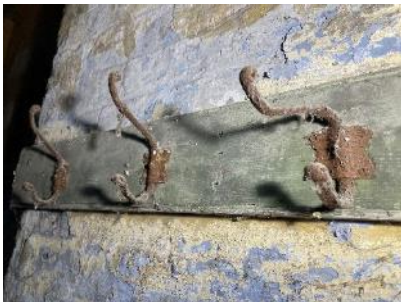
| 2 | Early-20 <sup>th</sup> century mill worker's metal shawl/coat hooks on painted timber planks rails– in varying degrees of completion/condition | 23 | Early-20 <sup>th</sup> century mill worker's shawl/coat rails, originally affixed to each window pier to allow for mill girls to hang their belongings on behind where their station was at the loom. | | <p>REMOVE</p> <p>H&amp;S RISK</p> <p>BC and ourselves worries about corrosion of the hangers and dangers of injury / eye lines</p> | <p>Remove and relocate item to a secure container for assessment.</p> <p>Review and design a heritage display for selected items in the concierge area.</p> <p>Offer any remaining heritage pieces to incoming commercial tenants.</p> <p>if item is used within the scheme it will be restored by specialist</p> |

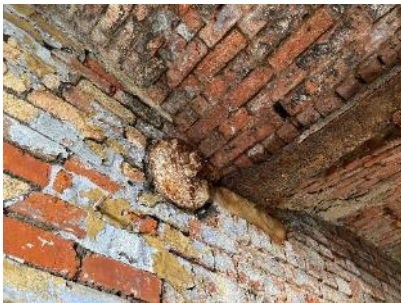
| 5 | Iron tie plate | 1 | An original/early patters plate between room D and room B. | | Retain, redecorate<br>To be restored by specialist | |

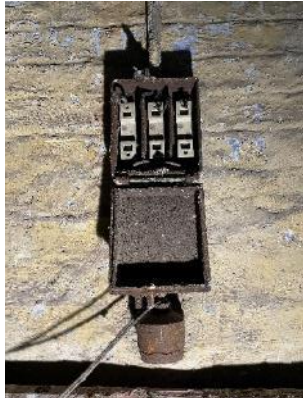
| 2 | C1909 iron clad fuse box with early electric socket | 1 | C1909 iron clad fuse box with early electric socket | | Remove<br><br>Sits in lift service void and clashes with lifts | |

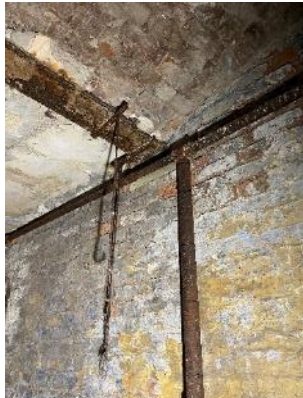
| 3 | C1909 water sprinkler pipes. | / | C1909 water sprinkler pipes. Positioned across entire ceiling of room | | REMOVE<br><br>KEEP sprinkler system in communal areas and restore / paint where possible as indicated by drawings provided | / |

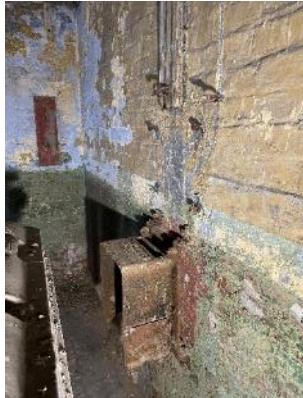
| 2 | Remains of c1909 fuse/electric wall mounted boxes/conduits. | 1/3 | <p>C1909 fuse/electric boxes that are likely to date to the introduction of electricity into the mill in 1909 when the cotton looms/lighting were transferred to electric power.</p> <p>Top iron panel has slot for lever and embossed lettering denoting different power settings.</p> | | <p>All sat in living room area – remove</p> <p>Corroded and badly damaged</p> | |

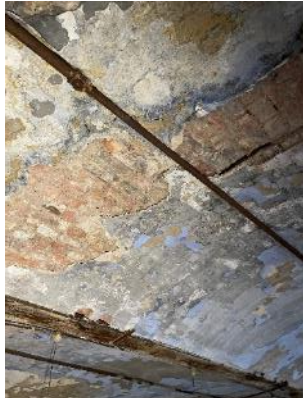
| 3 | C1909 water sprinkler pipes. | / | C1909 water sprinkler pipes. Positioned across entire ceiling of room | | REMOVE<br><br>KEEP sprinkler system in communal areas and restore / paint where possible as indicated by drawings provided | / |

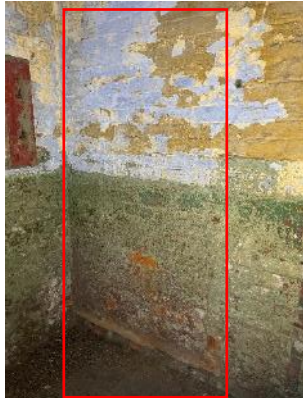
| 4 | Blocked entrance into original 1840 mill worker's latrine. | 1 | Blocked entrance into original 1840 mill worker's latrine. The original narrow room is now inaccessible and marked by the surviving segmental, brick-arched door head and sandstone step. | | Retain projecting stone step and outline of original door opening. | / |

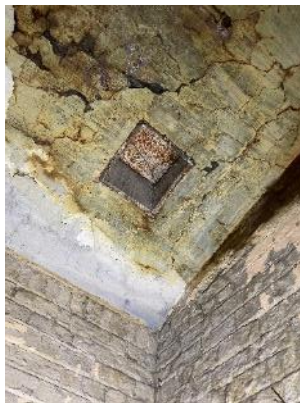
| Inventory of Significant Fixtures & Fittings – Fifth Floor Level | | | | | | |
|---|---|---|---|---|---|---|
| 1 | Ceiling hatch from room above (room A, floor 6 – see entry above) | 1 | Underside of hatch from the room above. Unknown purpose. | | <p>Leave in situ</p> <p>To be restored by specialist</p> | |

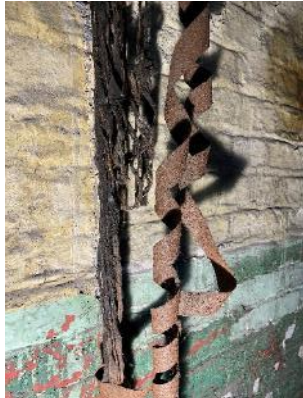
| 2 | Example of a still connected length of original 1909 electric cable. | / | Example of a still connected length of original 1909 electric cable, referred to in the 1910 write-up of the electric installation as “three-score, steel-taped armoured” type. (Source: Electrical Review and Western Electrician, Vol 56, No 15 1910) | | Remove<br><br>Significantly damaged | |

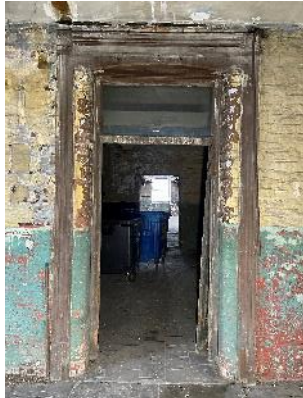
| 6 | A “polite” timber doorcase (and panelled door/fanlight). | 1 | <p>A “polite” timber doorcase (and panelled door/fanlight) leading into the room from room B, dating to the early-1900s. This may have been inserted to form a new room type, such as one of the “recreation rooms” as described in a 1926 article.</p> <p>The original glass panel in the door was later replaced with timber with the sign “mill stores” painted on the outside face.</p> | | <p><b>REMOVE</b></p> <p><b>FIRE / H&amp;S RISK</b></p> <p>Items are in a sterile area / lobby / don’t have the correct fire protection measures.</p> | <p>Remove and relocate item to a secure container for assessment.</p> <p>Review and design a heritage display for selected items in the concierge area.</p> <p>Offer any remaining heritage pieces to incoming commercial tenants.</p> <p>if item is used within the scheme it will be restored by speacilist</p> |

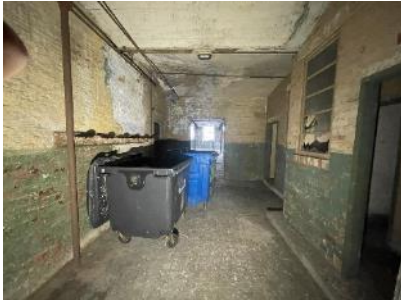
| 2 | C1909 water sprinkler pipes. | / | C1909 water sprinkler pipes. Positioned across entire ceiling of room | | REMOVE<br><br>KEEP sprinkler system in communal areas and restore / paint where possible as indicated by drawings provided | / |

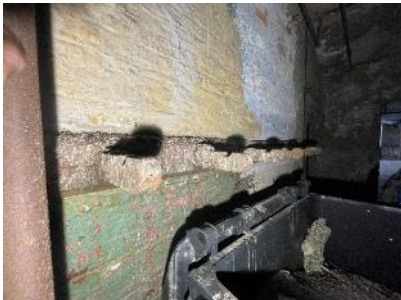
| 3 | C late-19th century timber fire bucket rack | 1 | C late-19 <sup>th</sup> century timber fire bucket rack, designed to hold tin buckets of sand, presumably installed before the installation of the 1909 sprinkler system. | | Remove as they clash with lift service void | Remove and relocate item to a secure container for assessment.<br><br>Review and design a heritage display for selected items in the concierge area.<br><br>Offer any remaining heritage pieces to incoming commercial tenants.<br><br>if item is used within the scheme it will be restored by specialist |

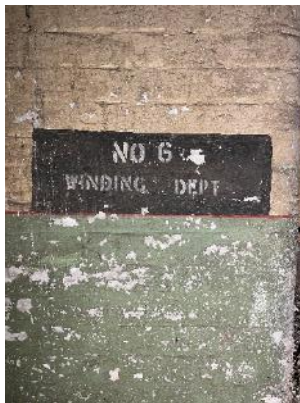
| Room C | | | | | | |
|---|---|---|---|---|---|---|
| 1 | Early 20th century painted floor level sign for "No 6 Winding Dept" | 1 | Early 20th century painted floor level sign for "No 6 Winding Dept" | | paint scheme to pier to be retained and sealed as a feature. | |

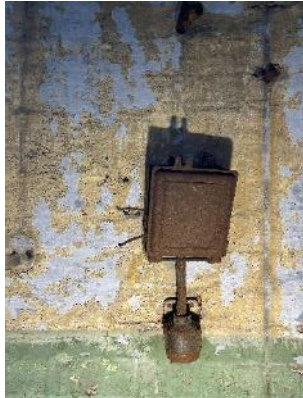
| 1 | C1909 iron clad fuse box with early electric socket | 1 | C1909 iron clad fuse box with early electric socket | | <p><b>REMOVE</b></p> <p><b>FIRE / H&amp;S RISK</b></p> <p>Corroded and damaged</p> | <p>Remove and relocate item to a secure container for assessment.</p> <p>Review and design a heritage display for selected items in the concierge area.</p> <p>Offer any remaining heritage pieces to incoming commercial tenants.</p> <p>if item is used within the scheme it will be restored by specialist</p> |

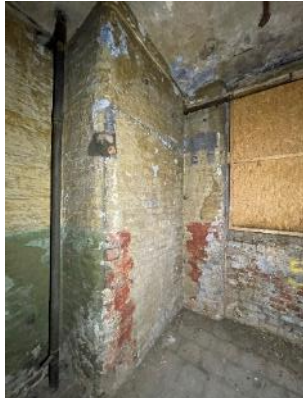
| 3 | Scaring and painted evidence of how the original mill worker's latrines operated. | 1 | Caring and differences in historic limewash layers in the north-east corner of the landing room show that originally the now blocked, narrow original latrines were serviced by an external water cistern, with pipework being fed into the back wall of the latrine, which was accessed from the other side in room G (see below entry). | | Retain outline of original door opening. | / |

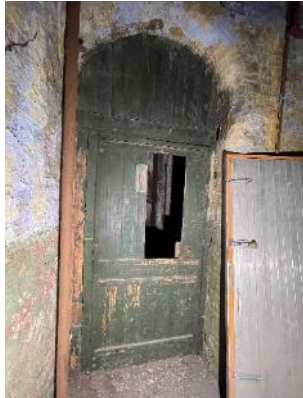
| 4 | 19 <sup>th</sup> /early-20 <sup>th</sup> century mill bale hoist door/fanlight – with ironmongery/mechanism on the inside face | 1 | 19 <sup>th</sup> /early-20 <sup>th</sup> century mill bale hoist door/fanlight – with ironmongery/mechanism on the inside face | | <p><b>REMOVE</b></p> <p><b>FIRE / H&amp;S RISK</b></p> <p>Timbers in sterile area and don't hold correct fire ratings</p> | <p>Remove and relocate item to a secure container for assessment.</p> <p>Review and design a heritage display for selected items in the concierge area.</p> <p>Offer any remaining heritage pieces to incoming commercial tenants.</p> <p>If item is used within the scheme it will be restored by specialist</p> |

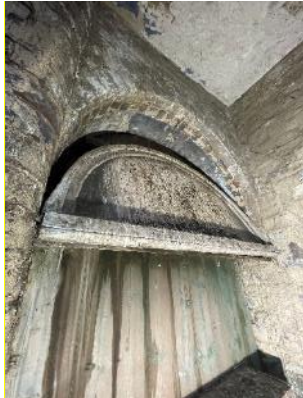
| 1 | Last remaining original glazed fanlight to bale hoist. | 1 | Original glazed fanlight allowed for daylight from the staircase landing to light the bale hoist well – this has been either boarded over or bricked-up on other floors. | | <p><b>REMOVE</b></p> <p><b>FIRE / H&amp;S RISK</b></p> <p>Timbers in sterile area and don't hold correct fire ratings</p> | <p>Remove and relocate item to a secure container for assessment.</p> <p>Review and design a heritage display for selected items in the concierge area.</p> <p>Offer any remaining heritage pieces to incoming commercial tenants.</p> <p>If item is used within the scheme it will be restored by specialist</p> |

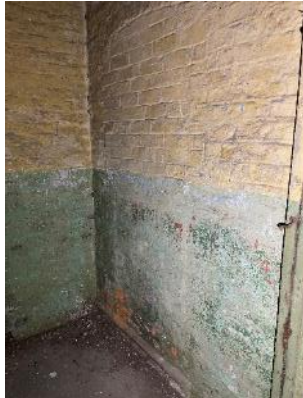
| 2 | Blocked entrance into original 1840 mill worker's latrine. | 1 | Blocked entrance into original 1840 mill worker's latrine. The original narrow room is now inaccessible and marked by the surviving segmental, brick-arched door head and sandstone step. | | Retain outline of original door opening. | |

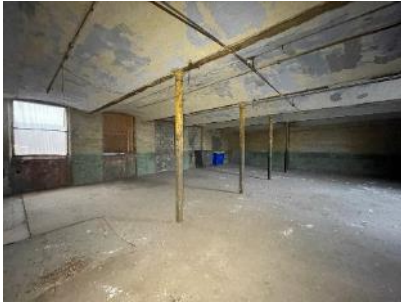
| 3 | C1909 water sprinkler pipes. | / | C1909 water sprinkler pipes. Positioned across entire ceiling of room | | REMOVE<br><br>KEEP sprinkler system in communal areas and restore / paint where possible as indicated by drawings provided | / |

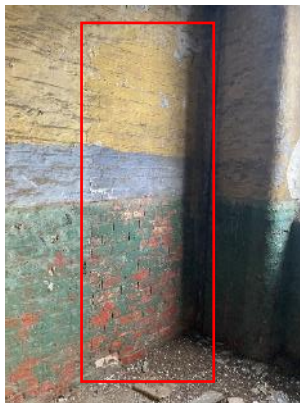
| Inventory of Significant Fixtures & Fittings – Fourth Floor Level | | | | | | |
|---|---|---|---|---|---|---|
| 1 | Blocked entrance into original 1840 mill worker's latrine. | 1 | Blocked entrance into original 1840 mill worker's latrine. The original narrow room is now inaccessible and marked by the surviving segmental, brick-arched door head. | | Retain outline of original door opening. | |

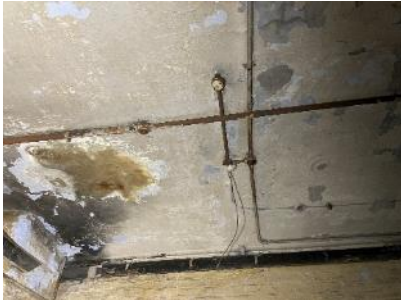
| 4 | C1909 water sprinkler pipes and electric lighting conduits. | / | C1909 water sprinkler pipes and electric lighting conduits (majority with white ceramic pendant roses).<br><br>Positioned across entire ceiling of room | | REMOVE<br><br>KEEP sprinkler system in communal areas and restore / paint where possible as indicated by drawings provided | / |

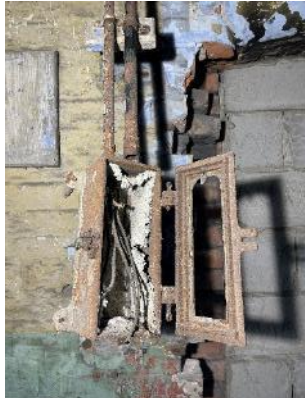
| 6 | C1909 fuse box/conduits. | 1 | C1909 fuse box/conduits. | | <p><b>REMOVE</b></p> <p><b>FIRE / H&amp;S RISK</b></p> <p>Corroded and damaged with sharp edges</p> | |

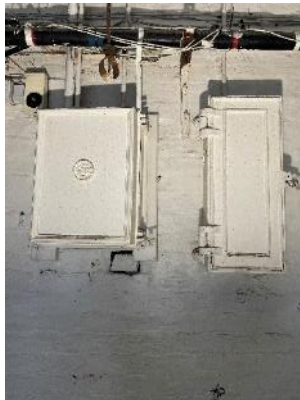
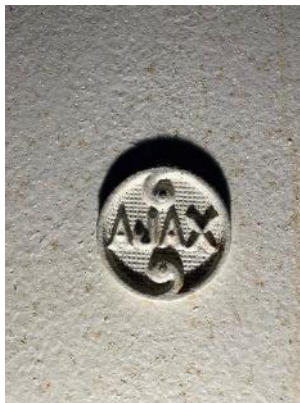
| Room D | | | | | | |
|---|---|---|---|---|---|---|
| 1 | Two c1909 metal fuse boxes. | 2 | Two c1909 metal fuse boxes, with larger box being made by "AJAX" | | <p>Remove</p> <p>Sits within kitchen area of the designed scheme</p> | <p>Remove and relocate item to a secure container for assessment.</p> <p>Review and design a heritage display for selected items in the concierge area.</p> <p>Offer any remaining heritage pieces to incoming commercial tenants.</p> <p>if item is used within the scheme it will be restored by specialist</p> |

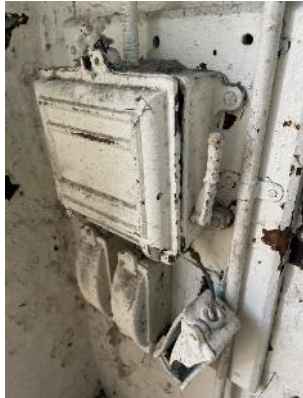
| 2 | Possible metal fuse box with metal lever handle and three smaller fuses boxes beneath. | 1 | Possible metal fuse box with metal lever handle and three smaller fuses boxes beneath. | | Decorate and keep in situ. | |

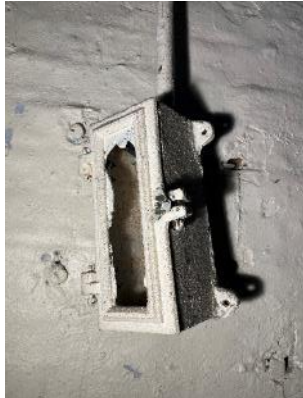
| 3 | Metal fuse board with broken glass cover. | 1 | Metal fuse board with broken glass cover. | | Remove<br>Sharp corroded item | |

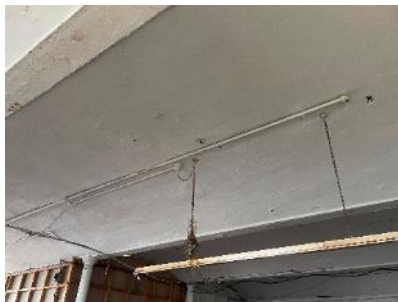
| Room E | | | | | | |
|---|---|---|---|---|---|---|
| 1 | C1909 water sprinkler pipes and electric lighting conduits. | / | C1909 water sprinkler pipes and electric lighting conduits (majority with white ceramic pendant roses).<br><br>Positioned across entire ceiling of room. | | REMOVE<br><br>KEEP sprinkler system in communal areas and restore / paint where possible as indicated by drawings provided | / |

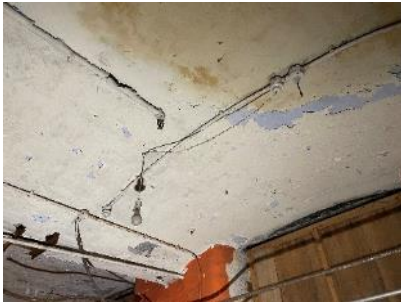
| Inventory of Significant Fixtures & Fittings – Third Floor Level | | | | | | |
|---|---|---|---|---|---|---|
| 1 | C1909 water sprinkler pipes and electric lighting conduits. | / | C1909 water sprinkler pipes and electric lighting conduits (majority with white ceramic pendant roses).<br><br>Positioned across entire ceiling of room | | Remove due to condition and issues with new sprinkler installation.<br><br>fire and compartment issues | |

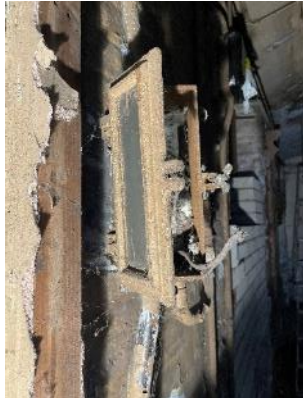
| 3 | Glass fronted c1909 metal fuse box. | 1 | Glass fronted c1909 metal fuse box. | | Poor condition - remove<br><br>Sharp and corroded | / |

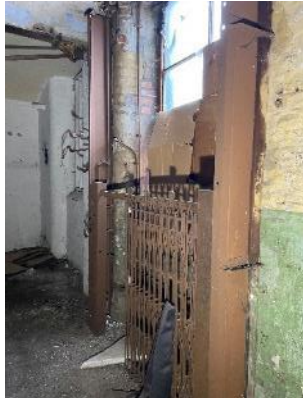
| 5 | C1950s/60s cage/hoists to external windows (south elevation) | 6 | C1950s/60s cage/hoists to external windows (south elevation) | | sits in an apartment - remove<br><br>corroded and large elements in apartment | / |

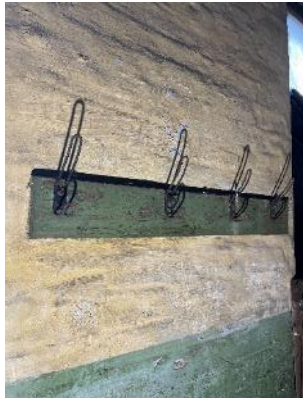
| 6 | Early-20 <sup>th</sup> century mill worker's metal shawl/coat hooks on painted timber planks rails– in varying degrees of completion/condition | 2 | Early-20 <sup>th</sup> century mill workers' shawl/coat rails, originally affixed to each window pier to allow for mill girls to hang their belongings on behind where their station was at the loom. | | REMOVE<br><br>H&S RISK<br><br>BC – highlighted the dangers of the hook been corroded and been a eye level | Remove and relocate item to a secure container for assessment.<br><br>Review and design a heritage display for selected items in the concierge area.<br><br>Offer any remaining heritage pieces to incoming commercial tenants.<br><br>if item is used within the scheme it will be restored by specialist |

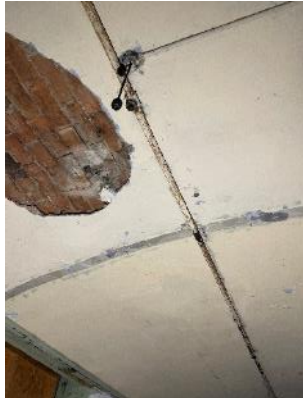
| 7 | C1909 water sprinkler pipes and electric lighting conduits. | / | C1909 water sprinkler pipes and electric lighting conduits (majority with white ceramic pendant roses).<br><br>Positioned across entire ceiling of room | | REMOVE<br><br>KEEP sprinkler system in communal areas and restore / paint where possible as indicated by drawings provided | |

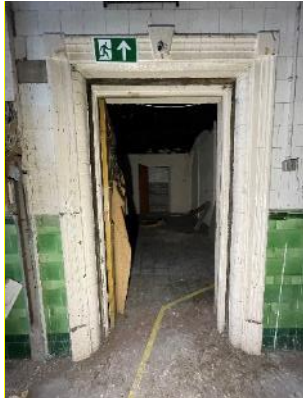
| 2 | A “polite” timber doorcase and braced/ledged door. | 1 | A “polite” timber doorcase with timber keystone and corner blocks/plinths, and timber door installed in c1909 when this room was turned into the mill’s tiled dining room in order to improve the decorative scheme. | | Needs to be blocked up and made good for fire purposes<br>Frame can stay in situ | |

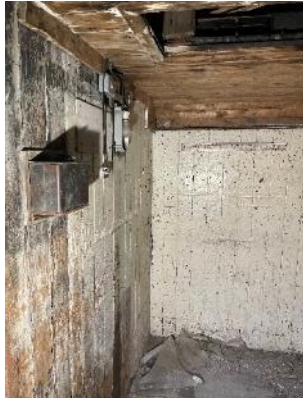
| 2 | 1920s lift/goods hoist/timber braced plank doors | 1 | 1920s lift/goods hoist/timber braced plank doors, installed by Etchells Congdon & Muir Ltd when this top storey was added. | | <p><b>Remove</b></p> <p>Significantly damaged lift and heavily corroded</p> | / |

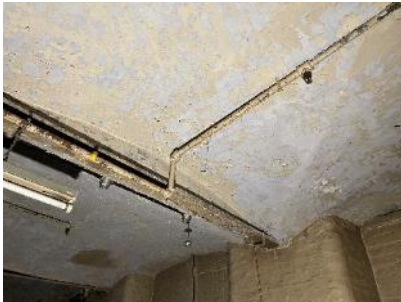
| Inventory of Significant Fixtures & Fittings – Second Floor Level | | | | | | |
|---|---|---|---|---|---|---|
| 1 | C1909 water sprinkler pipes and electric lighting conduits. | / | C1909 water sprinkler pipes and electric lighting conduits (majority with white ceramic pendant roses).<br><br>Positioned across entire ceiling of room | | REMOVE<br><br>KEEP sprinkler system in communal areas and restore / paint where possible as indicated by drawings provided | / |

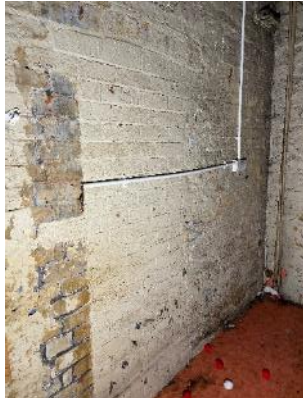
| 3 | Blocked entrance into original 1840 mill worker's latrine. | 1 | Blocked entrance into original 1840 mill worker's latrine. The original narrow room is now inaccessible and marked by the surviving segmental, brick-arched door head and sandstone step. | | Retain outline of original door opening. | / |

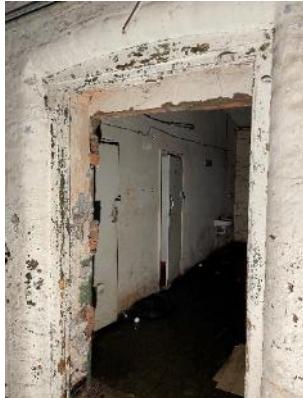
| 1 | Original timber doorframe between room D and B. | 1 | Original timber doorframe between room D and B. | | KEEP in situ block both sides so not visible | |

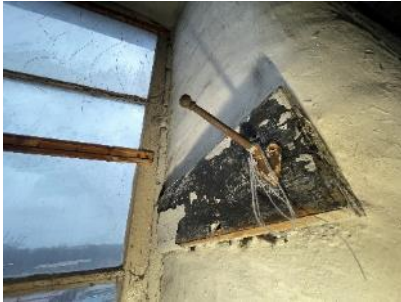
| 2 | Mill worker's coat hooks. | 10 | Mill worker's coat hooks. | | REMOVE<br>H&S RISK<br><br>BC – stated these pose a risk due to corrosion / damage and the height at eye level | |

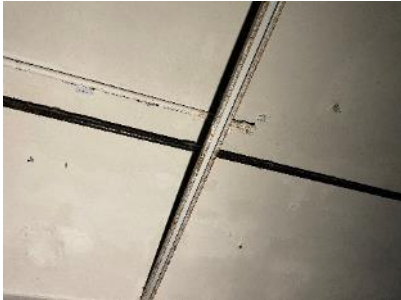
| 3 | C1909 water sprinkler pipes. | / | C1909 water sprinkler pipes. | | REMOVE<br><br>KEEP sprinkler system in communal areas and restore / paint where possible as indicated by drawings provided | / |

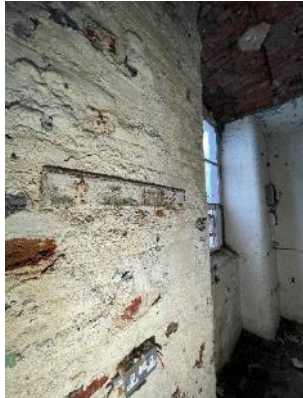
| 2 | Mill worker's coat hook rail. | 1 | Mill worker's coat hook rail. | | <p><b>REMOVE</b></p> <p><b>H&amp;S RISK</b></p> <p>BC – stated these pose a risk due to corrosion / damage and the height at eye level</p> | <p>Remove and relocate item to a secure container for assessment.</p> <p>Review and design a heritage display for selected items in the concierge area.</p> <p>Offer any remaining heritage pieces to incoming commercial tenants.</p> <p>if item is used within the scheme it will be restored by speacilist</p> |

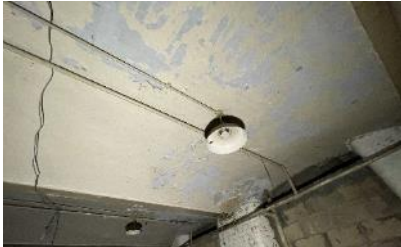
| 1 | C1909 water sprinkler pipes and c 1920s/30s electric light conduits and green and white enamel shades. | / | C1909 water sprinkler pipes and c 1920s/30s electric light conduits and a number of green and white enamel shades. | | REMOVE<br><br>KEEP sprinkler system in communal areas and restore / paint where possible as indicated by drawings provided | Remove and relocate item to a secure container for assessment.<br><br>Review and design a heritage display for selected items in the concierge area.<br><br>Offer any remaining heritage pieces to incoming commercial tenants.<br><br>if item is used within the scheme it will be restored by specialist |

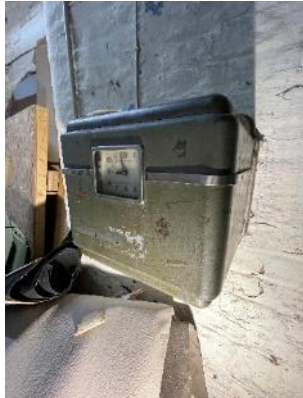
| 2 | C1950s mill clocking on machine. | 1 | C1950s mill clocking on machine. | | <b>RETAIN</b><br>Restore by specialist | |

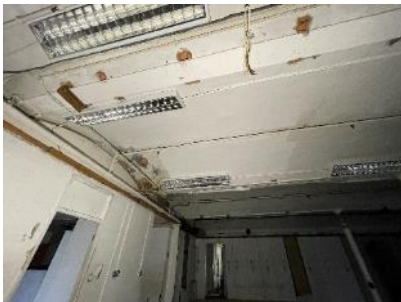
| Plan ref number | Item | Number | Description | Photograph | Proposal/treatment/ repair | Location if being removed / relocated |
|---|---|---|---|---|---|---|
| 1 | C1909 water sprinkler pipes. | / | C1909 water sprinkler pipes. | | <p>REMOVE</p> <p>KEEP sprinkler system in communal areas and restore / paint where possible as indicated by drawings provided</p> | / |

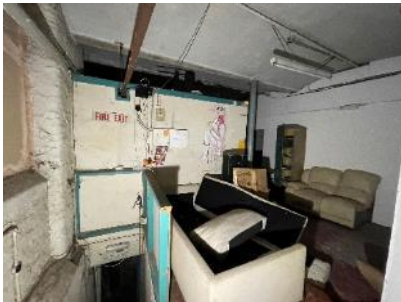
| Room L | | | | | | |
|---|---|---|---|---|---|---|
| 2 | C1909 water sprinkler pipes. | / | C1909 water sprinkler pipes. | | REMOVE<br><br>KEEP sprinkler system in communal areas and restore / paint where possible as indicated by drawings provided | / |

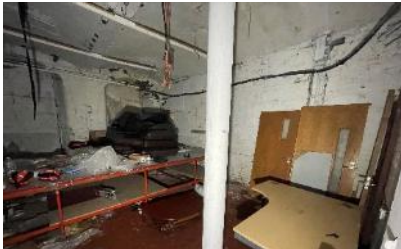
| Inventory of Significant Fixtures & Fittings – Ground Floor Level | | | | | | |
|---|---|---|---|---|---|---|
| 1 | C1909 water sprinkler pipes. | / | C1909 water sprinkler pipes. | | <p>REMOVE</p> <p>KEEP sprinkler system in communal areas and restore / paint where possible as indicated by drawings provided</p> | / |

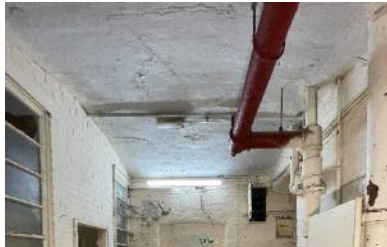
| 1 | C1909 water sprinkler pipes. | / | C1909 water sprinkler pipes. | | <p>REMOVE</p> <p>KEEP sprinkler system in communal areas and restore / paint where possible as indicated by drawings provided</p> | / |

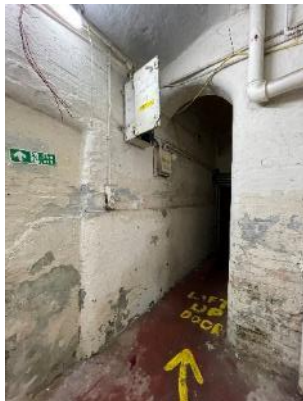
| 3 | Length of original/early plastered dado to link corridor between room B and C. | 1 | Length of original/early plastered dado to link corridor between room B and C. | | <p>REMOVE</p> <p>FIRE /H&amp;S RISK</p> <p>Timber in sterile areas</p> | |

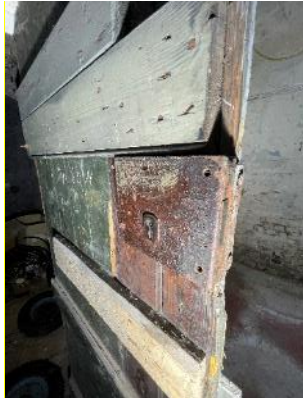
| 1 | Original timber ledged and braced door into downstairs cupboard with rimlock. | 1 | Original timber ledged and braced door into downstairs cupboard with rimlock. (see entry above) | | <p><b>REMOVE</b></p> <p><b>FIRE /H&amp;S RISK</b></p> <p>Damaged and wont hold the sufficient fire rating</p> | <p>Remove and relocate item to a secure container for assessment.</p> <p>Review and design a heritage display for selected items in the concierge area.</p> <p>Offer any remaining heritage pieces to incoming commercial tenants.</p> <p>if item is used within the scheme it will be restored by speacilist</p> |

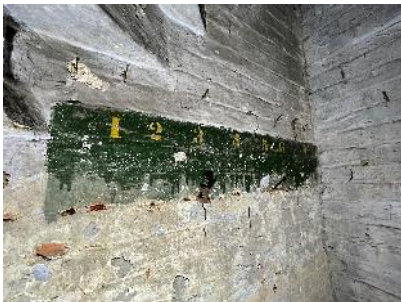
| 2 | Two c1920s/30s painted signs to north and south understairs cupboard walls. | 2 | Two c1920s/30s painted signs to north and south understairs cupboard walls (with some hooks/nails surviving) which would have held floor and department keys. | | <p><b>RETAIN</b></p> <p>Will be behind lift services so won't need any works doing to it</p> | |

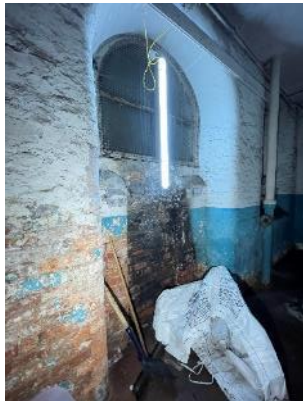
| Room C | | | | | | |
|---|---|---|---|---|---|---|
| 1 | Upper part of glazed, round-headed window with blocked doorway below. | 1 | Upper part of glazed, round-headed window with blocked doorway below. The window would have given borrowed light into the 1909 transformer house (room D) whilst the blocked door would have given access into the below room (room D1). | | <p><b>REMOVE</b></p> <p><b>FIRE /H&amp;S RISK</b></p> <p>Will not have the sufficient fire rating</p> | <p>Remove and relocate item to a secure container for assessment.</p> <p>Review and design a heritage display for selected items in the concierge area.</p> <p>Offer any remaining heritage pieces to incoming commercial tenants.</p> <p>if item is used within the scheme it will be restored by speacilist</p> |

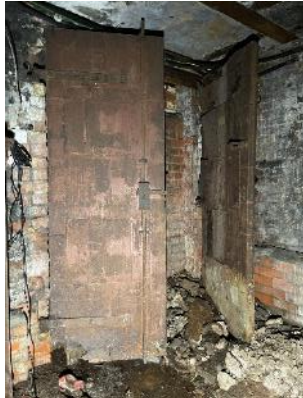
| 1 | Two reinforced steel doors. | 1 | Two reinforced steel doors leading from sub-basement of transformer house into the original (now demolished) electric tower. | | Keep in situ decorative finish | / |

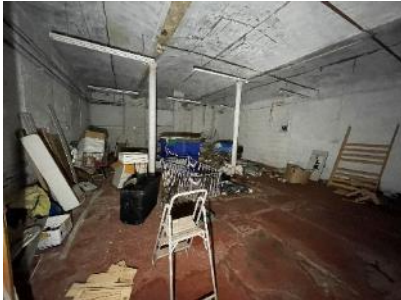
| 1 | C1909 water sprinkler pipes. | / | C1909 water sprinkler pipes. | | REMOVE<br><br>KEEP sprinkler system in communal areas and restore / paint where possible as indicated by drawings provided | / |

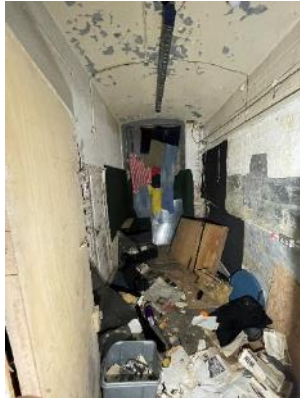
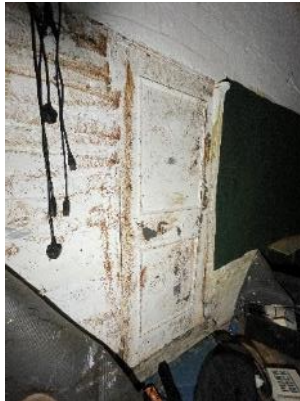
| 1 | Original vault room with c1840s reinforced iron safe door leading into inaccessible vault. | / | Original vault room with c1840s reinforced iron safe door leading into inaccessible vault.<br><br>Door has name plaque (unreadable through paint layers) and in cast moulded panels. | | Building to be demolished | |

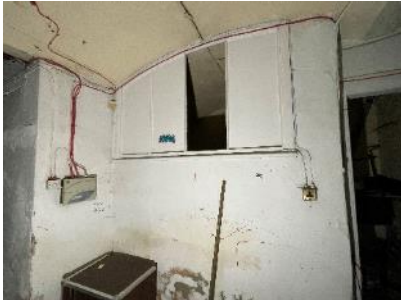
| 1 | Original c1840s borrowed light between original managerial entrance corridor and managerial toilet. | 1 | Original c1840s borrowed light between original managerial entrance corridor and managerial toilet. | | Remove<br><br>Item situated In area where wall is to be demolished | |

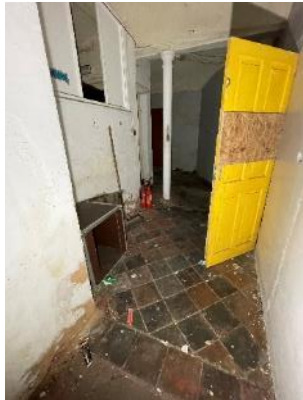
| 2 | Original 1840s blue and red quarry tile floor to original managerial entrance corridor. | 1 | Original 1840s blue and red quarry tile floor to original managerial entrance corridor.<br><br>Tiles are different to main mill floor tiles as these are laid in a diamond pattern and have both blue and red tiles (instead of just red used in main mill) | | remove due to drastic changes in floor levels which would impact the whole development | |

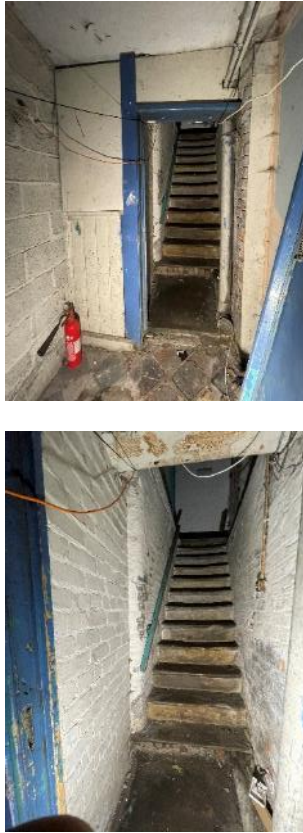
| 3 | Original 1840s sandstone staircase leading from managerial entrance up to mill offices. Entrance vestibule contains original diamond patten blue and red quarry tile floor. | 1 | Original 1840s sandstone staircase leading from managerial entrance up to mill offices. Entrance vestibule contains original diamond patten blue and red quarry tile floor. | | Steps to remain in situ | Steps to remain in situ |

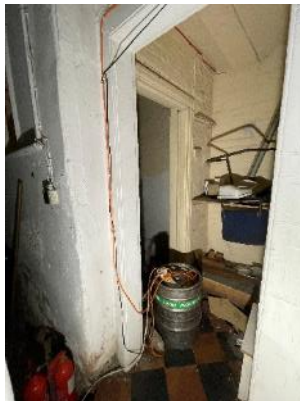
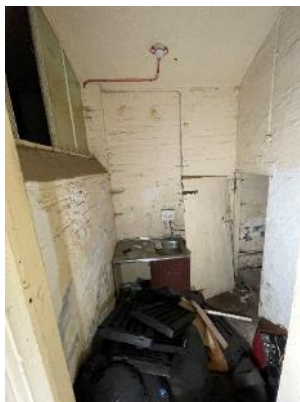
| 4 | Original managerial toilet leading from main entrance corridor. | 1 | Original managerial toilet leading from main entrance corridor, including moulded architrave, and ledged and braced timber WC door. | | <p>As above</p> <p>Due to walls to be removed and new commercial units formed as per planning</p> | |

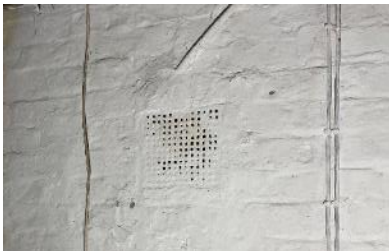
| Room F | | | | | | |
|---|---|---|---|---|---|---|
| 1 | Original 1840s cast iron safe vault air grill (to room E1) | 1 | Original 1840s cast iron safe vault air grill (to room E1) | | RETAIN | |

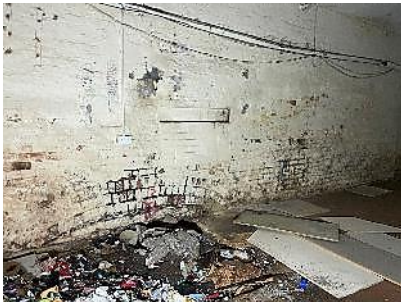
| Room F | | | | | | |
|---|---|---|---|---|---|---|
| 1 | Two original brick arches at floor level against the wall to original engine house. | 2 | Two original brick arches at floor level against the wall to original engine house which appear to have been connected to the original beam engines.<br><br>Archway to the south has an infilled pit. | | RETAIN | / |

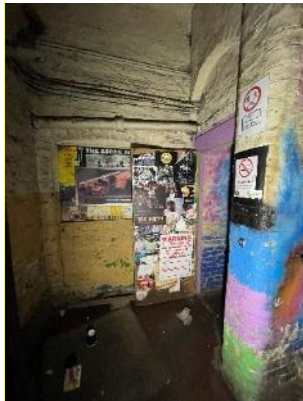
| 1 | C1909 water sprinkler pipes. | / | C1909 water sprinkler pipes. | | REMOVE<br><br>KEEP sprinkler system in communal areas and restore / paint where possible as indicated by drawings provided | / |
|---|---|---|---|---|---|---|
| 1 | Blocked original doorway leading from entrance corridor into western arched cartway (room N) | 1 | Blocked original doorway leading from entrance corridor into western arched cartway (room N). Now infilled with late-19 <sup>th</sup> century brickwork and window. | | Leave as is walls to be shot blasted / DOF system | |

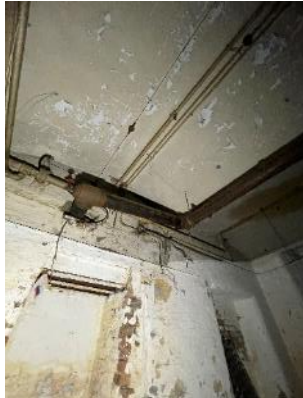
| 1 | C1909 water sprinkler pipes. | / | C1909 water sprinkler pipes. | | Remove due to condition and issues with new sprinkler installation<br><br>fire and compartment issues | / |

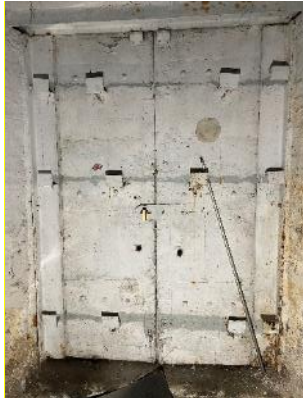
| 2 | C19th century steel doors | 2 | C19th century steel doors | | Remove<br><br>Wall to be removed in line with approved design | Remove and relocate item to a secure container for assessment.<br><br>Review and design a heritage display for selected items in the concierge area.<br><br>Offer any remaining heritage pieces to incoming commercial tenants.<br><br>if item is used within the scheme it will be restored by specialist |

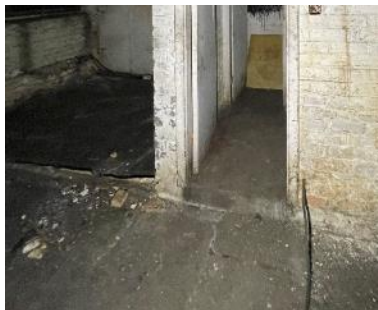
| Room P | | | | | | |
|---|---|---|---|---|---|---|
| 1 | 19 <sup>th</sup> century cobbles, flag stones and stone kerbs | / | 19 <sup>th</sup> century cobbles, flag stones and stone kerbs | | Building to be demolished and form part of the new approved landscape plan | / |

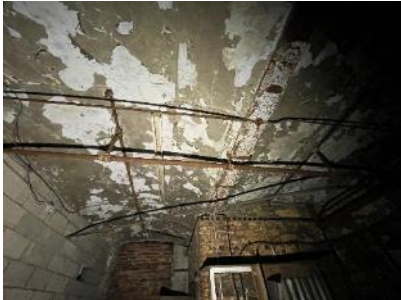
| 1 | C1909 water sprinkler pipes. | / | C1909 water sprinkler pipes. | | <p>REMOVE</p> <p>KEEP sprinkler system in communal areas and restore / paint where possible as indicated by drawings provided</p> | / |

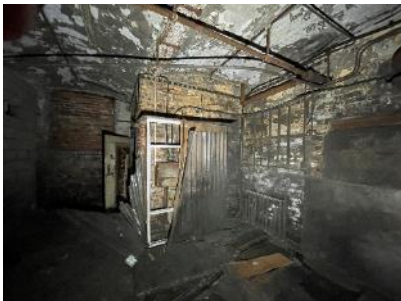
| 2 | 1920s hoist. | 1 | 1920s hoist. | | <p>REMOVE</p> <p>KEEP sprinkler system in communal areas and restore / paint where possible as indicated by drawings provided</p> | / |
