## Schedule of Condition

102-104 Market Street and  
2-4 Fountain Street  
Manchester  
M1 1PB

Dated: 8<sup>th</sup> April 2024

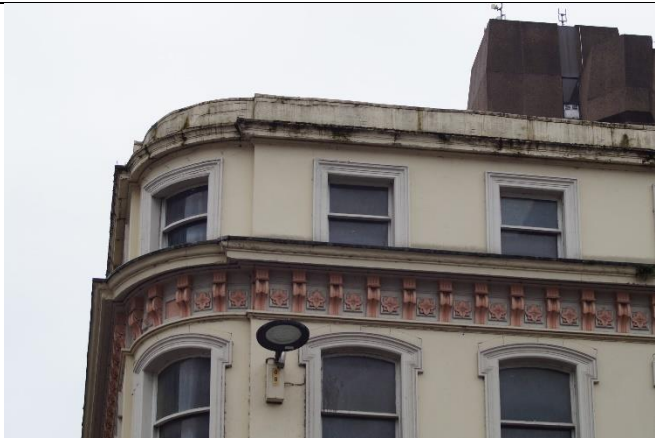
| <i>comments</i> | <i>photograph</i> | <i>comments</i> | <i>photograph</i> |
|---|---|---|---|
| <p>Brick, render and stone featureful Edwardian facade in need of some render and stone masonry repairs and some redecoration.</p> <p>Distressed timber windows with aged and flaking decoration.</p> | | <p>Brick, render and stone featureful Edwardian facade in need of some render and stone masonry repairs and some redecoration.</p> <p>Distressed timber windows with aged and flaking decoration.</p> | |

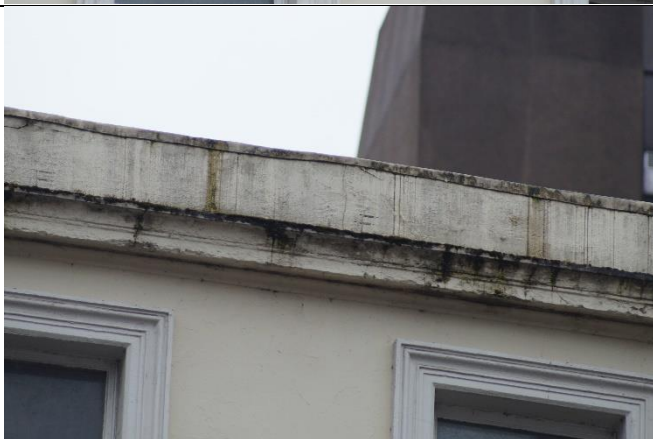
Some cracking to the masonry brickwork below the main facade, and in particular the parapets will need some further investigation by structural engineer into the cause of the cracking and may need some crack stitch repairs.

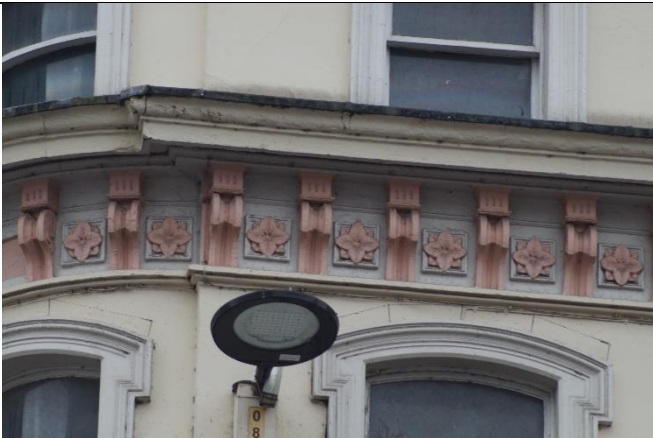
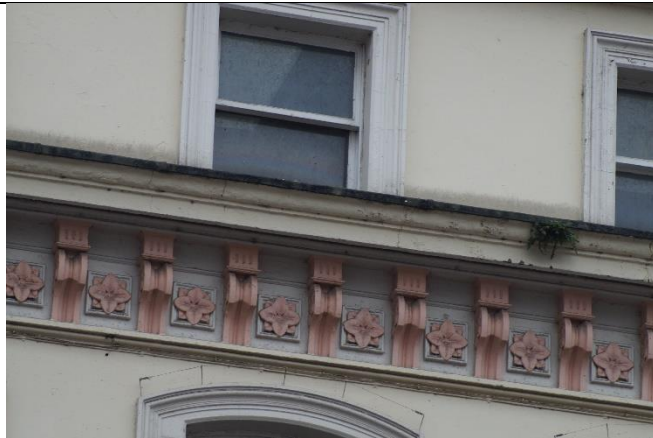
| <p>The decoration to the main facade, including the features and the timber windows is distressed, soiled and has flaking paint. Redecoration of the exterior of the property is very much now due.</p> | | <p>The decoration to the main facade, including the features and the timber windows is distressed, soiled and has flaking paint. Redecoration of the exterior of the property is very much now due.</p> | |

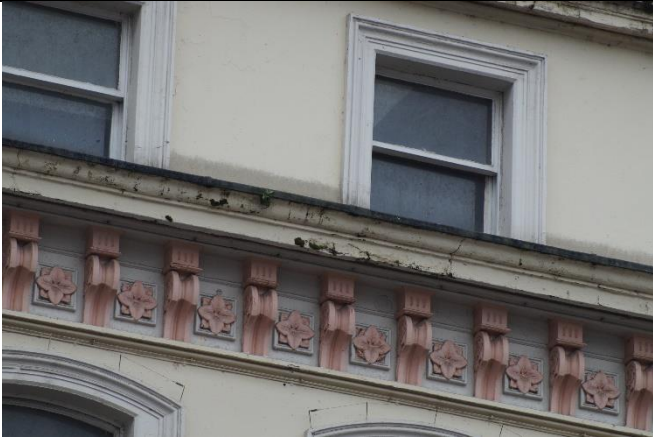
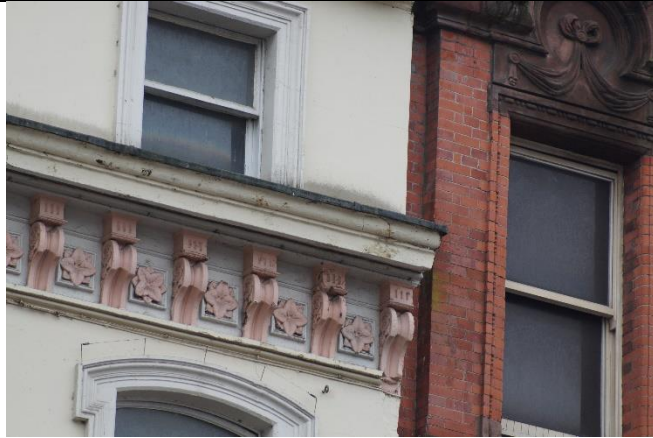
| <p>Generally.</p> | | <p>The decoration to the main facade, including the features and the timber windows is distressed, soiled and has flaking paint. Redecoration of the exterior of the property is very much now due.</p> | |

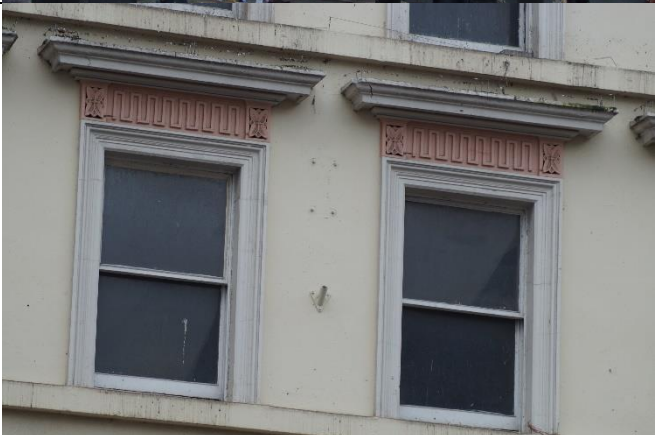
| <p>The decoration to the main facade, including the features and the timber windows is distressed, soiled and has flaking paint. Redecoration of the exterior of the property is very much now due.</p> | | <p>Some damaged and soft stone to the mouldings will need repair.</p> | |

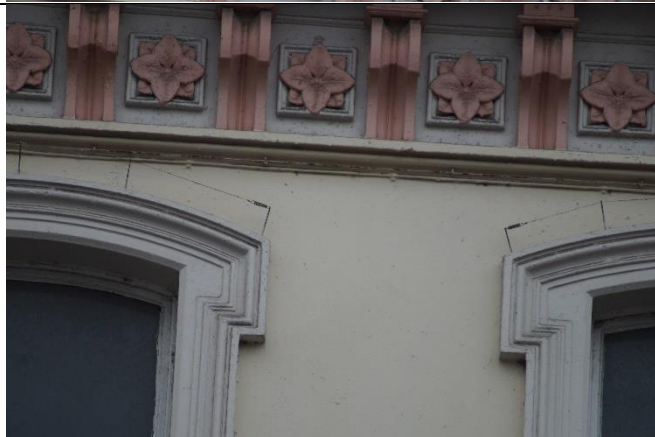
The decoration to the main facade, including the features and the timber windows is distressed, soiled and has flaking paint. Redecoration of the exterior of the property is very much now due.

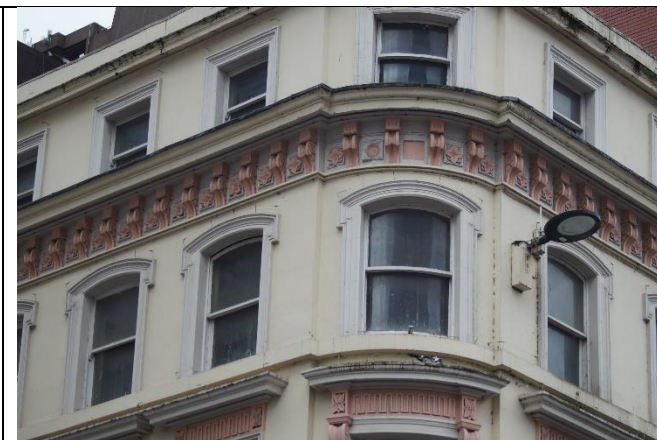
The decoration to the main facade, including the features and the timber windows is distressed, soiled and has flaking paint. Redecoration of the exterior of the property is very much now due.

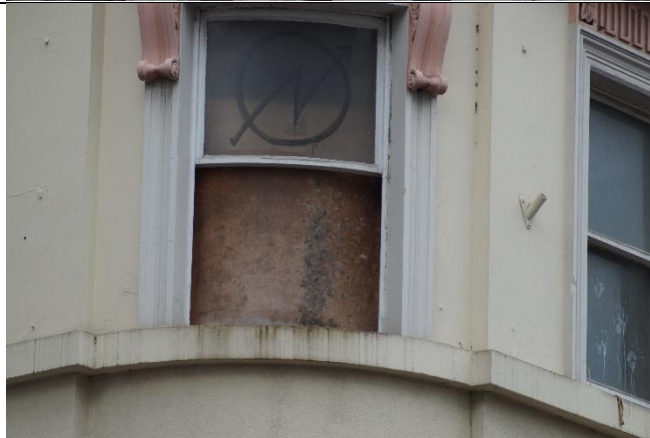
The decoration to the main facade, including the features and the timber windows is distressed, soiled and has flaking paint. Redecoration of the exterior of the property is very much now due.

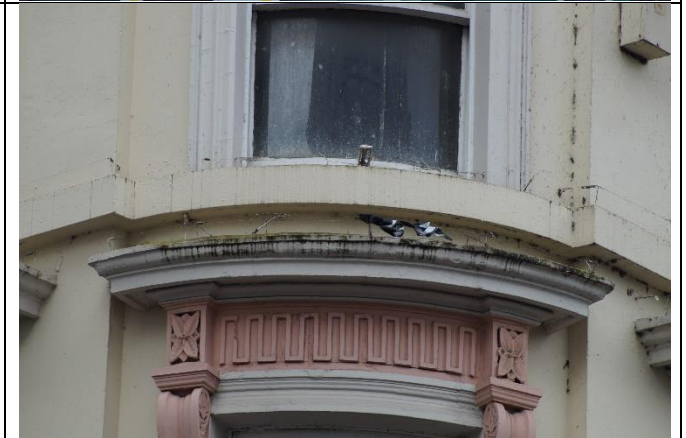
The decoration to the main facade, including the features and the timber windows is distressed, soiled and has flaking paint. Redecoration of the exterior of the property is very much now due.

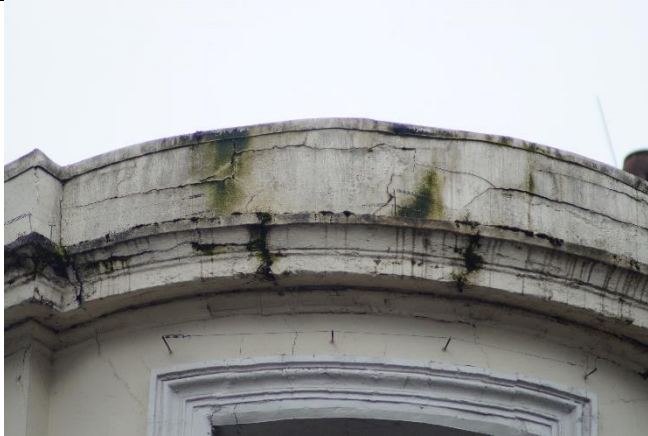
Some cracking to the masonry brickwork below the main facade, and in particular the parapets will need some further investigation by structural engineer into the cause of the cracking and may need some crack stitch repairs.

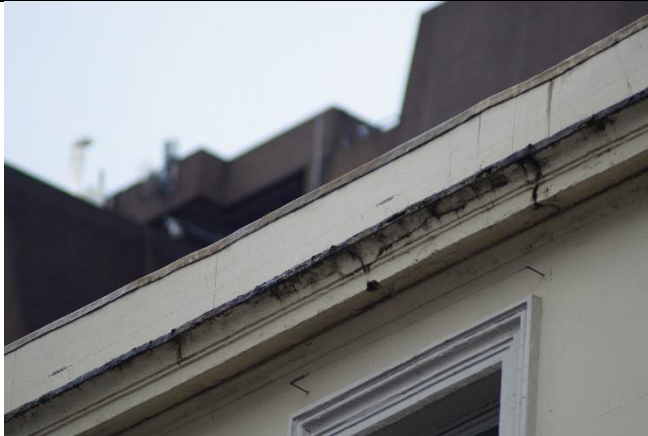
Some cracking to the masonry brickwork below the main facade, and in particular the parapets will need some further investigation by structural engineer into the cause of the cracking and may need some crack stitch repairs.

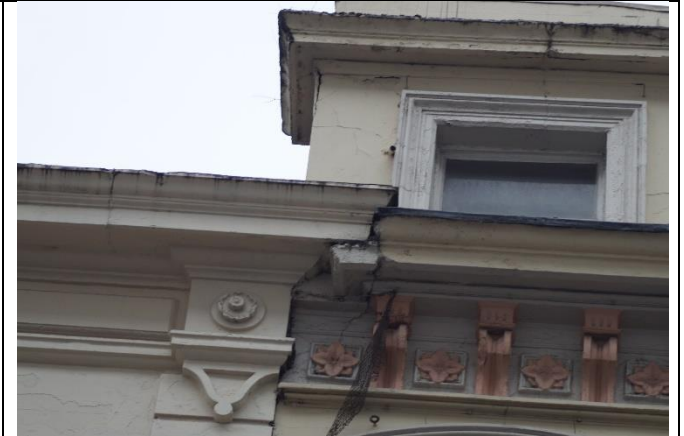
The decoration to the main facade, including the features and the timber windows is distressed, soiled and has flaking paint. Redecoration of the exterior of the property is very much now due.

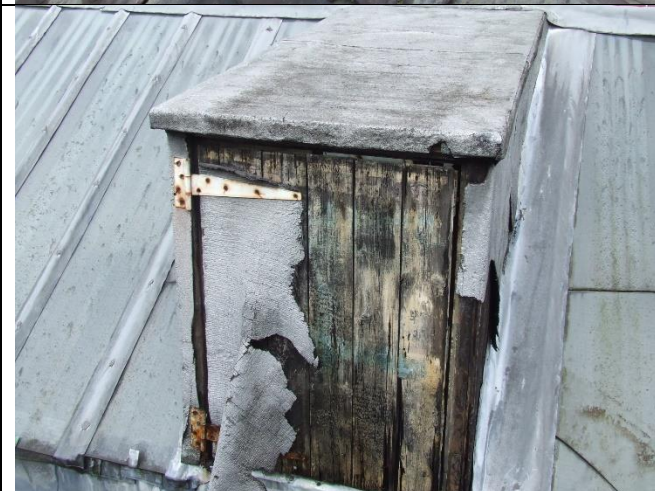
Rotten roof access door.

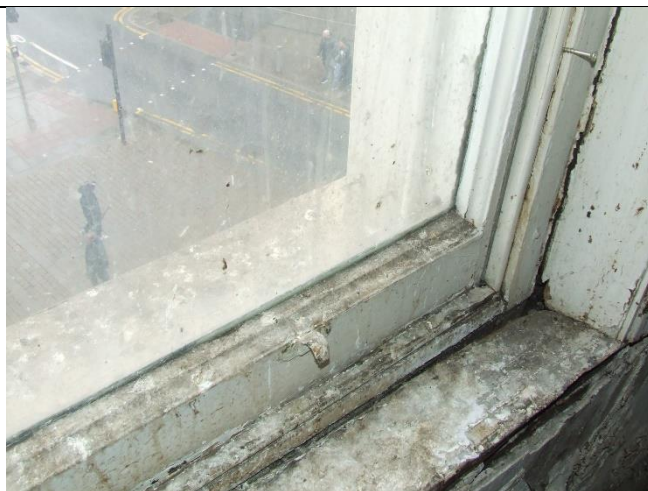
Examples of the general condition of the decoration to the windows.

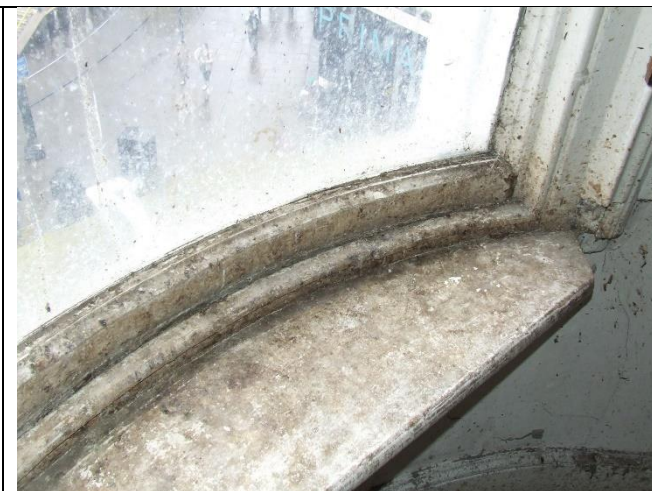
Examples of the general condition of the decoration to the windows.

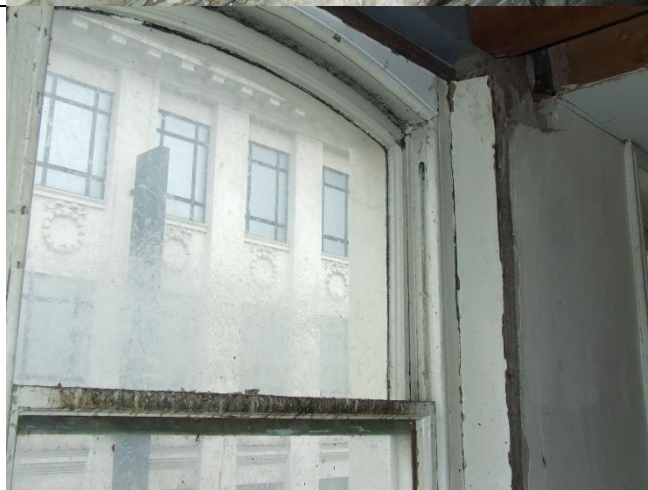
Water ingress damage generally from roof leaks.
