Sunlight House,  
Quay Street,  
Manchester  
M3 3HP

Façade Condition Survey  
February 2024

REF 24008-PAYE-RPT-001 **P03**

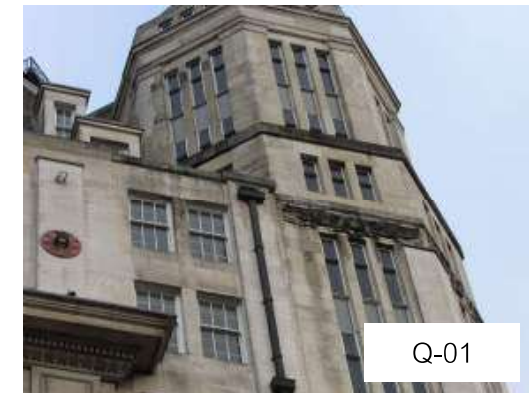
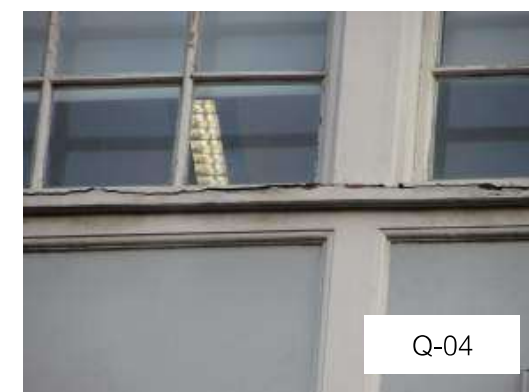
PHOTOS: Q-04, -05, (D)LQ-22

It appears that the curtain walling between the pilasters are formed from timber windows and spandrel panel. Decay was observed to several of the timber windowsills. Hairline cracks were observed to the paint of several spandrel panels. It is recommended to undertake a full condition survey of the timber windows and spandrels. Undertaking repairs – e.g., timber splice repairs - and re-decoration will improve the longevity of the windows.

*Common typical defect photographs; staining, rainwater goods, launching staining to stone windowsills, timber decay and flaking paint to timber sills.*

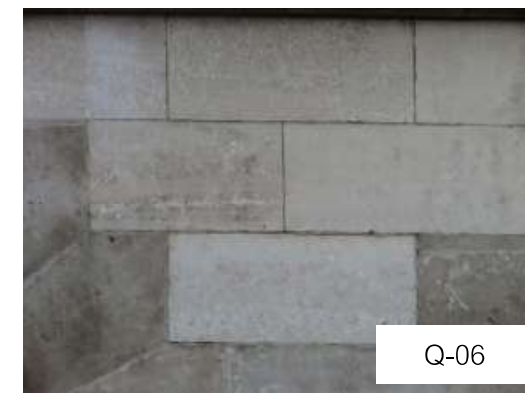
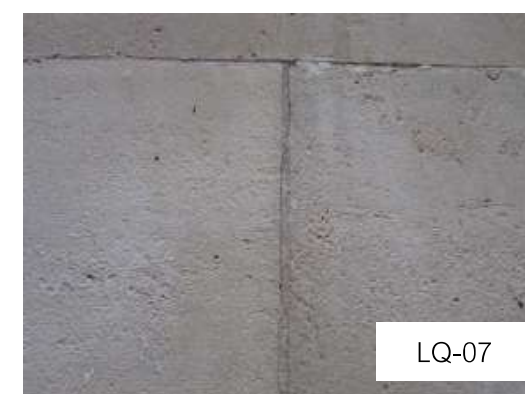
PHOTOS: Q-07, LQ-07

The pointing was generally friable, especially at high level and below stone windowsills. This is common as these areas are more exposed to the elements. An allowance should be made for raking out loose joints and repointing the joints with a lime-base mortar. This will maintain the buildings' ability to be weathertight.

Cementitious pointing is impervious to water and will cause deterioration to the facing Portland stone. Any trapped moisture migrates into the masonry as it cannot pass through the impermeable joints. The stone around the joints become saturated and break down over time through freeze-thaw.

Cement pointing is also stronger than the Portland stone, and therefore any differential movement in the façade will result in cracking through the stone and not the pointing.

*Common typical defect photographs; friable pointing, cementitious pointing observed to the ground floor.*

Although cracks and deterioration was only observed to localised areas at ground floor, this issue will only worsen over time. Consider making an allowance to rake out all joints to the ground and first floor and repoint with a lime-base mortar.

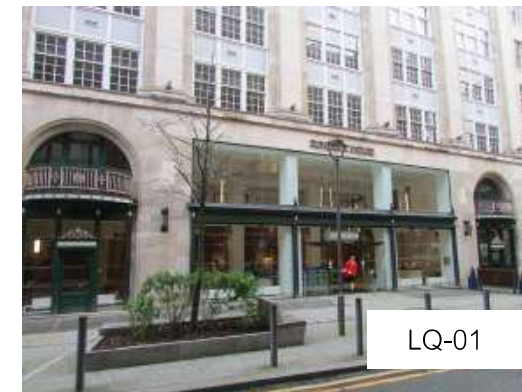
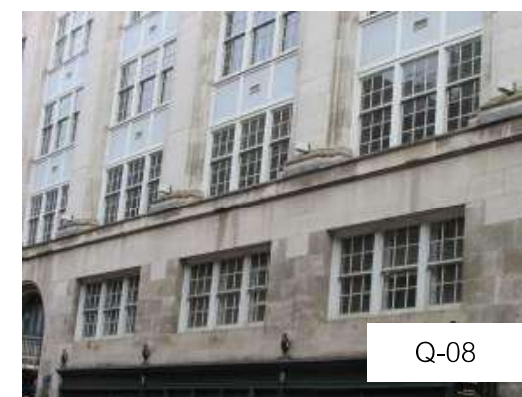
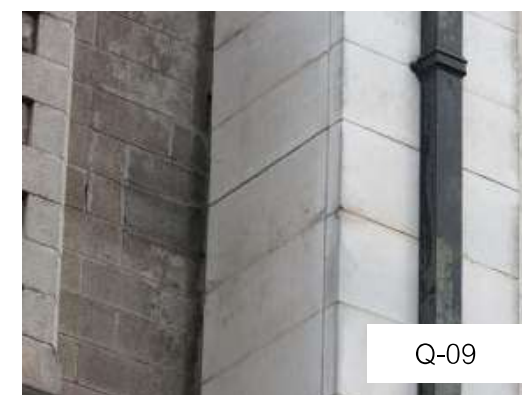
There is evidence of extensive repairs to all vertical pilasters and to the 2<sup>nd</sup> floor cornice, that were likely a result of historic steel frame corrosion. When steel corrodes it can expand x8-13 times its original volume, resulting in fractures to the Portland stone masonry. It is likely that the fractures to the façade (and extent of steel frame corrosion) was widespread as all pilasters appear to have been replaced with new “plant on” stone. From observations it can be concluded that the below works were undertaken.

1. The masonry between the 2<sup>nd</sup> floor windows and cornice has been replaced (with the exemption of the arched keystones which appear original). This may also have been part of the façade modifications which were undertaken to entrance on Little Quay Street.
2. All central pilasters (between L02- L06 and L08-L09) have been replaced with new ‘cladding’ built off corbel brackets at every floor level. A silicone movement joint has been included at the new-old stone vertical reveal joint and horizontally at every floor level.
3. All quoin / turret pilasters (between L02- L09) have been replaced with new ‘cladding’ built off corbel brackets at every floor level. A silicone movement joint has been included at the new-old stone vertical reveal joint and horizontally at every floor level.

*Notable defect photographs; modifications to ground floor (note ‘new’ stone below the cornice), movement joints observed to the pilasters*

It is strongly recommended to consult with a structural engineer and obtain the as-built drawings and photographs for the extensive repairs to confirm that the works was undertaken to a high standard and align with modern building codes.

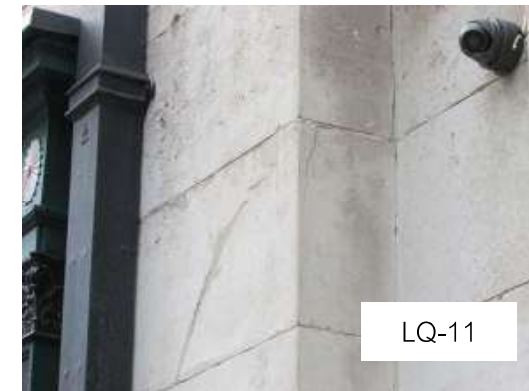
PHOTOS: (D)A-21, -23, -24

*Notable defect photograph; fractures observed through masonry to lower levels possibly caused by steel frame corrosion*

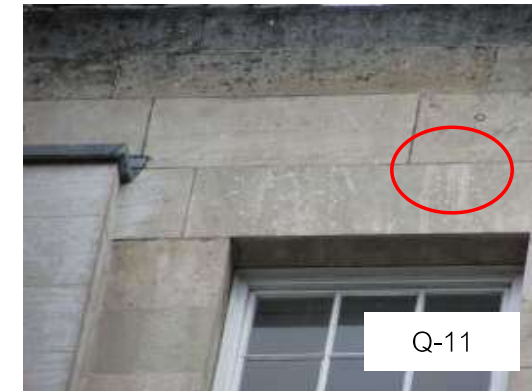
PHOTOS: A-01, -02, (D)Q-26, (D)LQ-20

*Notable defect photograph; fractures observed through masonry*

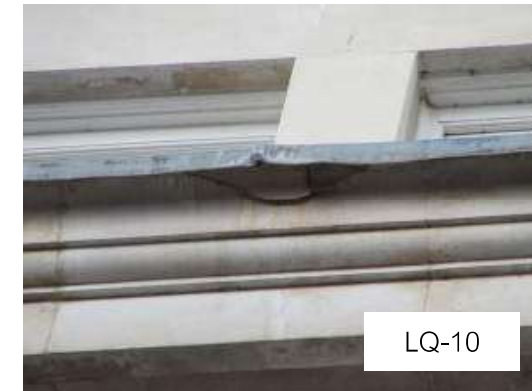
PHOTOS: A-03

*Notable defect photograph; Indent and pin repairs, repairs to ground floor threshold*

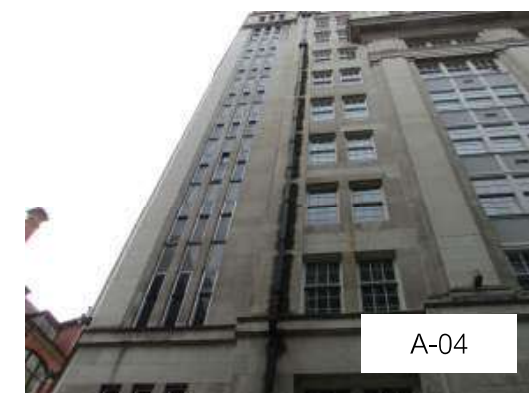
PHOTOS: Q-02, LQ-06, A-04

*Notable defect photograph; staining, staining caused by overflowing hoppers, paint flaking to rainwater downpipes*

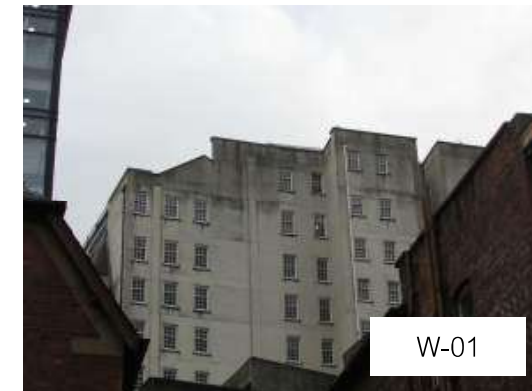
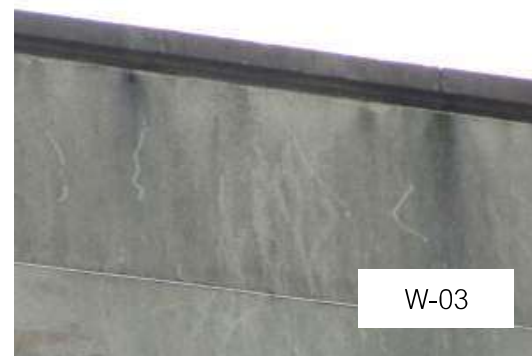
PHOTOS: (D)W-25

Common typical defect photographs; missing pointing, staining, hairline cracks to rendered facades

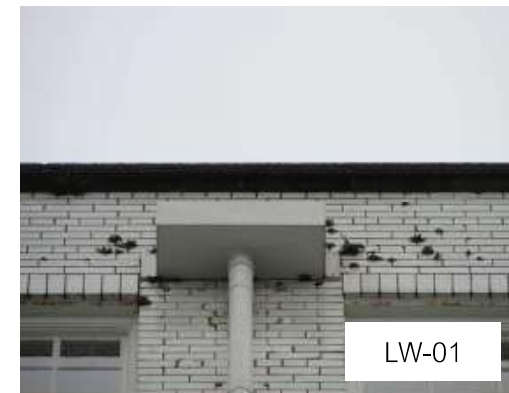
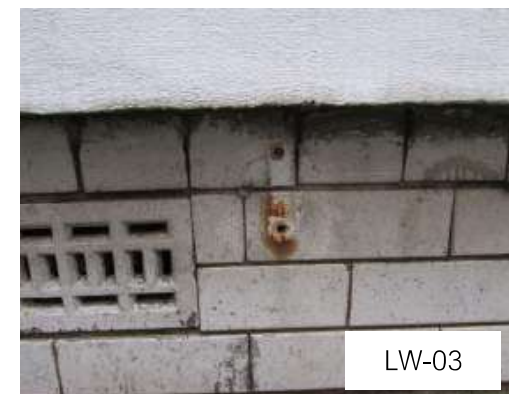
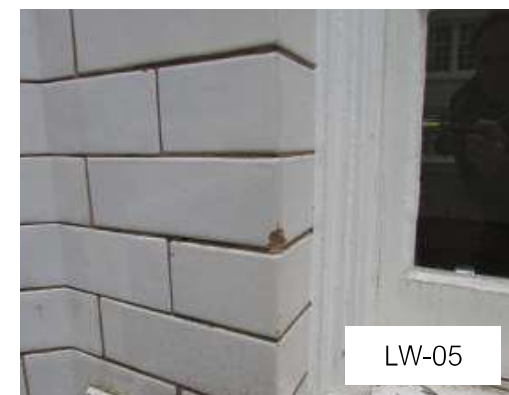
PHOTOS: (D)ROOF-14, (D)L13-09, 12-01

*Common typical defect photographs; vegetation growth to joints, rust staining to steel lintels and windowsills, small fixings, defective bricks, small chips, fractures observed to painted windowsill.*
