# Television Post-Construction Survey Report

Mobility Hub, Manchester

Bowmer + Kirkland Limited

November 2024

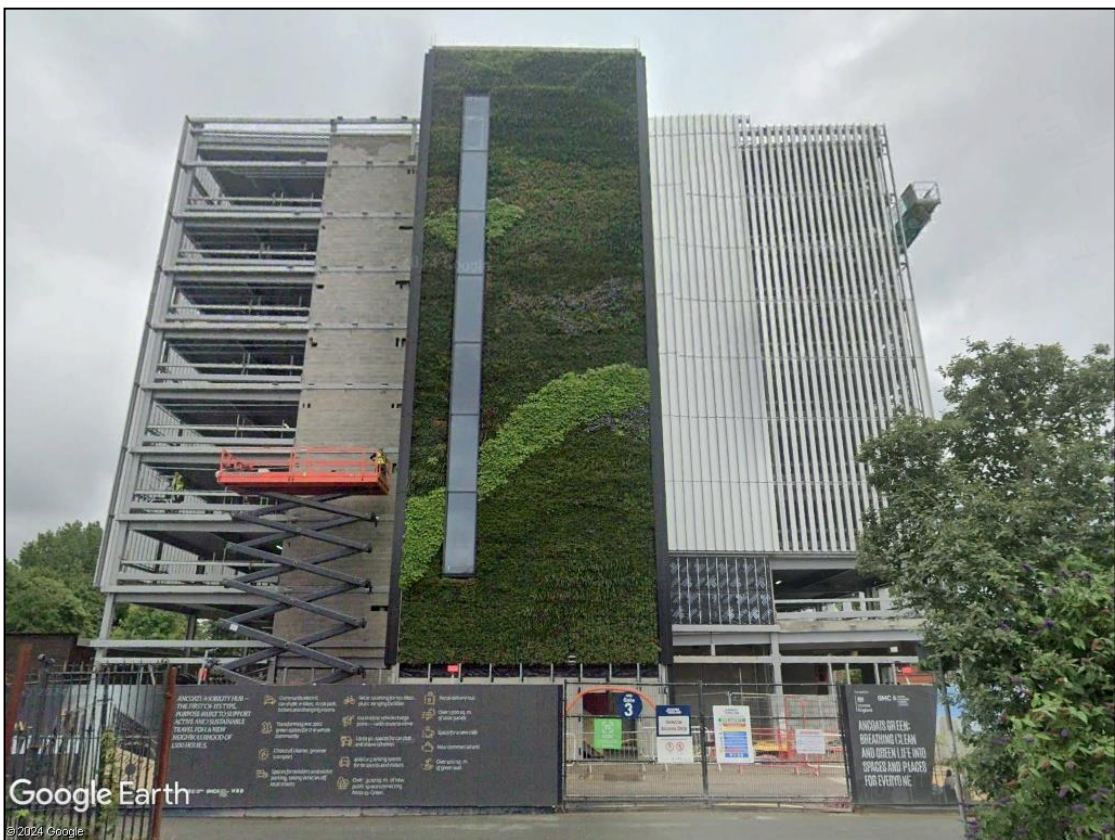
Figure 3 Streetview imagery of constructed development

Figure 3 below shows Streetview imagery (dated July 2024) of the development nearing completion.

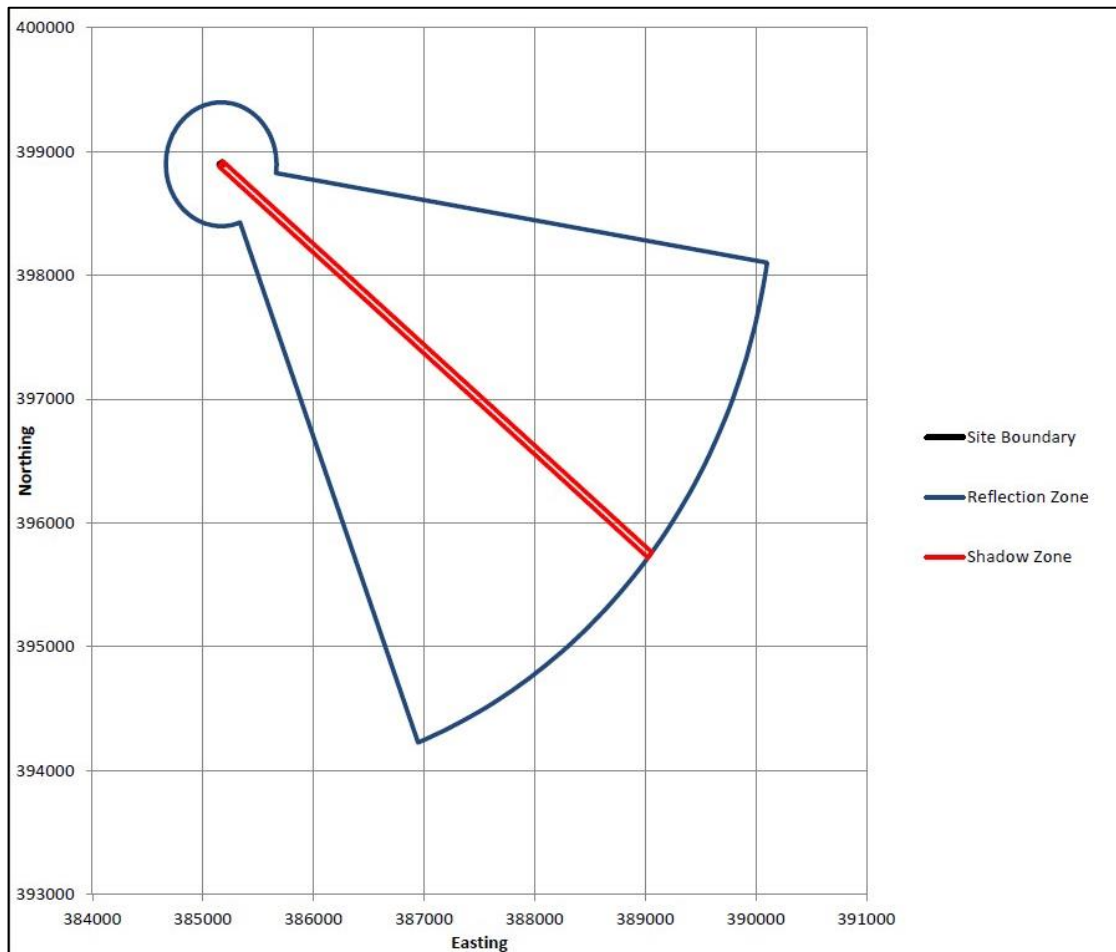
Figure 6 Interference areas

In the case of the shadow zone, this has been modelled as having straight sides in order to be conservative. In actuality, due to diffraction effects, the zone would have a more triangular shape as shown in Figure 4 in the previous section. Figure 6 below shows the potential interference areas associated with the development.

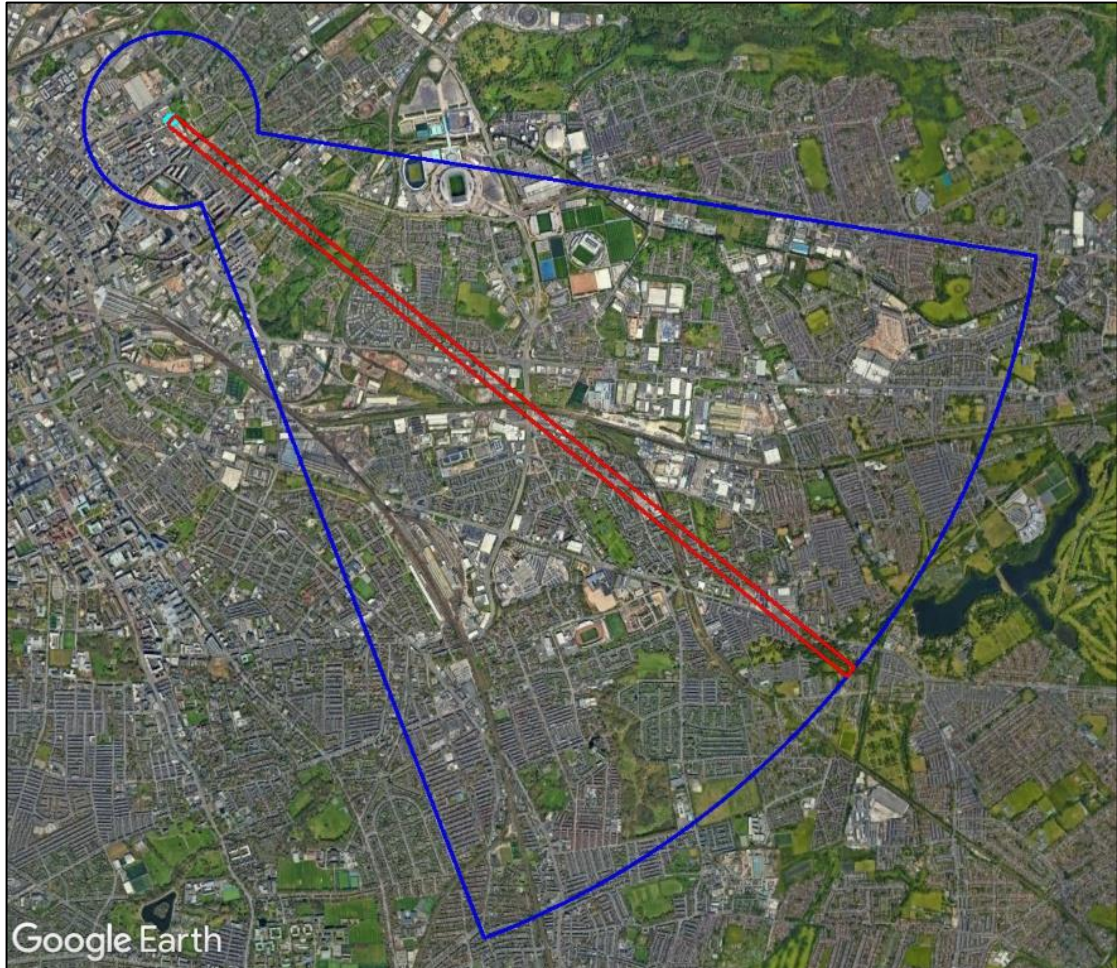
Figure 7 Interference zones map

Figure 7 below shows the interference zones overlaid onto aerial imagery.

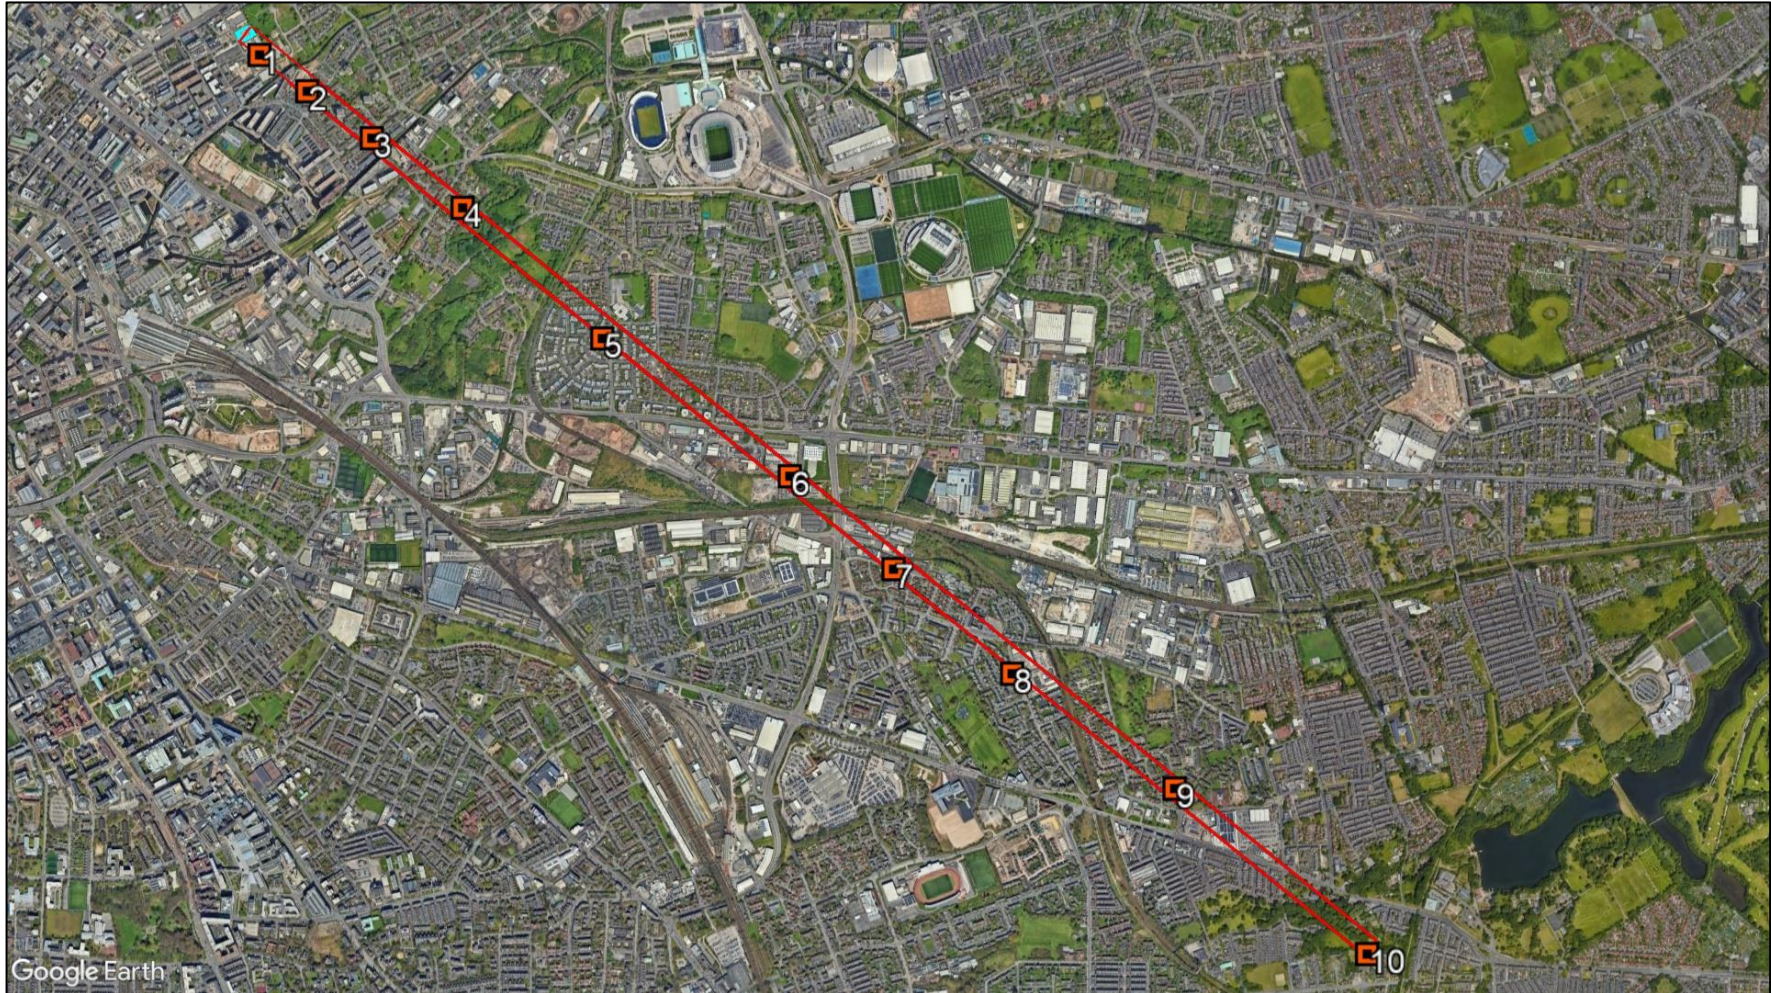
Figure 8 Survey locations

Figure 8 on the following pages show the survey locations overlaid onto aerial photography. The proposed development location and the shadow zone are also shown. The survey locations chosen for the baseline survey were revisited as best as possible for the post-construction survey<sup>8</sup>. The locations below show the actual survey locations.
