# Asbestos Analyst's Certificate Report

Job Ref No: **538234**, Cert Ref No: **89608**, Account Ref No: **25660**, Contract Ref No: **85664**

## First Street, Manchester City Centre, M15 4AA

**Title:** Asbestos Fibre Air Monitoring at First Street, Central Manchester

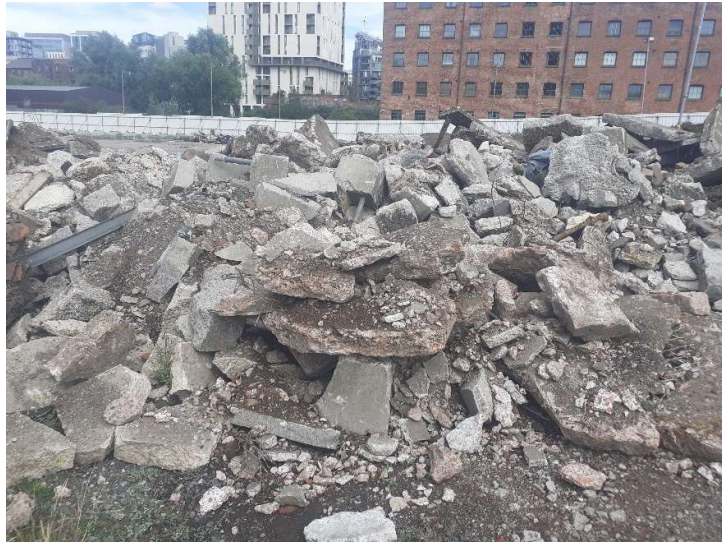
Plate 32: Monday 5<sup>th</sup> September 2022. Concrete which was broken out on site.
