# Design Note

| Project | SIM - Gantry Conservation |
| Subject | Conservation Philosophy |
| Project no | 054704 |

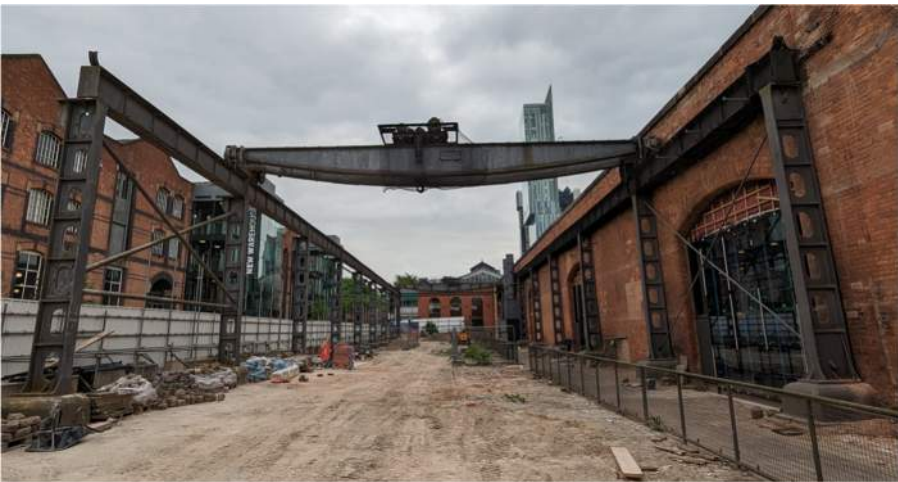
**Figure 1-1 SIM Gantry viewed from west**

The current protective coatings to the Gantry have failed in many locations, leading to widespread corrosion of the existing structures. Based on recent inspections the Gantry needs conservation works to stop the progressive deterioration and corrosion of the superstructure and safeguard its future.
