| 29 Red Lion Street<br>Chesham Bucks<br>HP5 1EJ | Phase 1 Only<br>Grimshaw Lane<br>Manchester | |

PIPELINE SCHEDULES for 9762 - SW

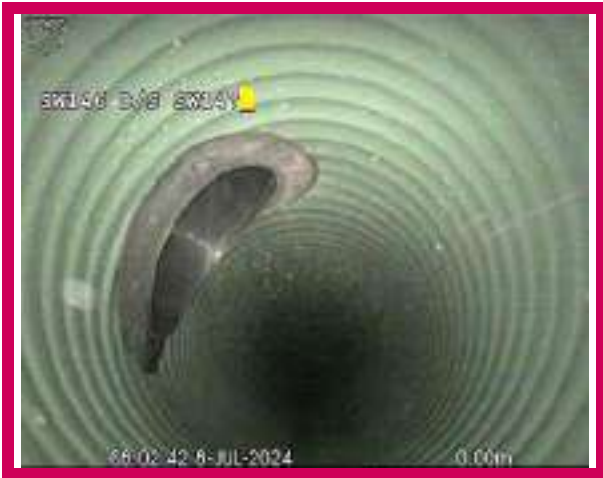
1, 00:00:00, 0.00 m  
Start node, manhole, reference: SW147

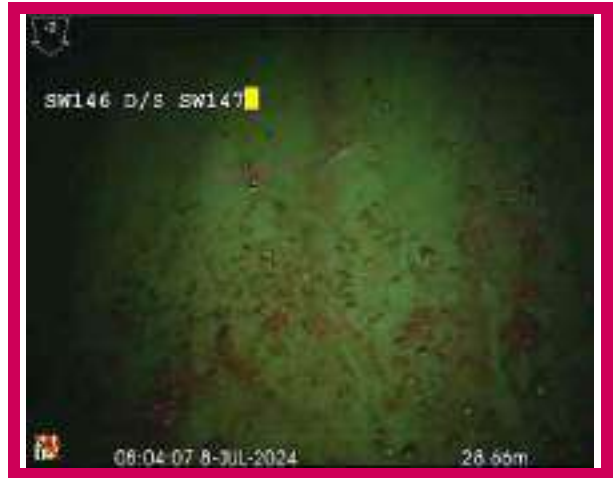
2, 00:01:23, 28.62 m  
Finish node, manhole, reference: SW147

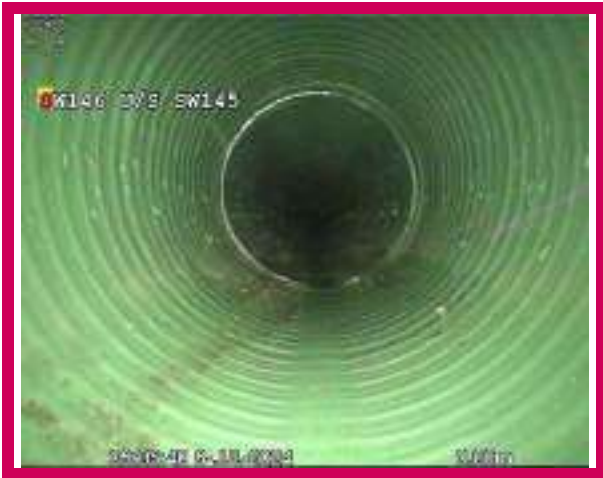
1, 00:00:00, 0.00 m  
Start node, manhole, reference: SW146

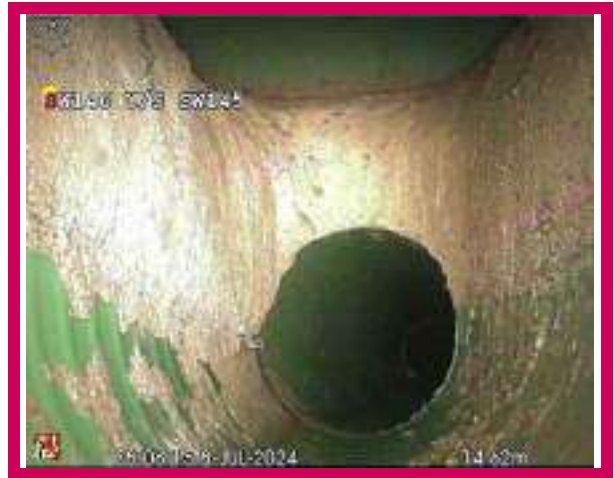
2, 00:00:34, 14.62 m  
Finish node, manhole, reference: SW145

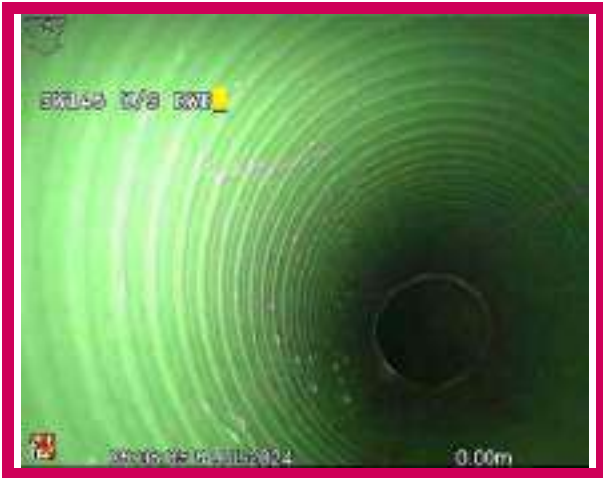
1, 00:00:00, 0.00 m  
Start node, manhole, reference: SW145

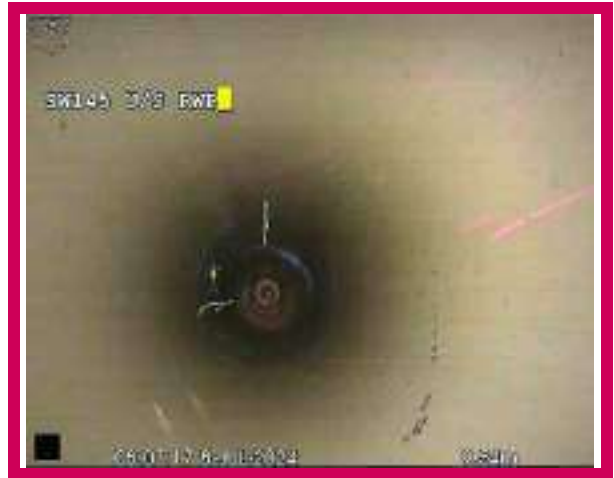
2, 00:00:40, 9.54 m  
Finish node, other special chamber, reference: RWP, In RWP

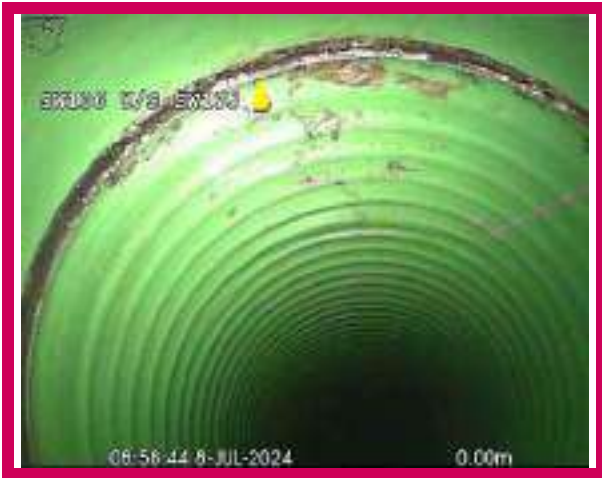
1, 00:00:00, 0.00 m  
Start node, manhole, reference: SW136

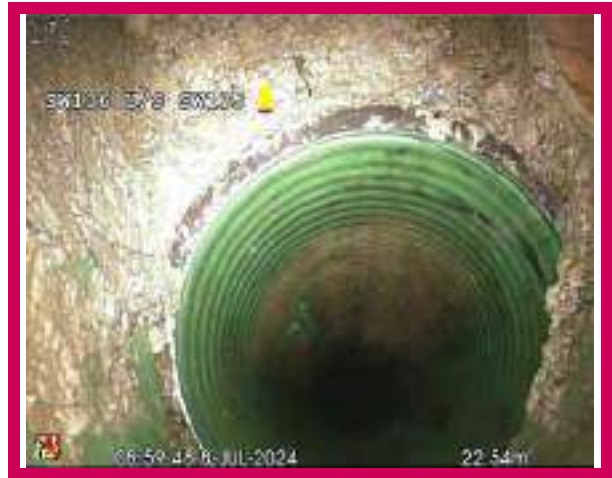
2, 00:01:03, 22.54 m  
Finish node, manhole, reference: SW135

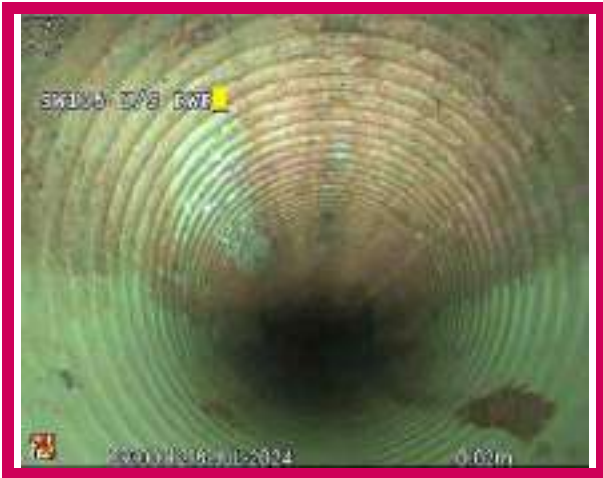
1, 00:00:00, 0.00 m  
Start node, manhole, reference: SW135

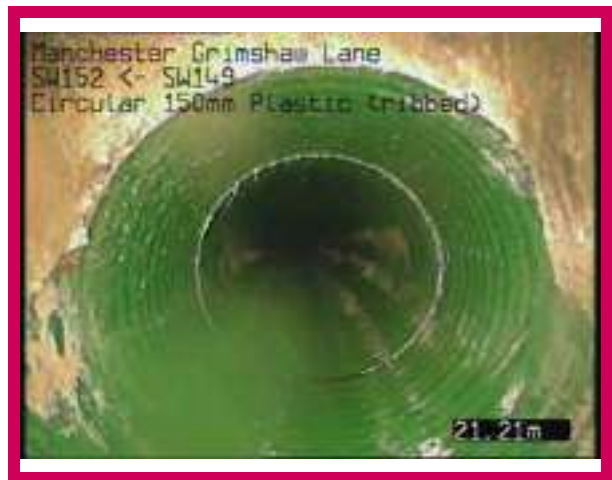
2, 00:02:46, 21.21 m  
Finish node, manhole, reference: SW149

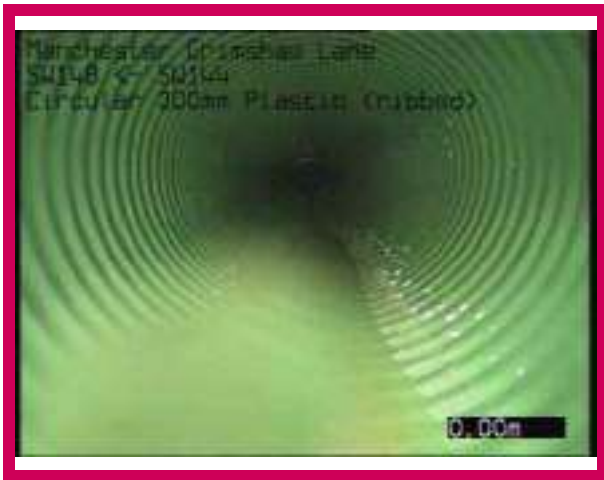
1, 00:00:00, 0.00 m  
Start node, manhole, reference: SW148

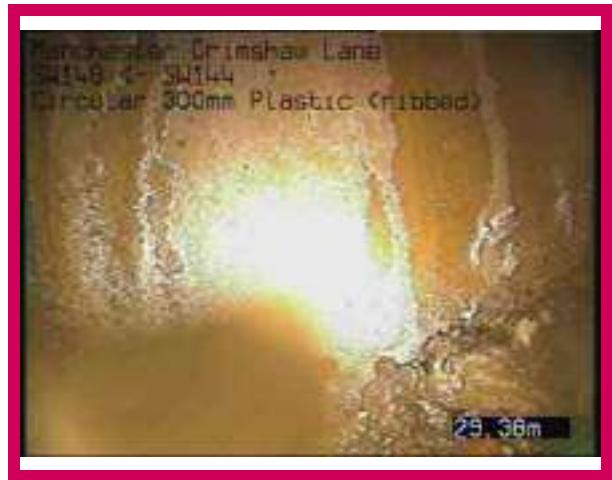
2, 00:02:11, 29.67 m  
Finish node, manhole, reference: SW144

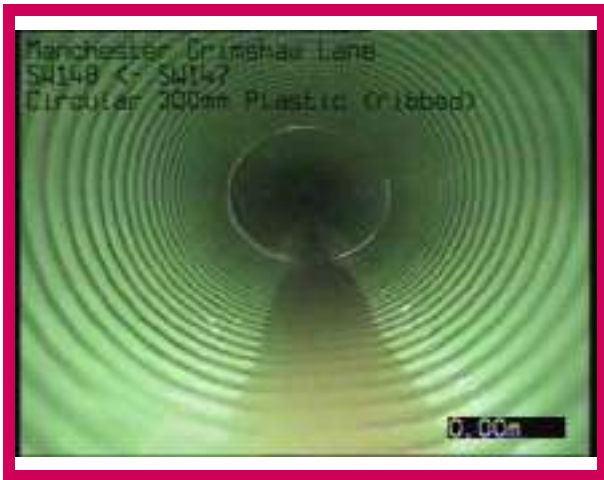
1, 00:00:00, 0.00 m  
Start node, manhole, reference: SW148

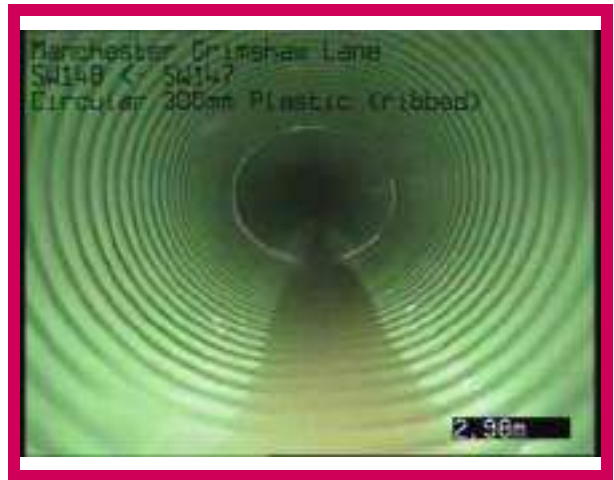
2, 00:01:53, 27.46 m  
Finish node, manhole, reference: SW147

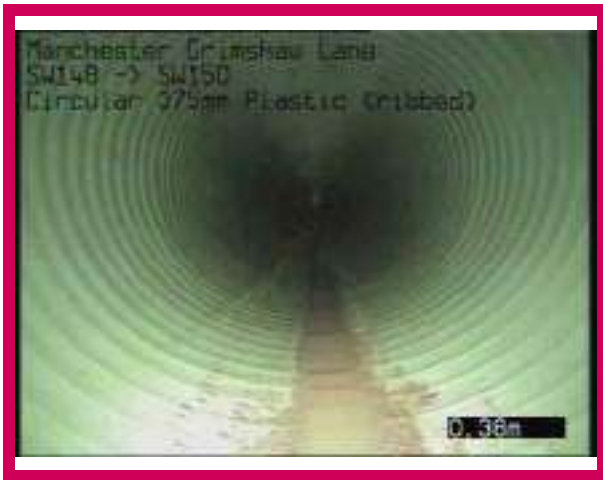
1, 00:00:00, 0.00 m  
Start node, manhole, reference: SW148

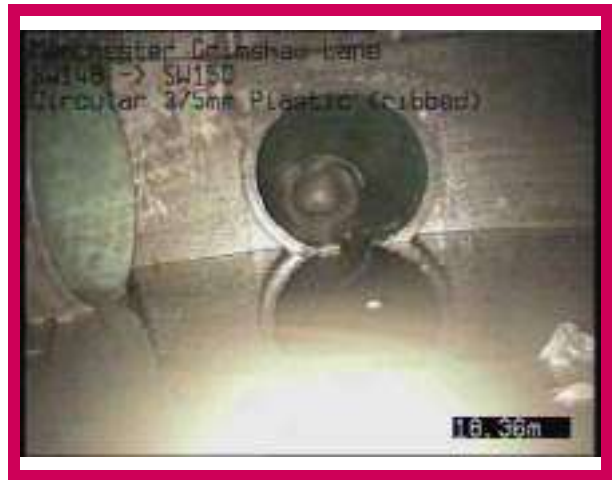
2, 00:01:39, 18.36 m  
Finish node, manhole, reference: SW150, MH is in a tank.

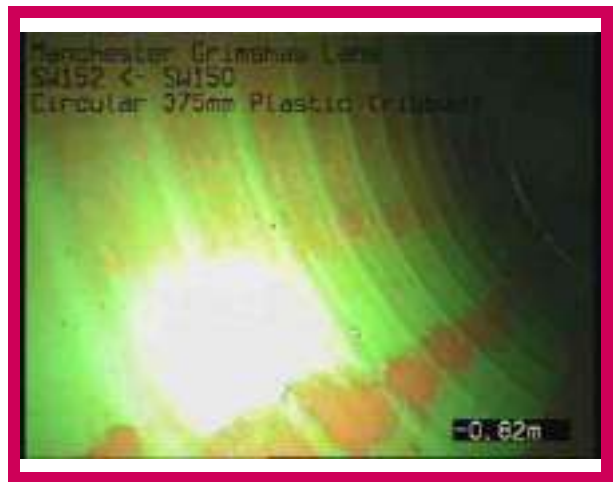
2, 00:00:29, 3.11 m  
Finish node, manhole, reference: SW150, Manhole is on a tank.

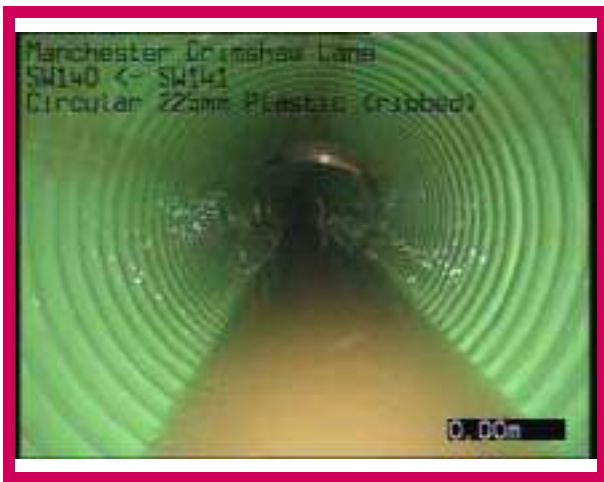
1, 00:00:00, 0.00 m  
Start node, manhole, reference: SW140

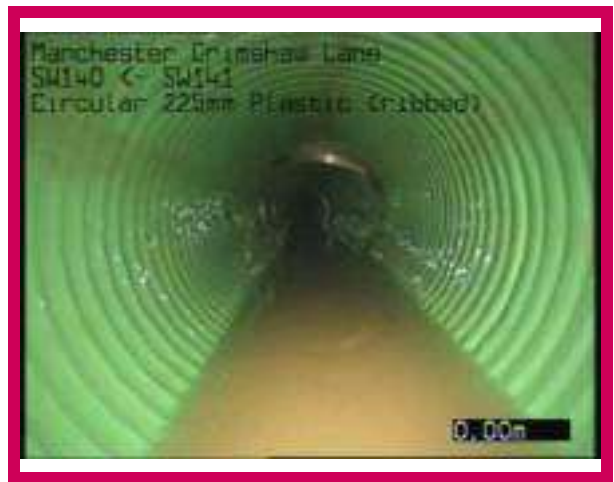
2, 00:01:18, 12.14 m  
Connection other than junction at 10 o'clock, diameter: 150mm

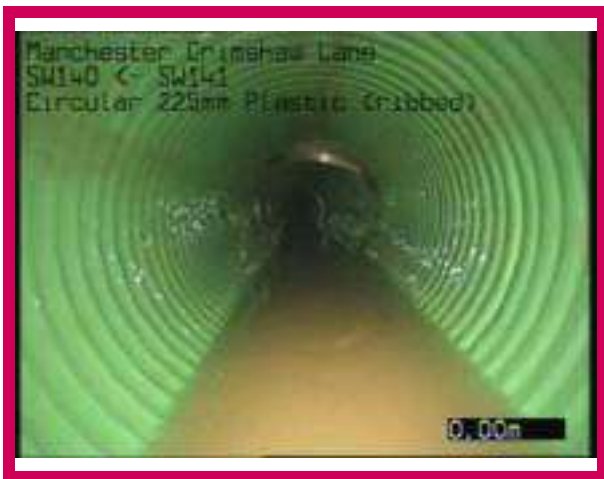
3, 00:04:03, 45.03 m  
Finish node, manhole, reference: SW141

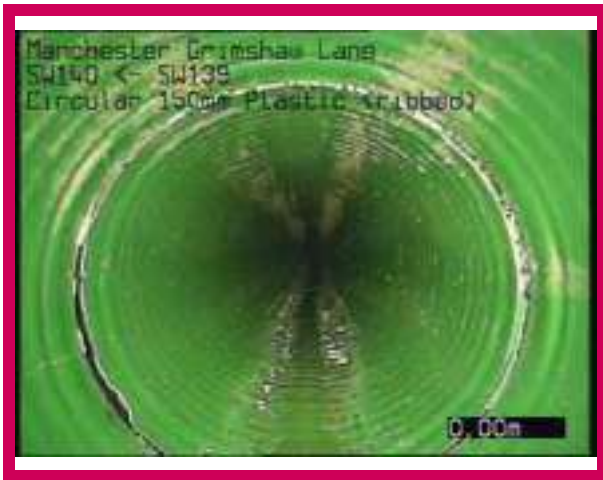
1, 00:00:00, 0.00 m  
Start node, manhole, reference: SW140

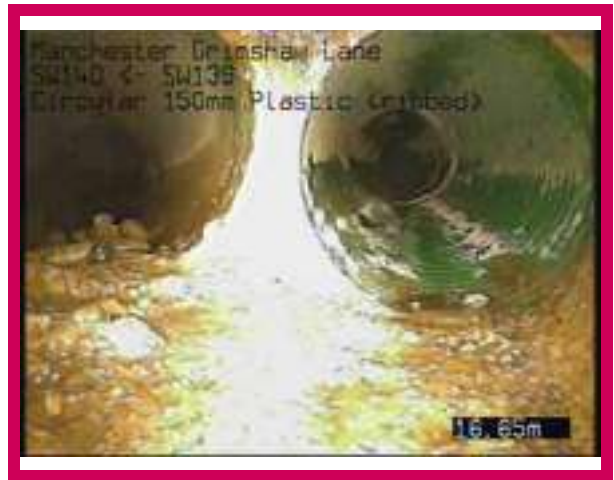
2, 00:02:37, 16.65 m  
Finish node, manhole, reference: SW139

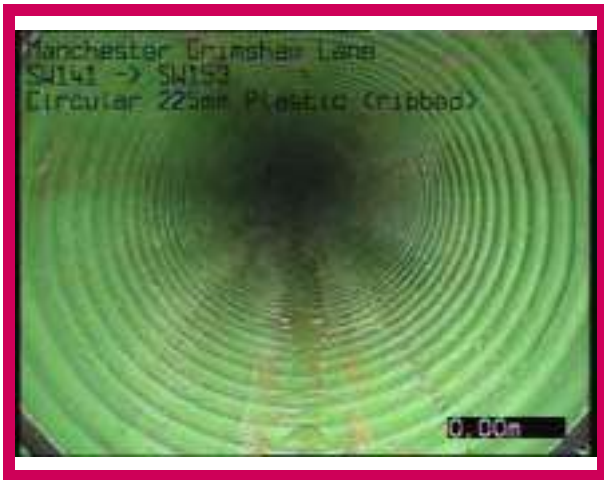
1, 00:00:00, 0.00 m  
Start node, manhole, reference: SW141

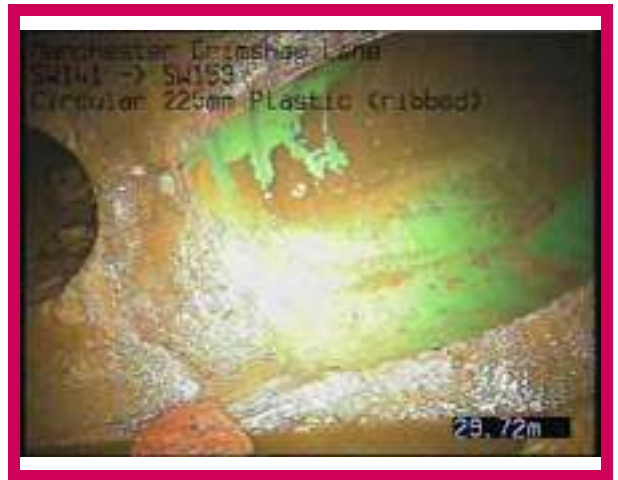
2, 00:02:28, 29.72 m  
Finish node, manhole, reference: SW153

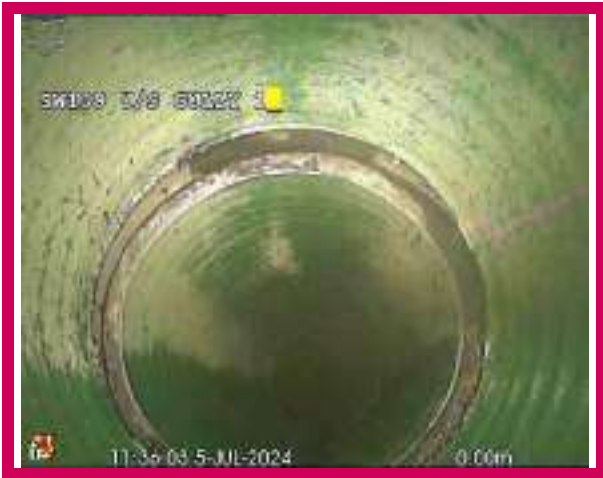
1, 00:00:00, 0.00 m  
Start node, manhole, reference: SW139

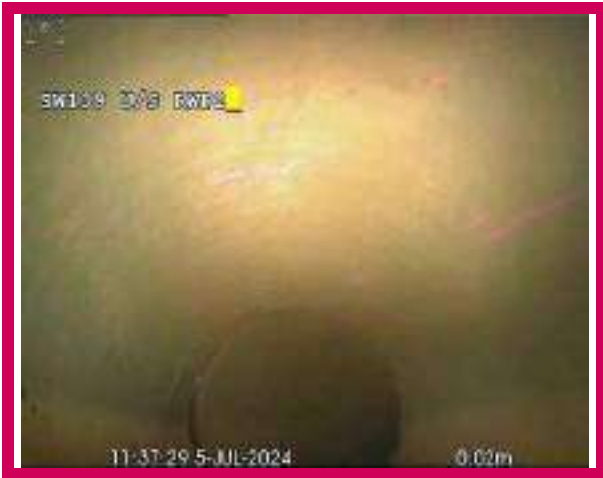
1, 00:00:00, 0.00 m  
Start node, manhole, reference: SW139

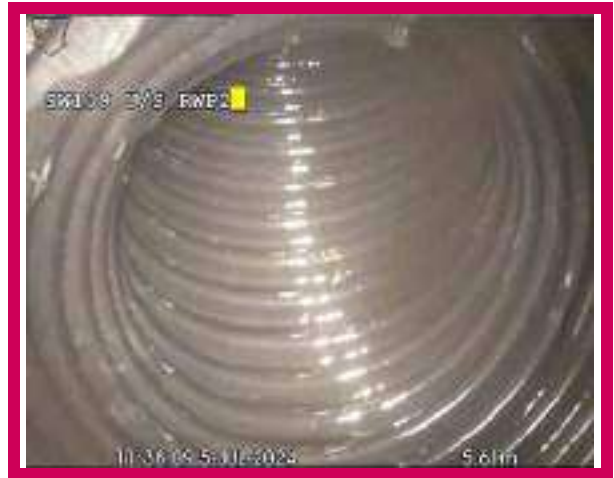
2, 00:00:39, 5.61 m  
Finish node, other special chamber, reference: RWP2, Pipe material changes back to ribbed plastic and goes up to RWP.

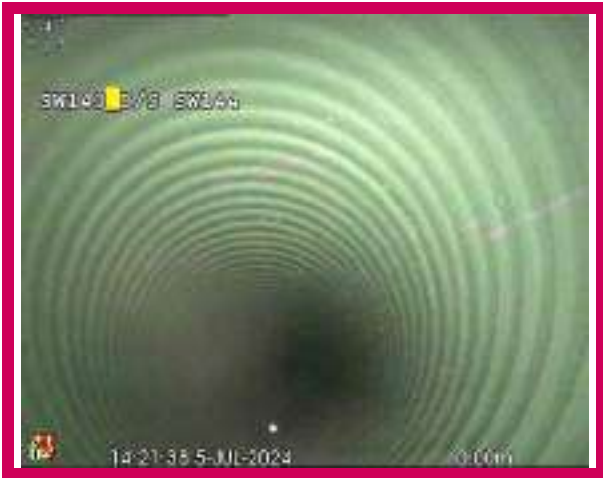
1, 00:00:00, 0.00 m  
Start node, manhole, reference: SW143

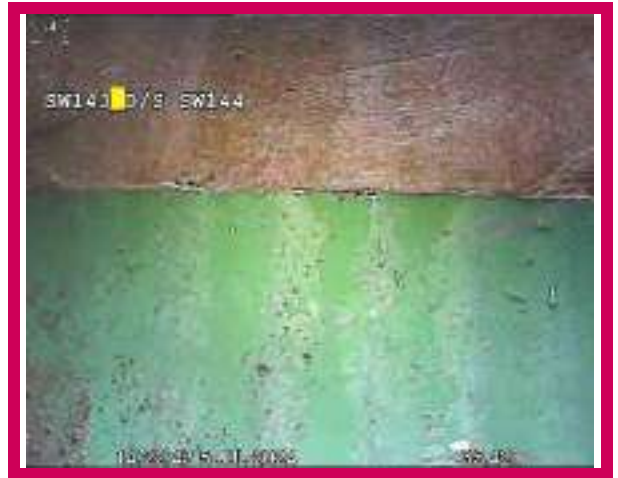
2, 00:01:04, 35.44 m  
Finish node, manhole, reference: SW144

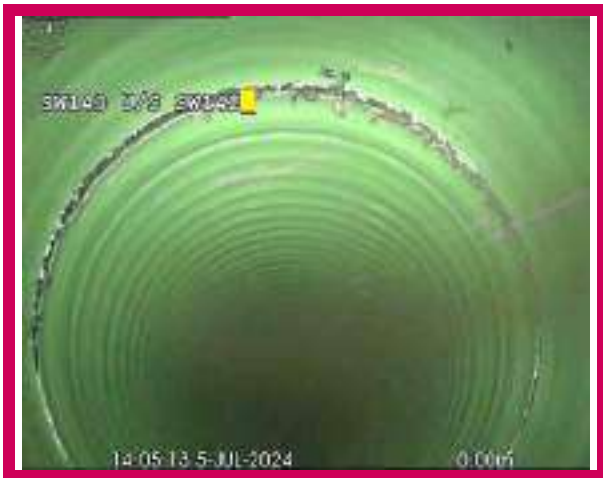
1, 00:00:00, 0.00 m  
Start node, manhole, reference: SW143

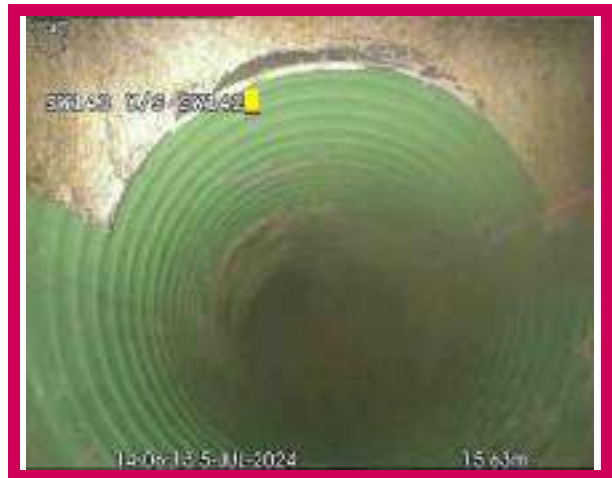
2, 00:00:59, 15.63 m  
Finish node, manhole, reference: SW142

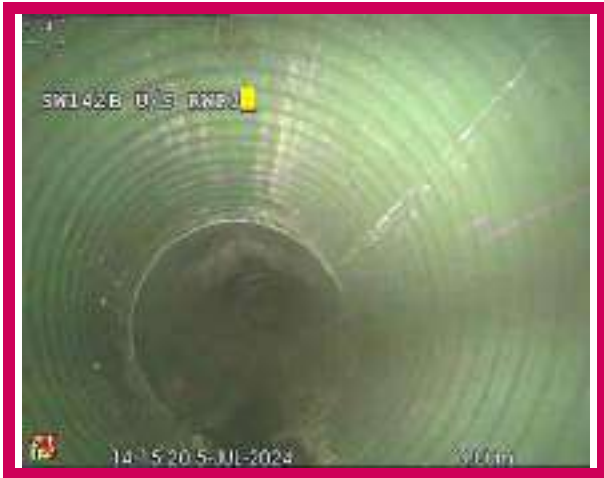
1, 00:00:00, 0.00 m  
Start node, manhole, reference: RWP3

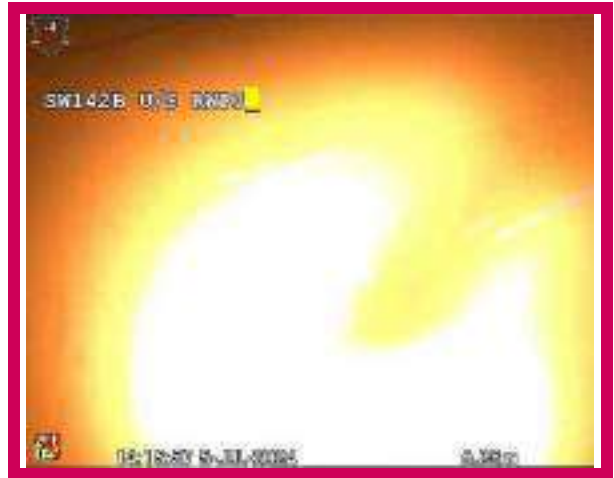
2, 00:00:35, 6.35 m  
Finish node, other special chamber, reference: SW142, Line  
reduces to RWP

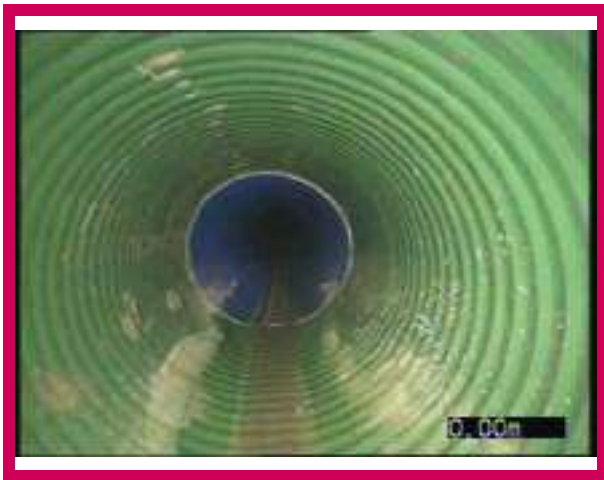
1, 00:00:00, 0.00 m  
Start node, manhole, reference: SW 125

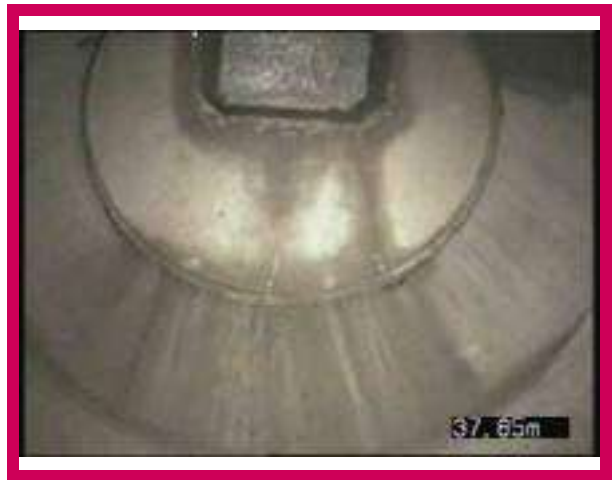
2, 00:03:03, 37.93 m  
Finish node, manhole, reference: SW126

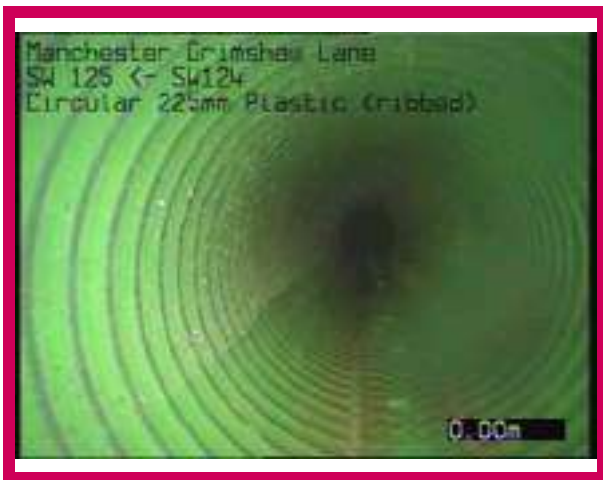
1, 00:00:00, 0.00 m  
Start node, manhole, reference: SW 125

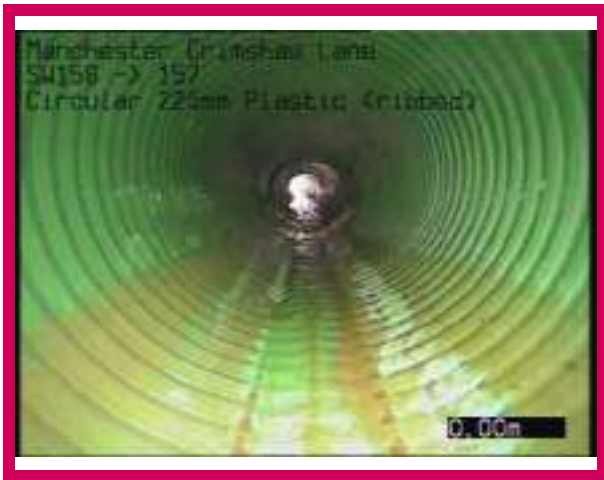
1, 00:00:00, 0.00 m  
Start node, manhole, reference: SW156

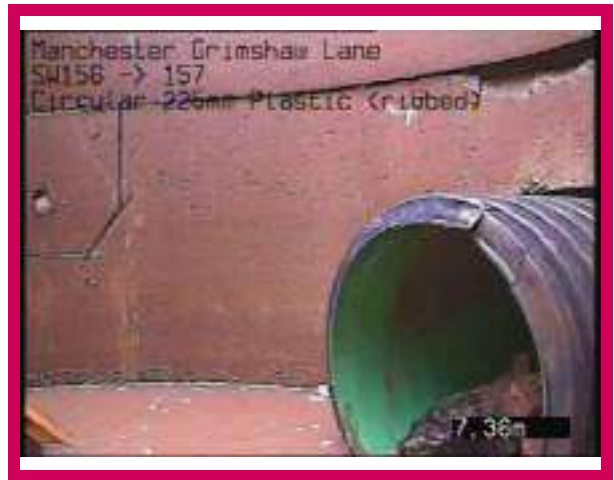
2, 00:00:53, 7.36 m  
Finish node, manhole, reference: SW157

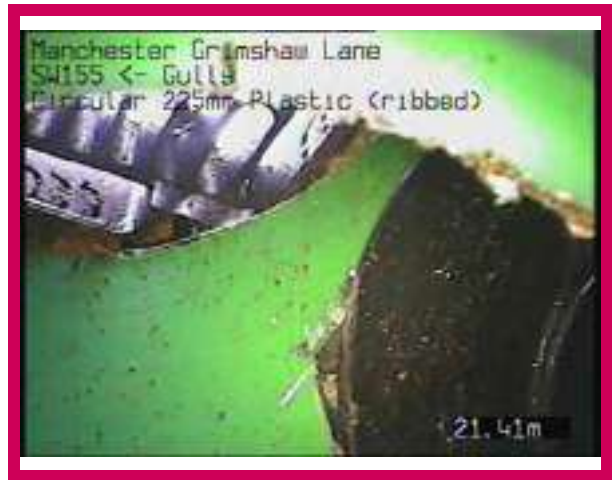
2, 00:03:39, 21.41 m  
Finish node, other special chamber, reference: Gully, In gully

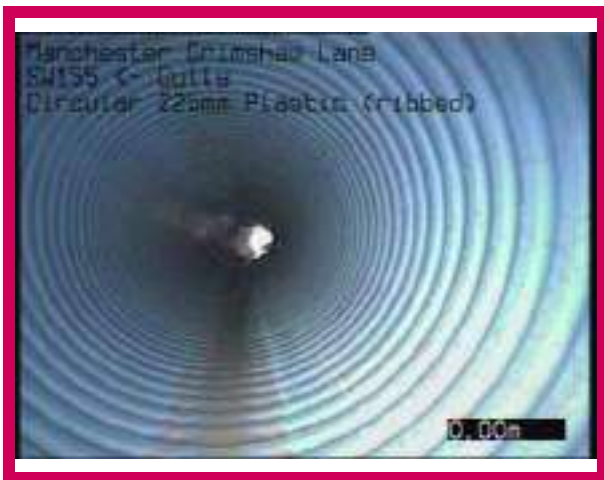
1, 00:00:00, 0.00 m  
Start node, manhole, reference: SW155

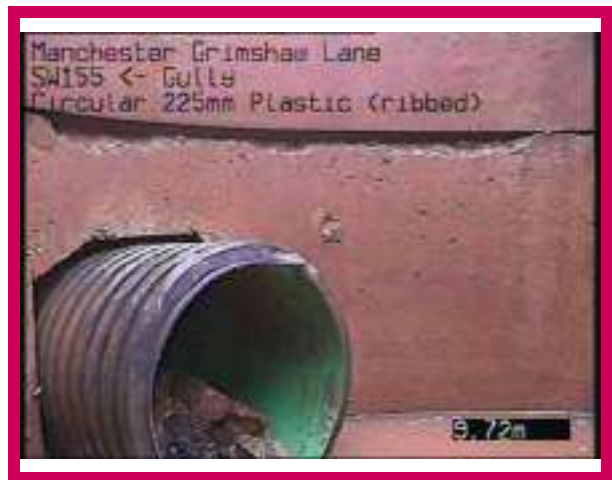
2, 00:01:00, 9.72 m  
Finish node, manhole, reference: SW157

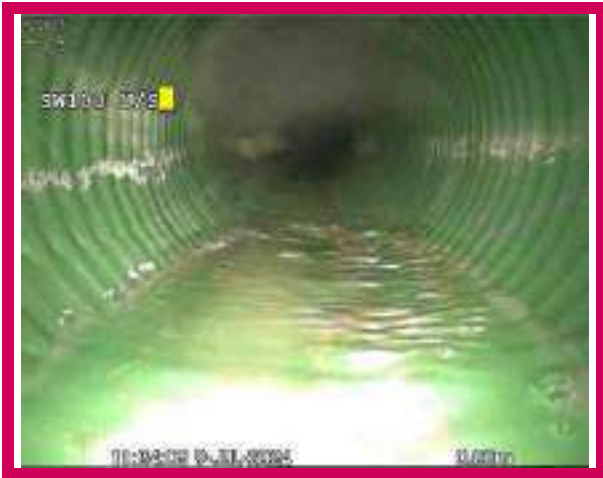
1, 00:00:00, 0.00 m  
Start node, manhole, reference: SW103

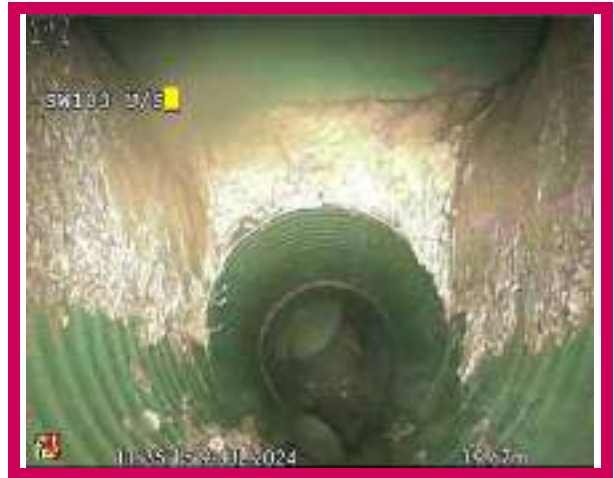
2, 00:01:06, 19.67 m  
Finish node, manhole, reference: Unmarked, MH not marked  
on plan.

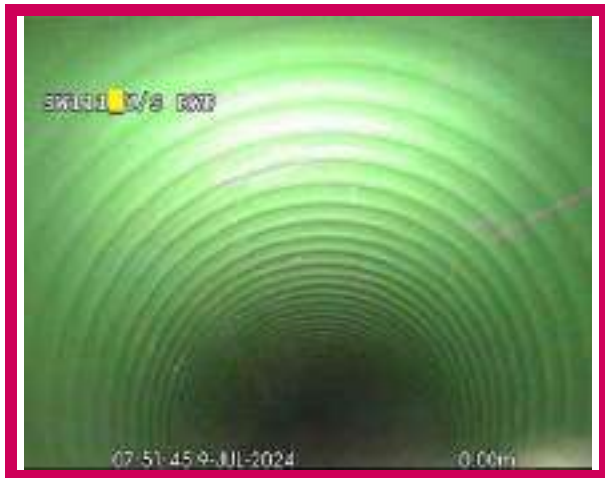
1, 00:00:00, 0.00 m  
Start node, manhole, reference: SW111

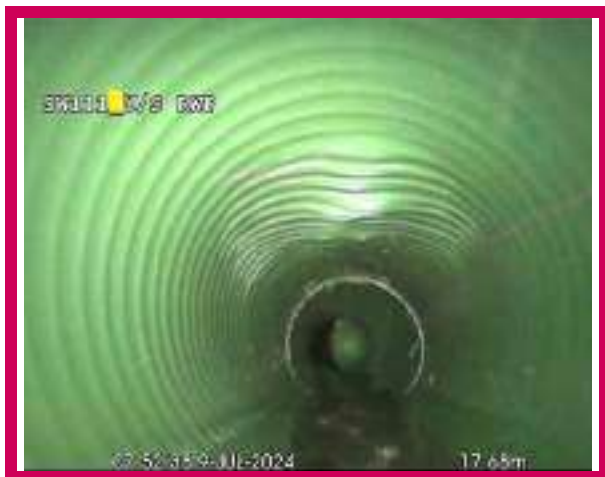
3, 00:00:52, 17.68 m  
Deformed drain or sewer, 10%

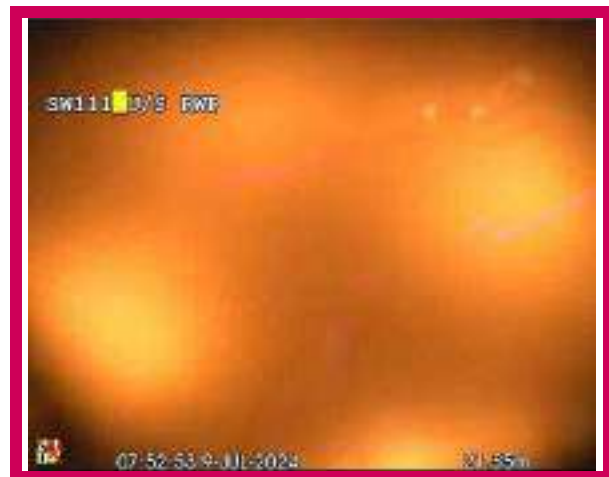
4, 00:01:07, 21.55 m  
Finish node, other special chamber, reference: RWP, Bottom of RWP

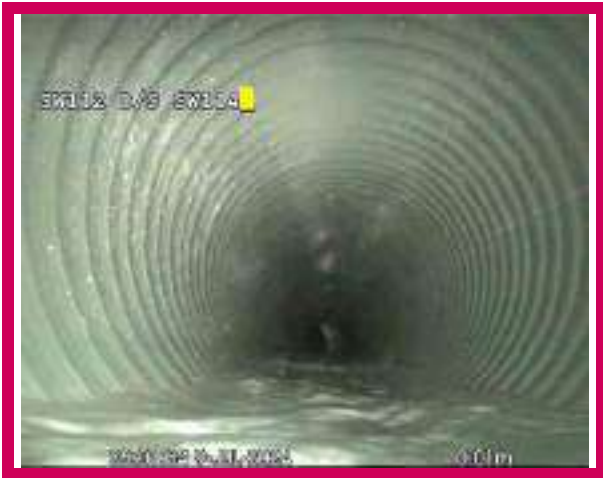
1, 00:00:00, 0.00 m  
Start node, manhole, reference: SW112

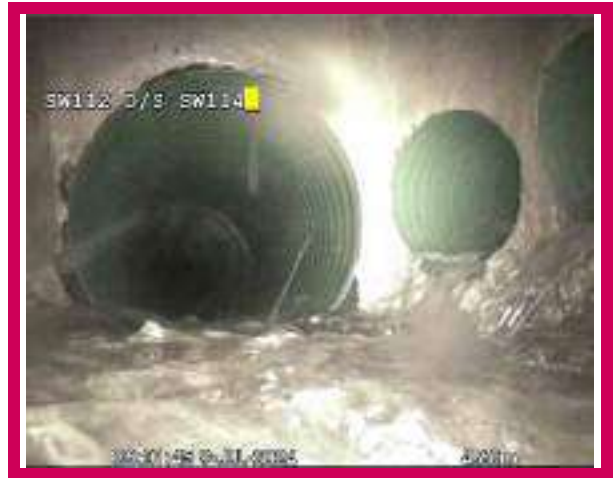
2, 00:00:10, 4.60 m  
Finish node, manhole, reference: SW114

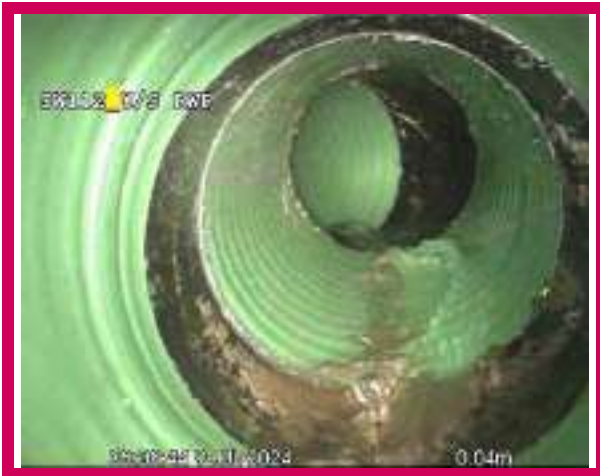
1, 00:00:00, 0.00 m  
Start node, manhole, reference: SW112

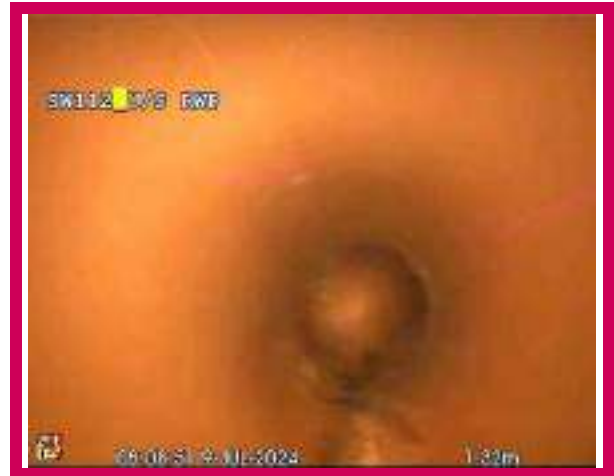
2, 00:00:06, 1.32 m  
General remark, Material change of pipe. to smooth plastic

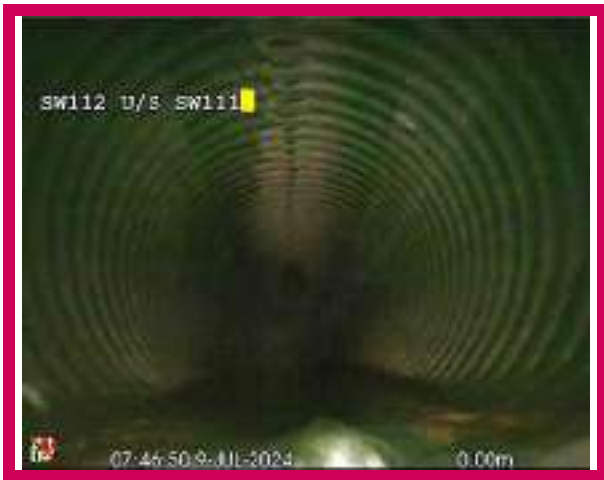
1, 00:00:00, 0.00 m  
Start node, manhole, reference: SW112

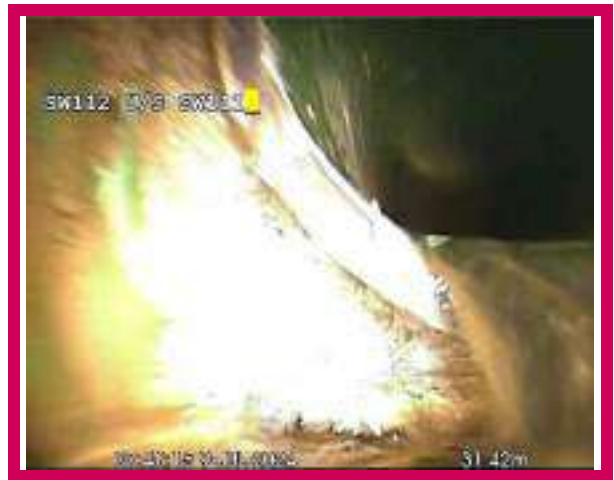
2, 00:01:24, 31.42 m  
Finish node, manhole, reference: SW111

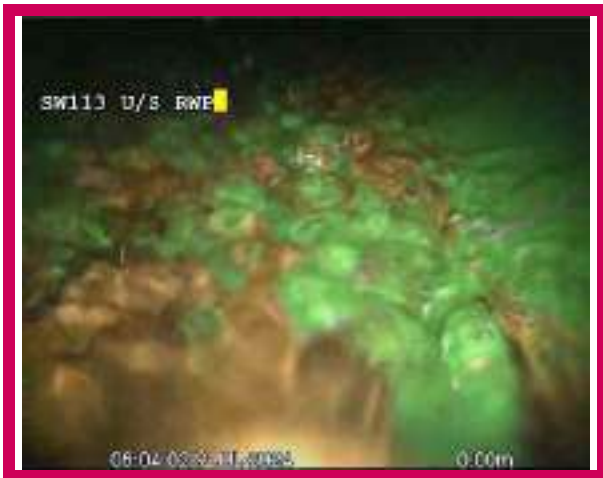
1, 00:00:00, 0.00 m  
Start node, manhole, reference: SW113

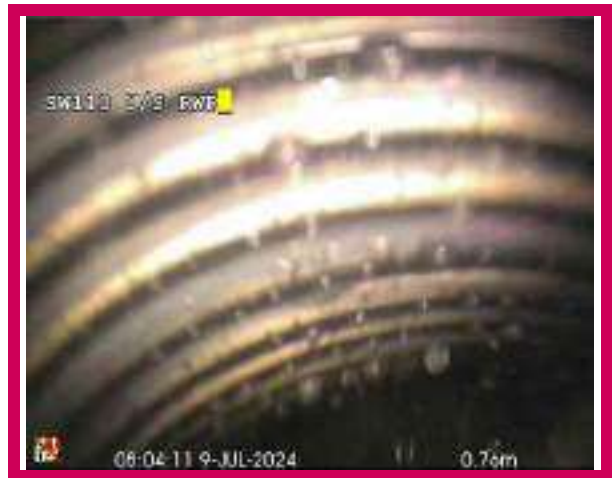
2, 00:00:08, 0.76 m  
Finish node, other special chamber, reference: RWP, In  
bottom of RWP

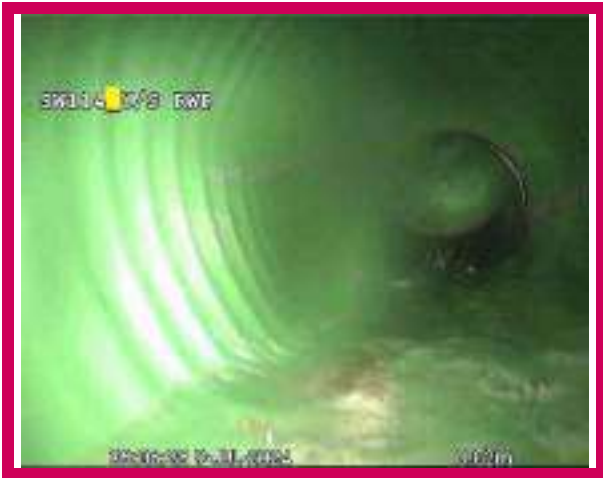
1, 00:00:00, 0.00 m  
Start node, manhole, reference: SW114

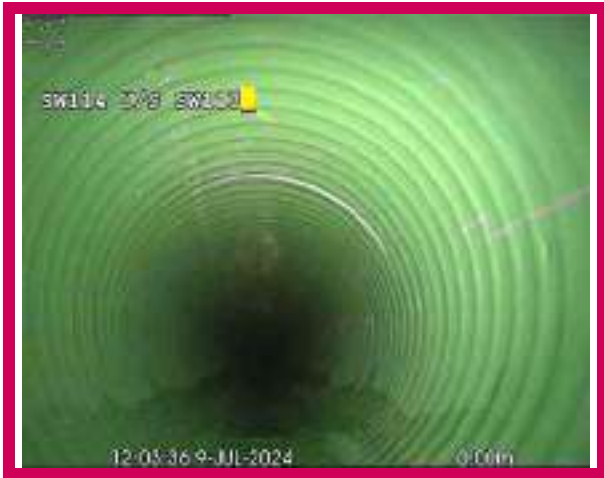
1, 00:00:00, 0.00 m  
Start node, manhole, reference: SW114

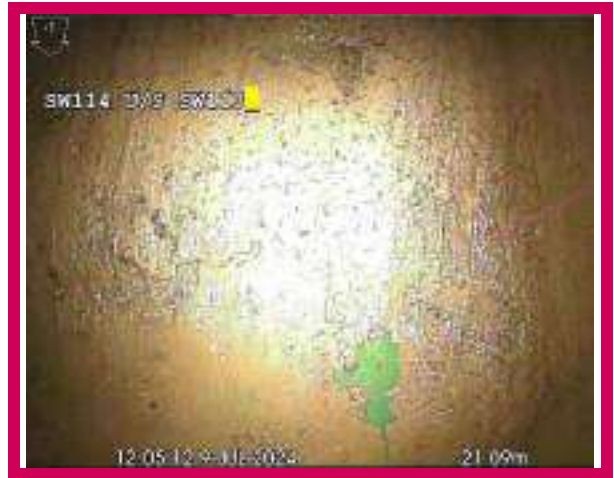
2, 00:01:35, 21.09 m  
Finish node, manhole, reference: SW113

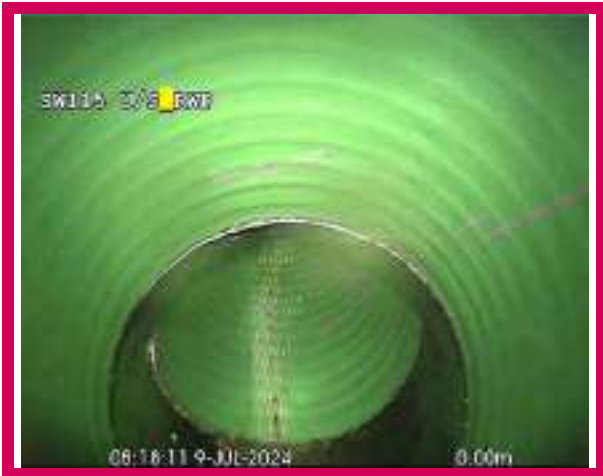
1, 00:00:00, 0.00 m  
Start node, manhole, reference: SW115

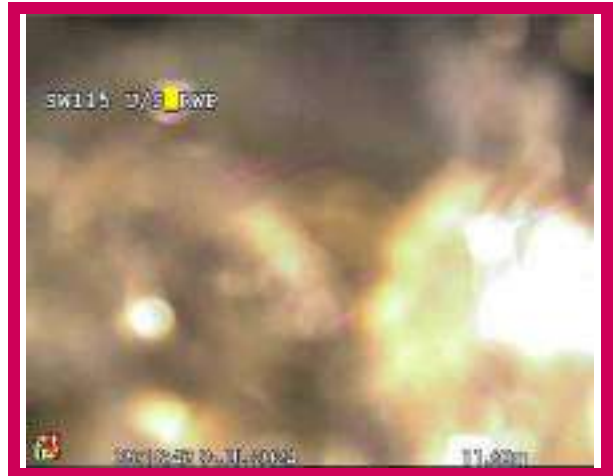
2, 00:00:32, 12.31 m  
Finish node, other special chamber, reference: RWP, In RWP

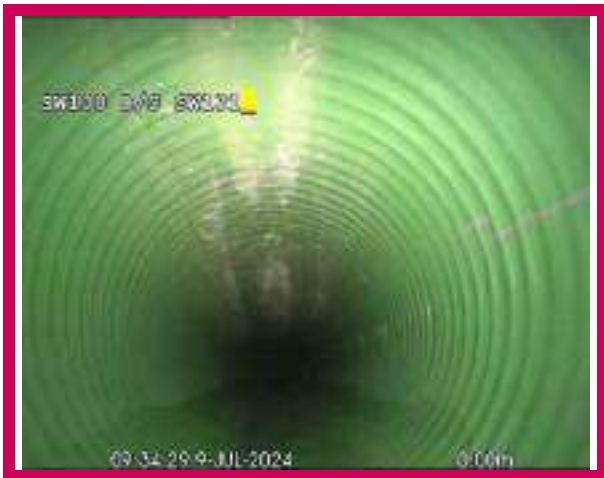
1, 00:00:00, 0.00 m  
Start node, manhole, reference: SW130

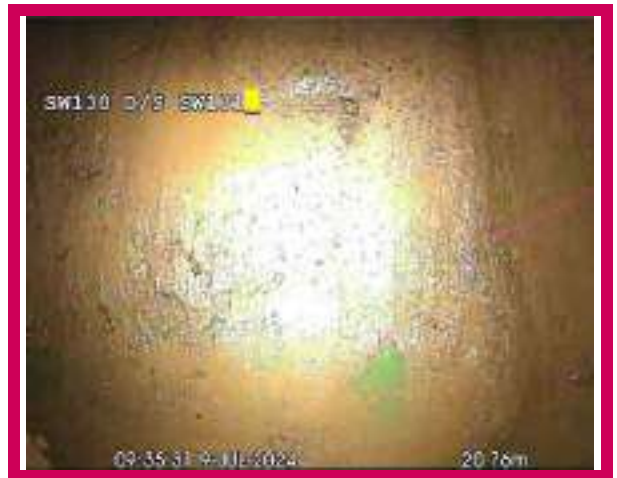
2, 00:01:01, 20.76 m  
Finish node, manhole, reference: SW131

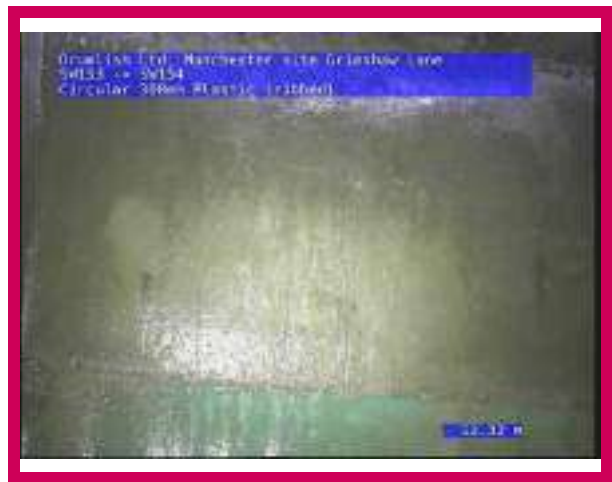
2, 00:00:40, 12.32 m  
Finish node, manhole, reference: SW154

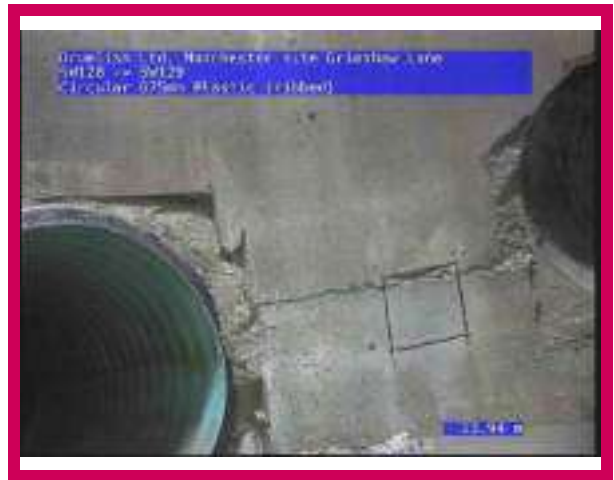
2, 00:00:51, 13.94 m  
Finish node, catchpit, reference: SW129

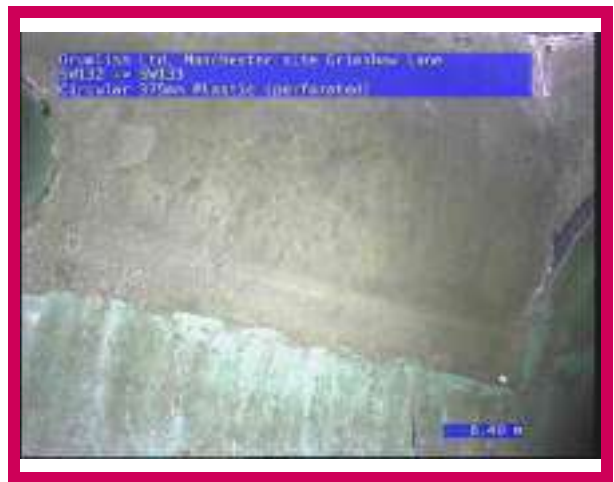
2, 00:00:37, 8.40 m  
Finish node, manhole, reference: SW133

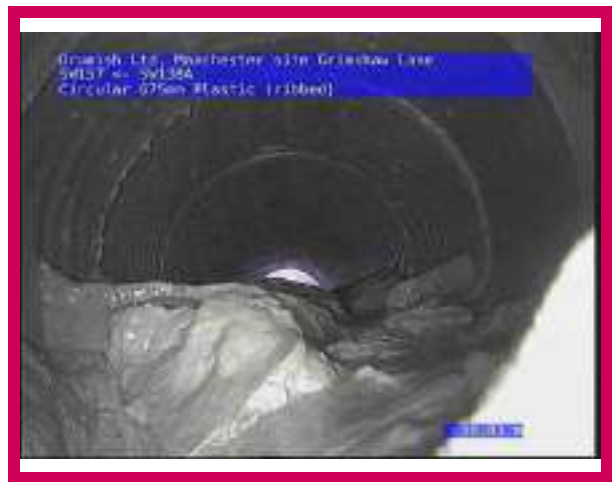
| <b>Comments:</b> | SW138A IS BURIED/ 600mm not 675mm | | | | |

2, 00:02:45, 36.82 m  
Finish node, manhole, reference: SW138A, Rubble in buried chamber

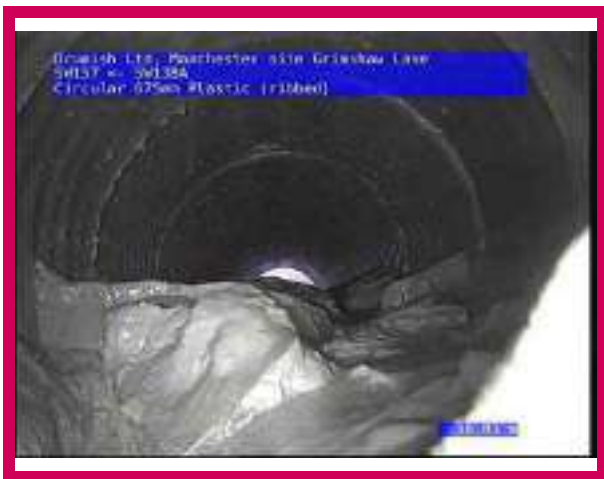
3, 00:02:45, 36.82 m  
Finish node, manhole, reference: SW138A, Rubble in buried chamber

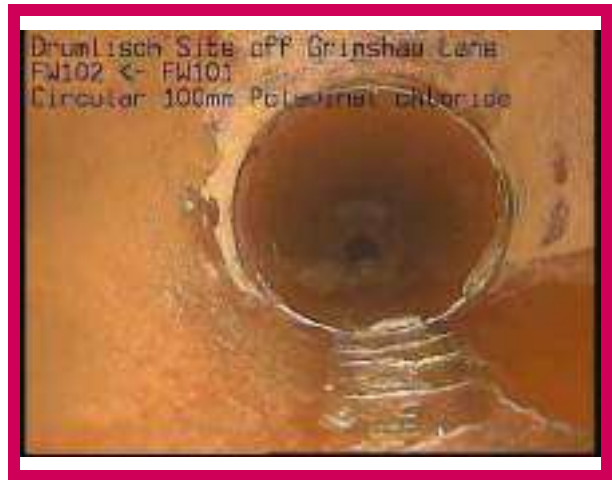
2, 00:04:25, 41.45 m  
Settled deposits, fine, 5% cross-sectional area loss

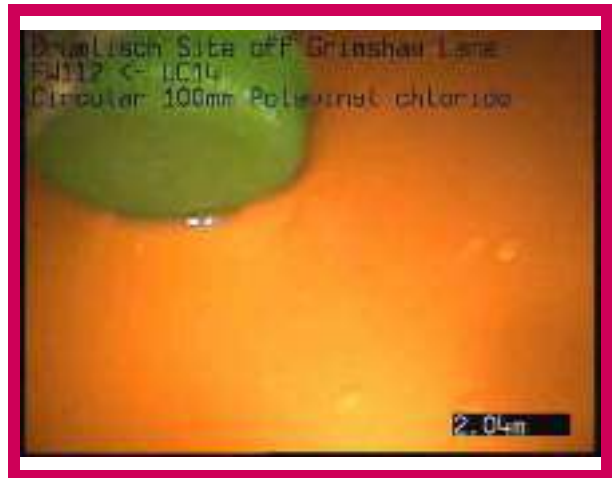
2, 00:00:22, 2.04 m  
Other obstacles, other object in invert at 6 o'clock, 10%  
cross-sectional area loss, Bottle in line

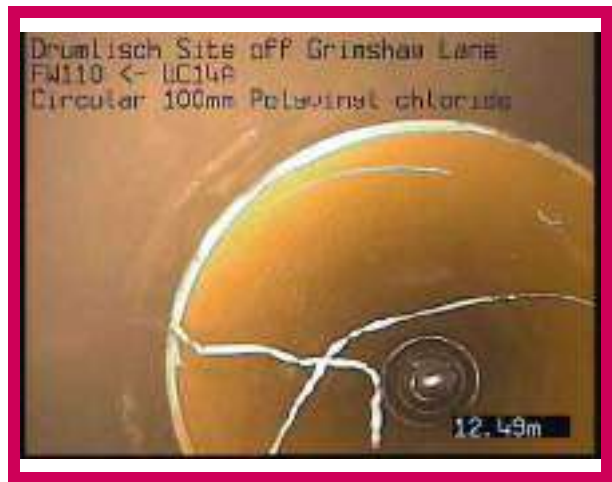
2, 00:01:10, 12.49 m  
Roots, fine at joint

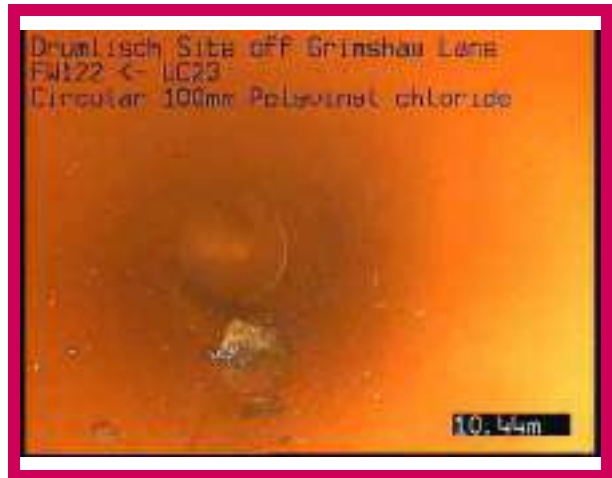
2, 00:01:13, 10.44 m  
Settled deposits, fine, 5% cross-sectional area loss

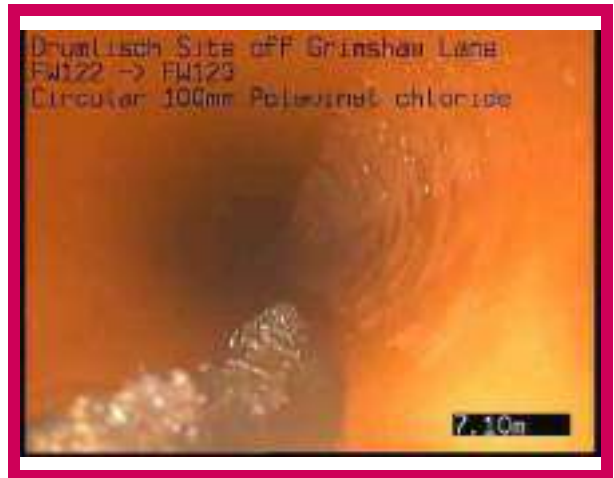
2, 00:00:26, 7.10 m  
Settled deposits, fine, 5% cross-sectional area loss

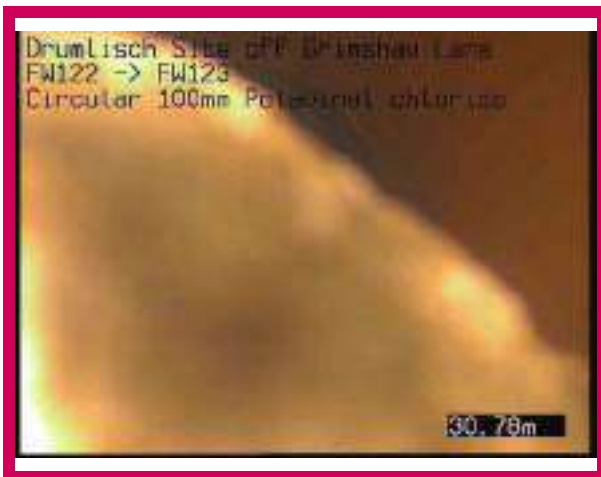
3, 00:01:55, 30.78 m  
Finish node, manhole, reference: FW123, Rubble removed at  
MH

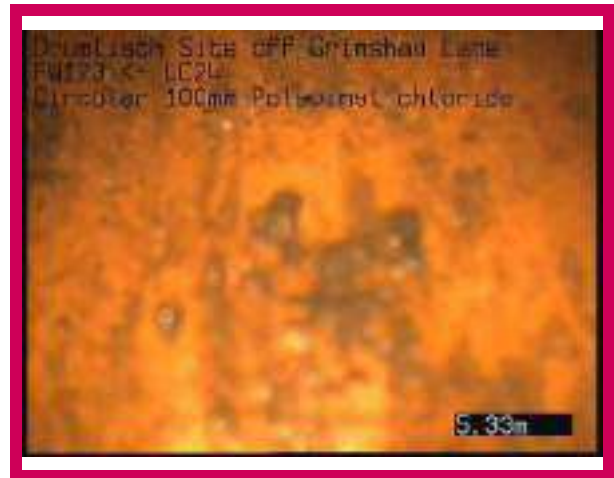
2, 00:00:31, 4.71 m  
Settled deposits, fine, 5% cross-sectional area loss

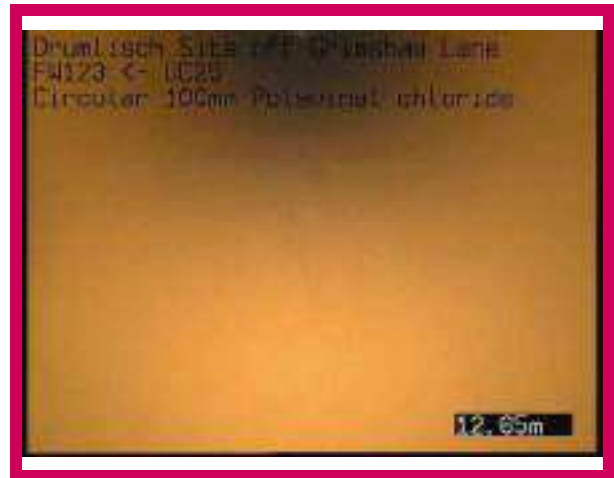
2, 00:01:09, 12.65 m  
Finish node, other special chamber, reference: UC25, In View  
unable to push round bends
